## HISTORIC HOME INSPECTIONS REPORT

1234 Main Street  
Newport, RI 02840

08/18/2026 9:00AM

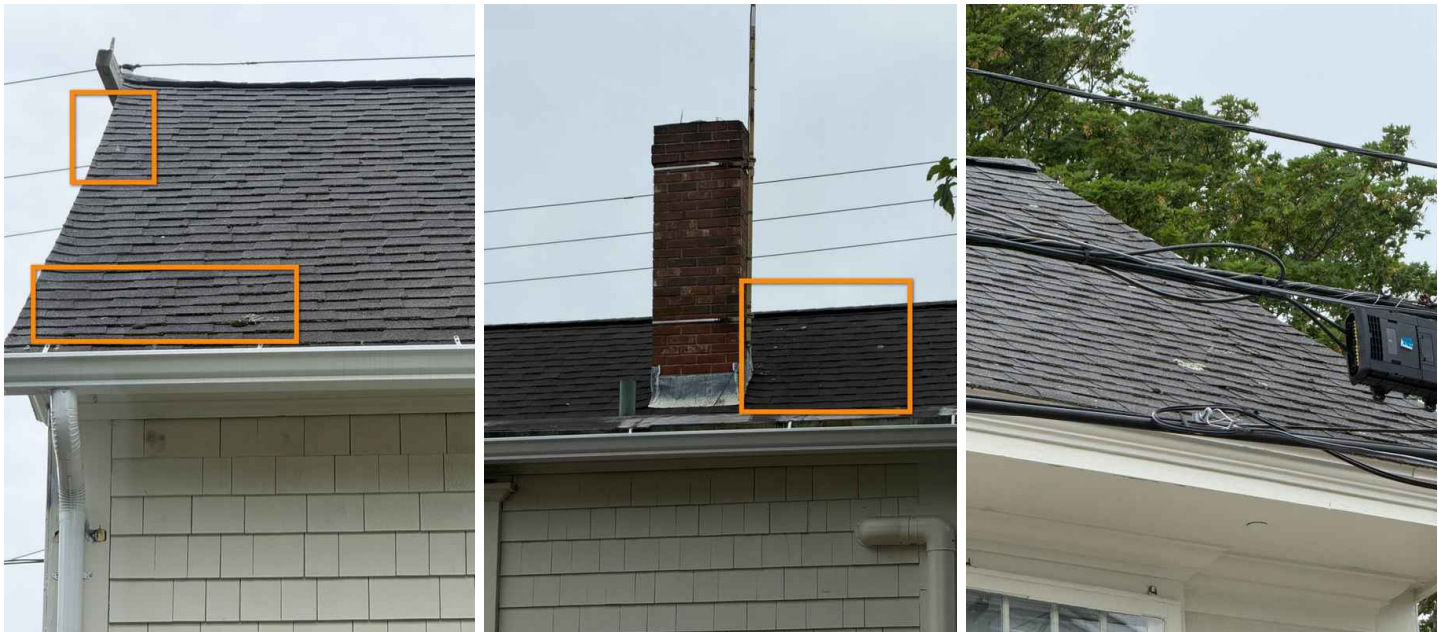
I noted organic material accumulation on the architectural shingles. This condition can retain moisture against the roof surface, accelerating deterioration and reducing the lifespan of the shingles. I recommend cleaning and treatment of the roof covering by a qualified roofing contractor.

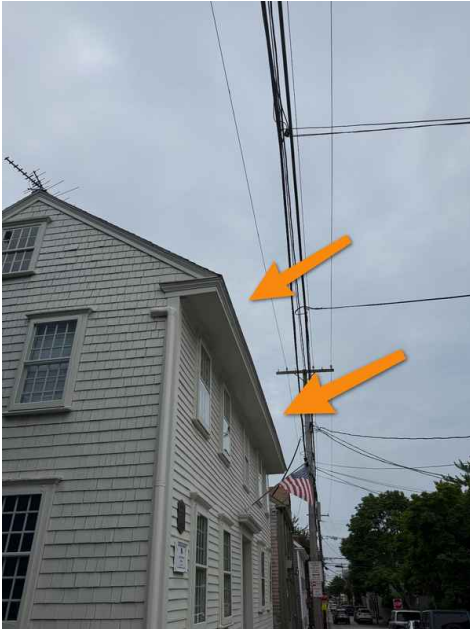
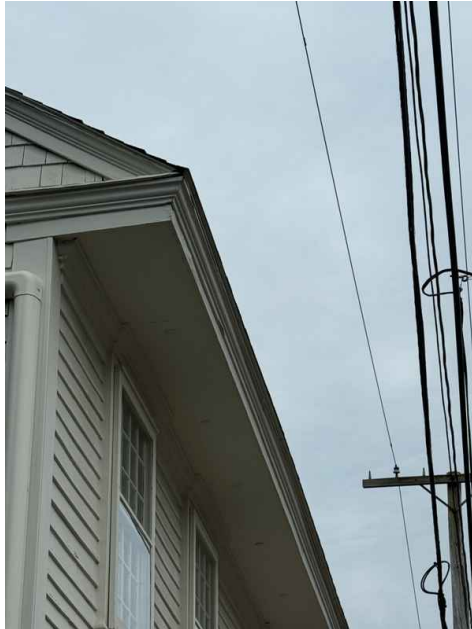
2.3.1 Gutters

GUTTERS: MISSING

I observed gutters were missing at portions of the roof perimeter during inspection. The absence of gutters may allow uncontrolled roof runoff to discharge directly adjacent to the foundation and exterior surfaces, which can contribute to erosion, moisture intrusion, and premature deterioration of building materials over time. I recommend installation of an appropriate gutter system by a qualified contractor to improve roof drainage management.

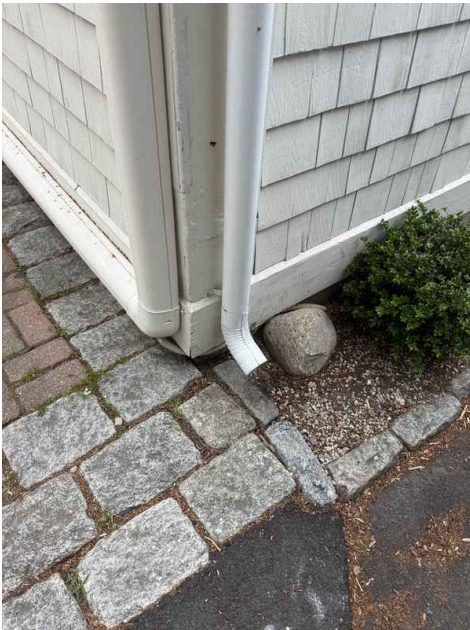
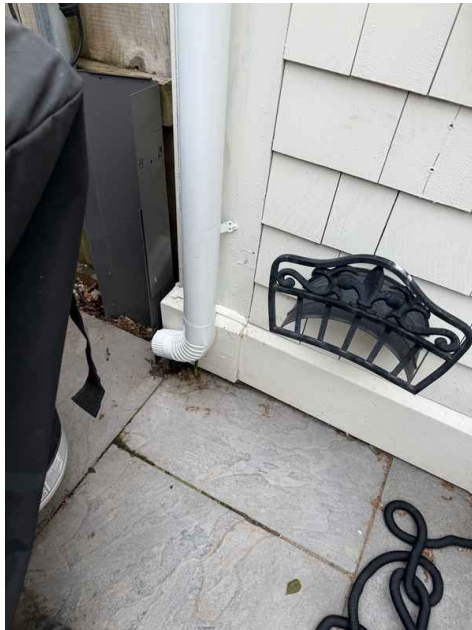
#### 2.4.1 Downspouts

### **DOWNSPOUTS TERMINATE NEAR FOUNDATION**

I observed the downspout terminates adjacent to the foundation. This condition can allow water to accumulate near the structure, increasing the risk of moisture intrusion and soil movement. I recommend installation of a downspout extension to discharge water 6 to 10 feet away from the foundation.

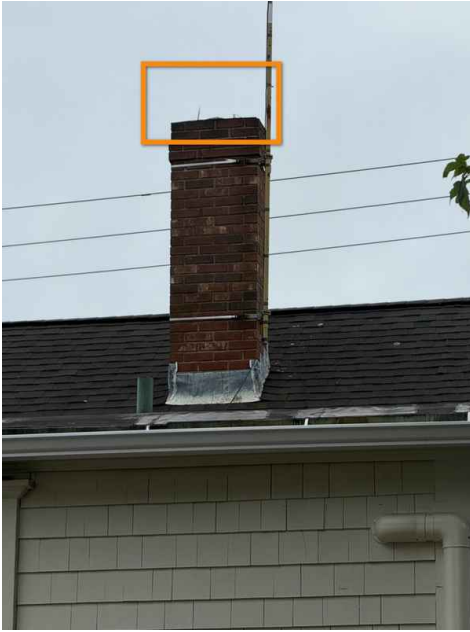
#### 2.5.1 Chimney (Above Roof-line)

### **CHIMNEY: MISSING RAIN CAP**

I observed the chimney rain cap is missing. This can allow water intrusion, debris entry, and potential animal access, which may contribute to deterioration or blockage. I recommend installation of a proper rain cap by a qualified chimney professional.

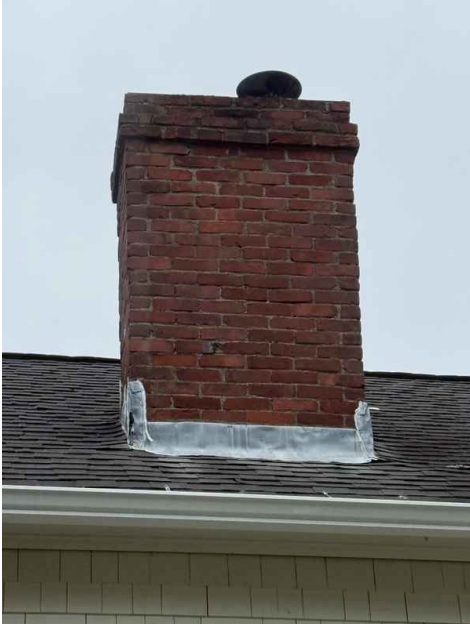
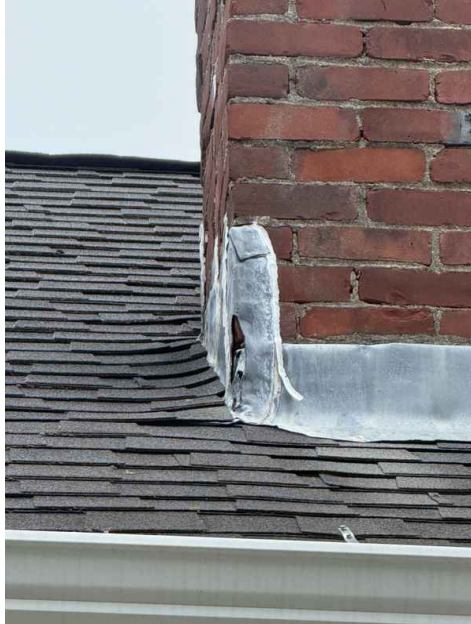
### 2.5.2 Chimney (Above Roof-line)

#### **DAMAGED FLASHING**

Damaged flashing was observed on the chimney above the roof-line during inspection. Flashing serves as a critical seal to prevent water intrusion where the chimney penetrates the roof. Deteriorated or compromised flashing can allow water to leak into the structure, potentially causing roof damage, interior water damage, and mold growth. A roofing professional should inspect and repair or replace the flashing to restore a proper weather-tight seal.

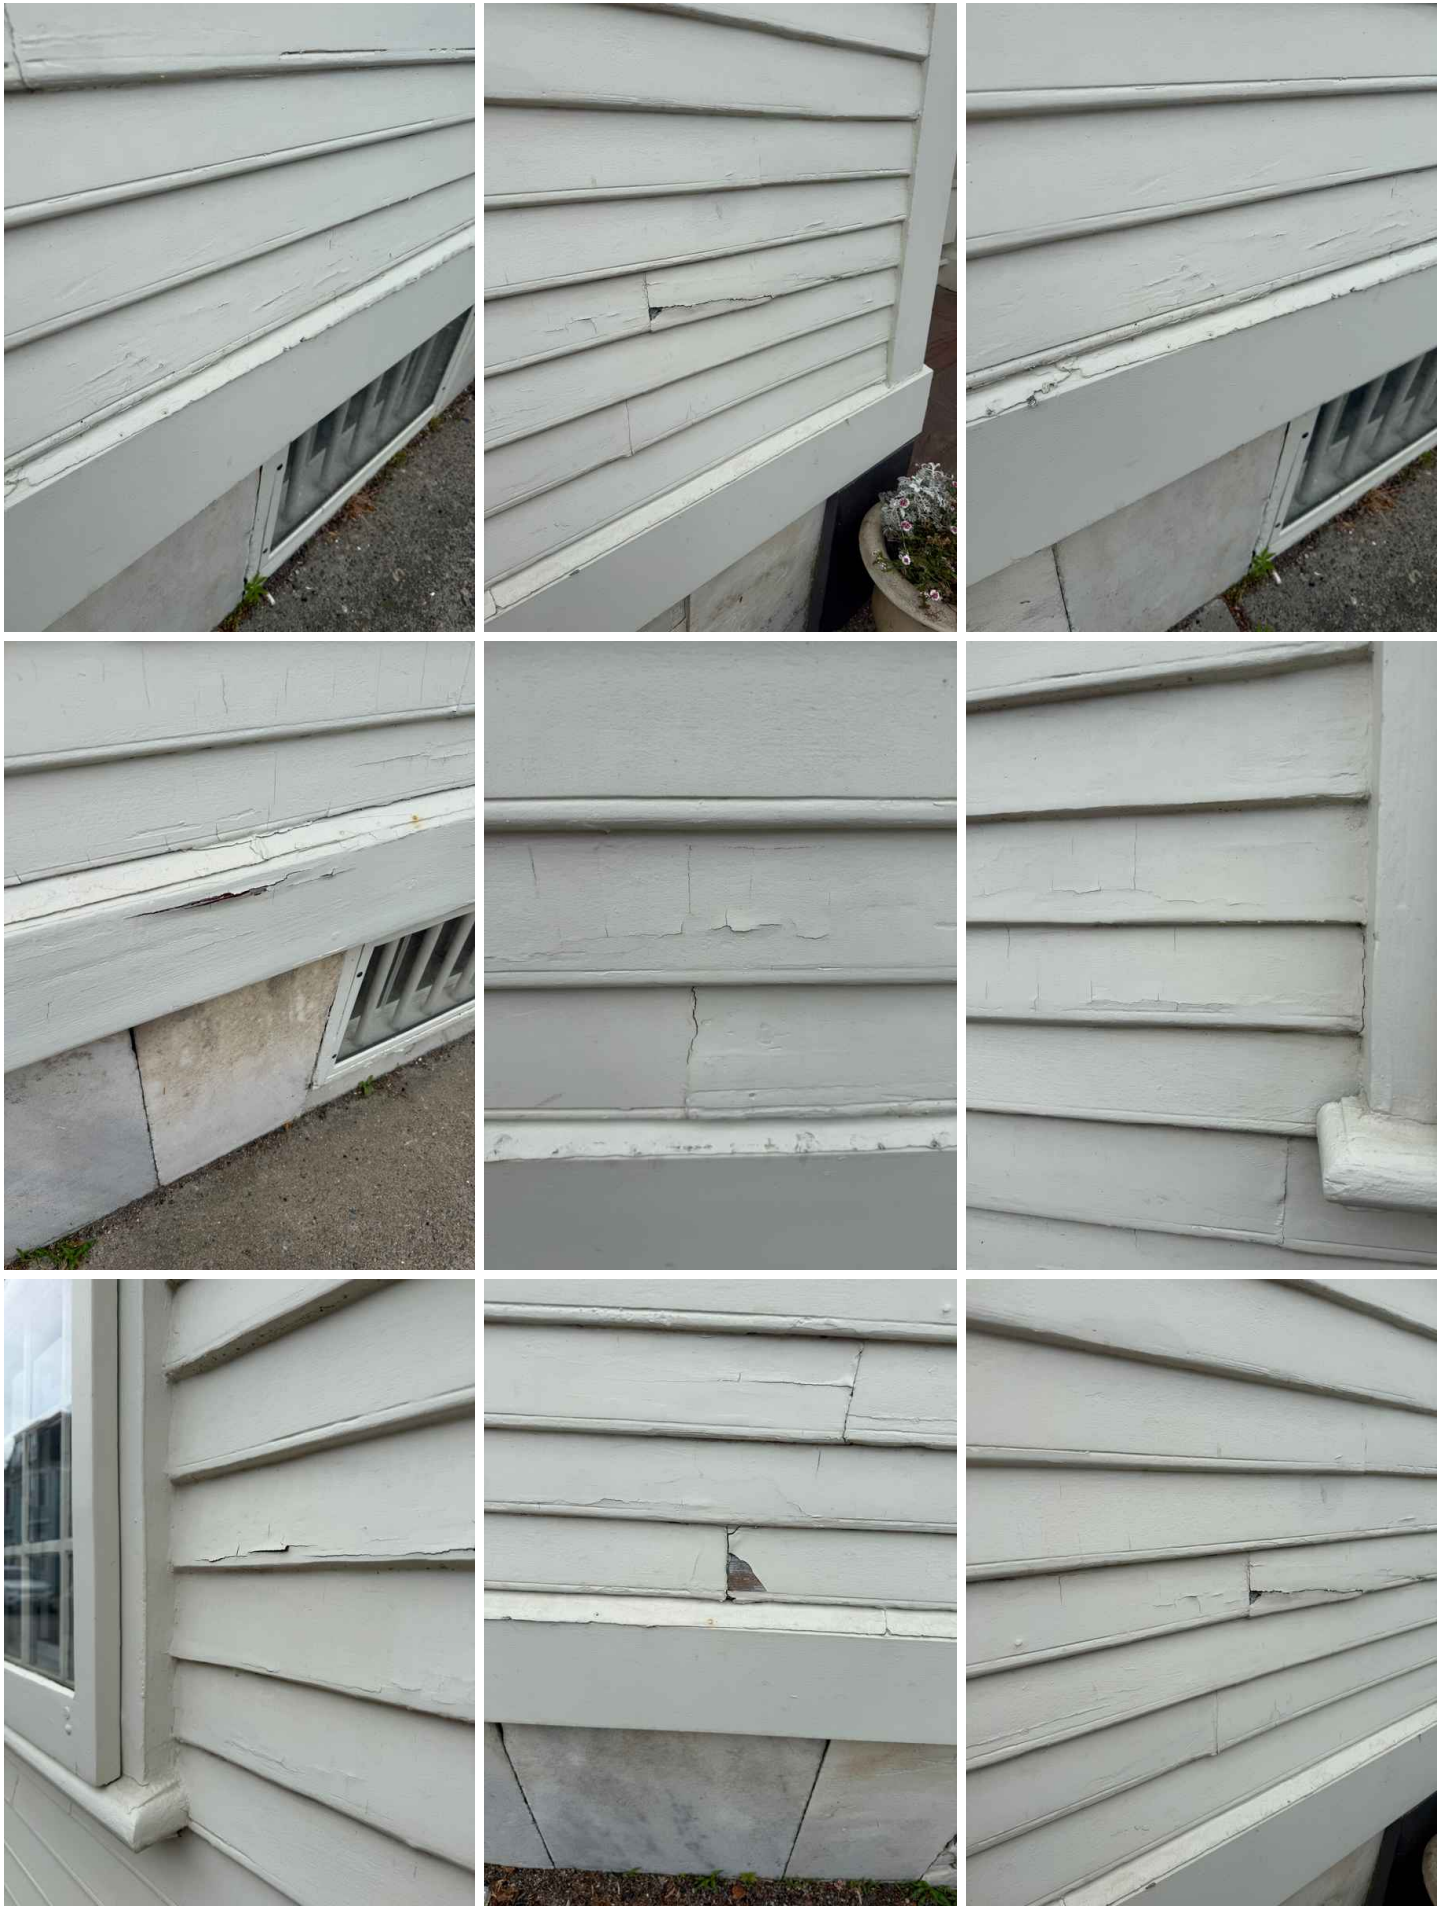
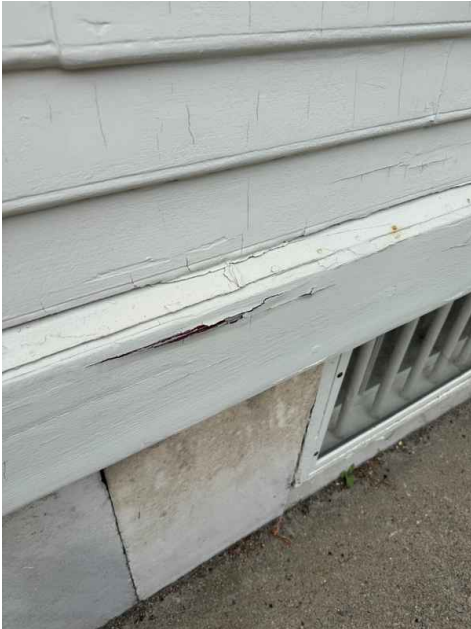
PAINT DETERIORATION

Paint on the wood lap siding is chipping, cracking, and deteriorating. This exposes the underlying wood to moisture infiltration and UV damage. Recommend having a painting contractor prepare and repaint the affected areas to restore protection and prevent further wood deterioration.

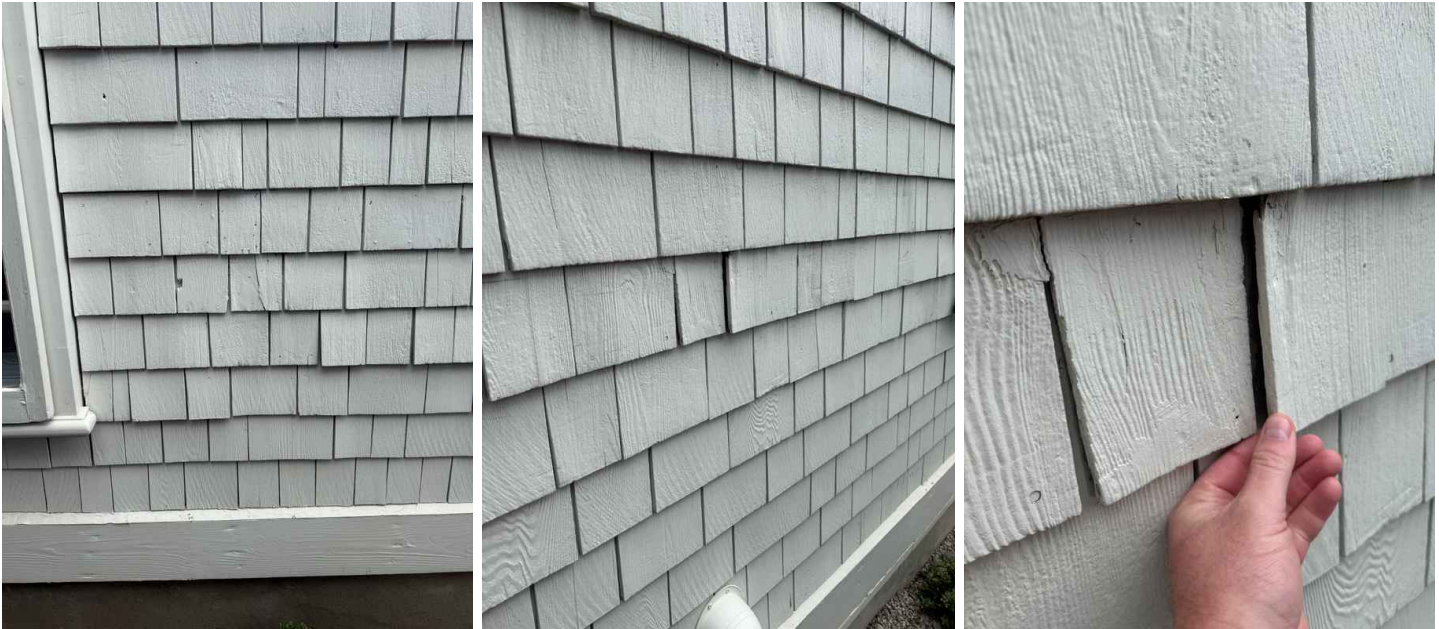
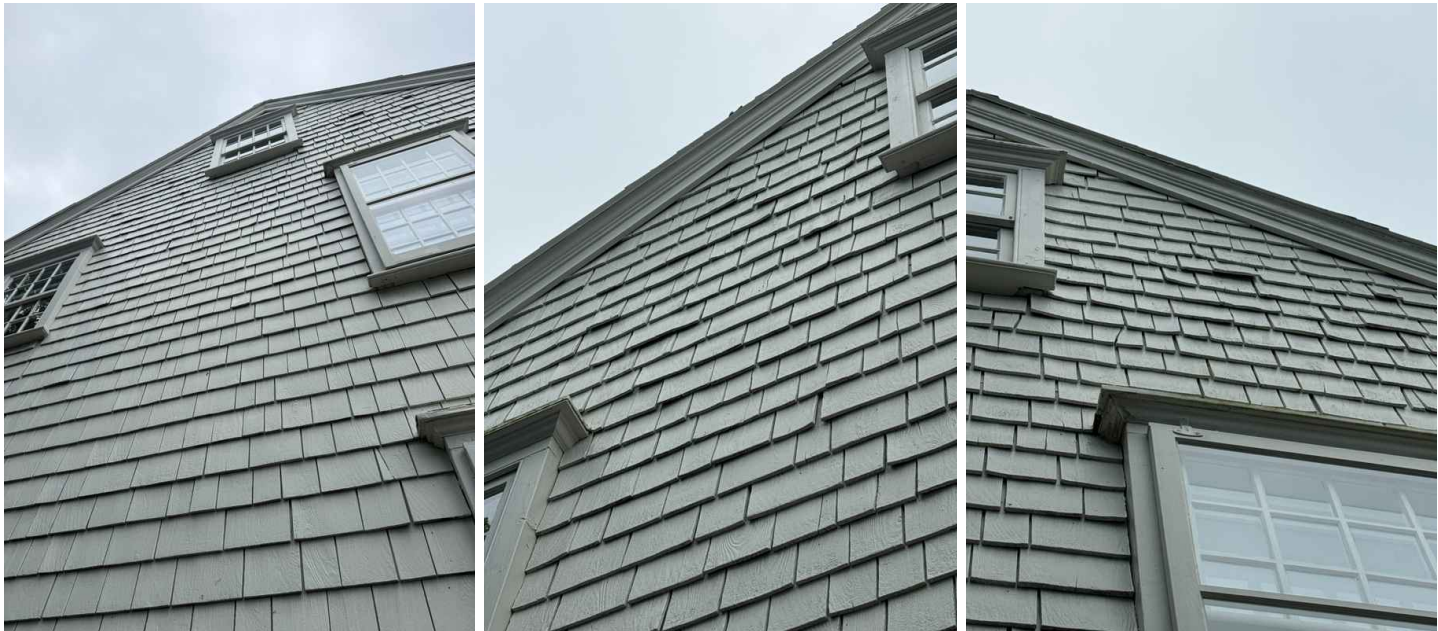
3.2.1 Wood Siding (shingles)

**DETERIORATING WOOD SIDING SHINGLES**

Localized sections of wood siding shingles exhibit aging characteristics including splitting, cupping, and brittleness. These conditions indicate the material is breaking down and losing structural integrity. Deteriorated shingles can allow moisture penetration, potentially leading to water damage, rot, and compromised weatherproofing. A siding contractor should evaluate the extent of damage and recommend repair or replacement of affected shingles to restore proper weather protection.

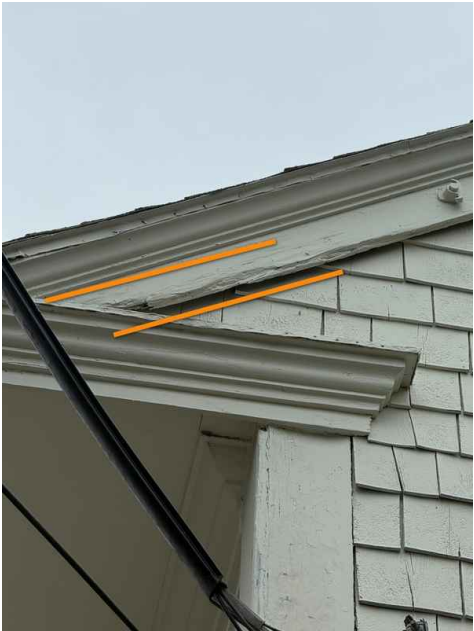
3.3.1 Exterior Trim

**WOOD ROT AT RAKE BOARD**

I noted wood rot at the rake board, likely caused by prolonged moisture exposure. This deterioration can worsen over time, potentially affecting the surrounding structure and trim. I recommend having a licensed carpenter replace the damaged section and address any sources of moisture to prevent future issues.

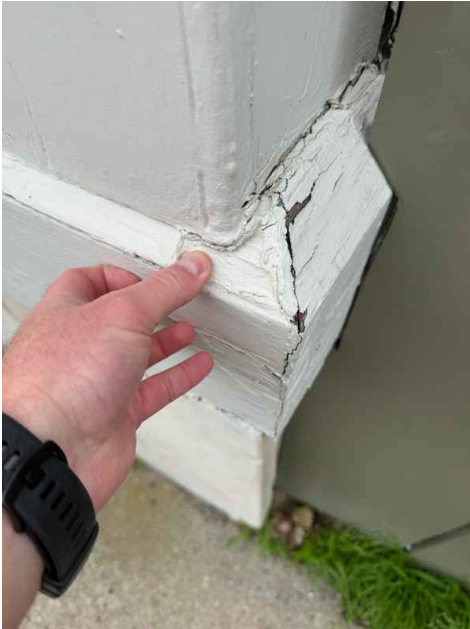
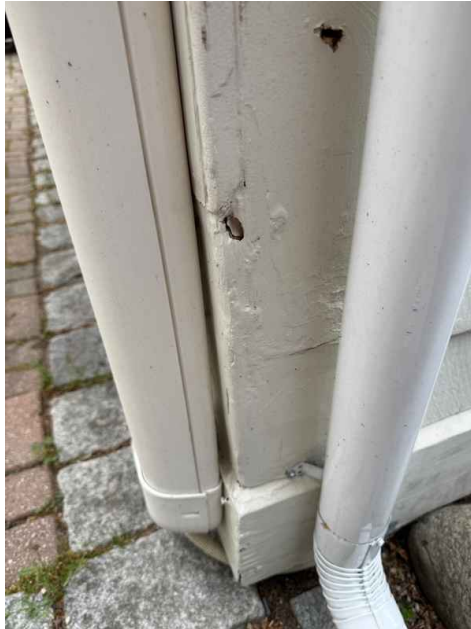
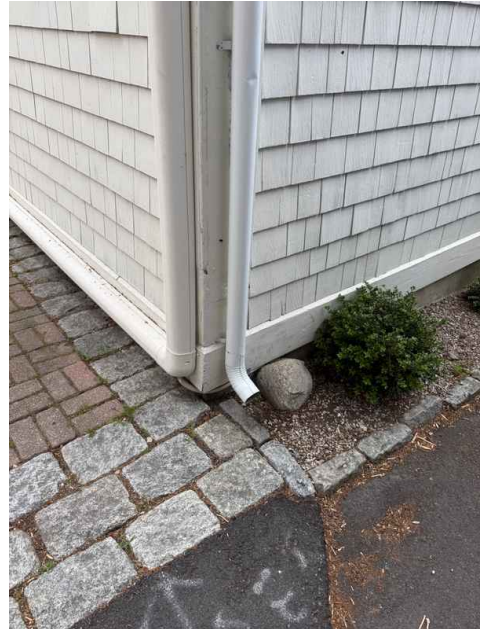
3.3.2 Exterior Trim

**TRIM: WOOD ROT**

Wood rot was noted on exterior trim components, indicating advanced material decay from prolonged moisture exposure. This condition can lead to further deterioration and may affect adjacent building materials. I recommend replacement of the rotted trim by a qualified contractor using properly sealed and weather-resistant materials.

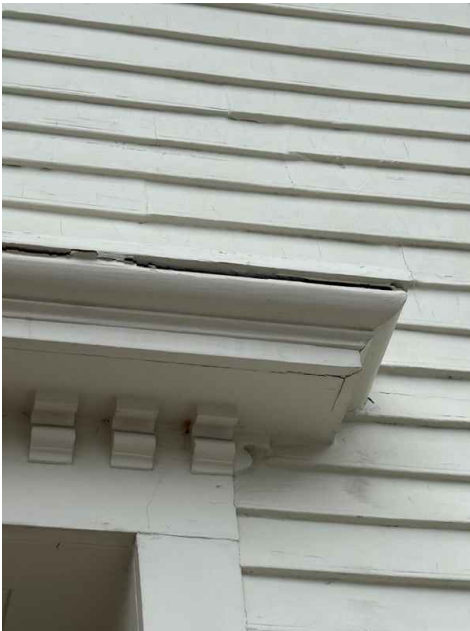
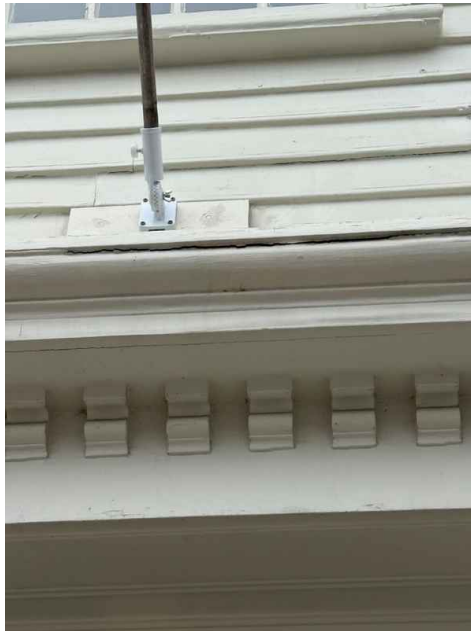
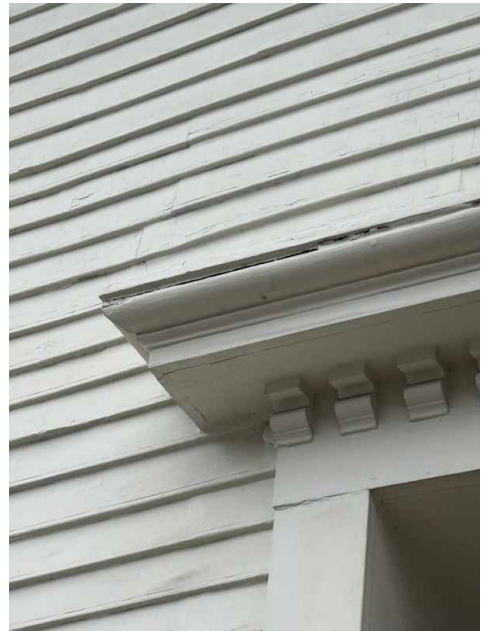
### 3.5.1 Conventional Exterior Doors

#### **SEPARATION AND WOOD ROT AT DOOR PEDIMENT**

Separation and possible wood rot were observed at the front door pediment during exterior inspection. Wood rot can compromise structural integrity and allow water infiltration into the wall cavity. A carpentry contractor should evaluate the extent of rot and repair or replace the affected pediment components as needed.

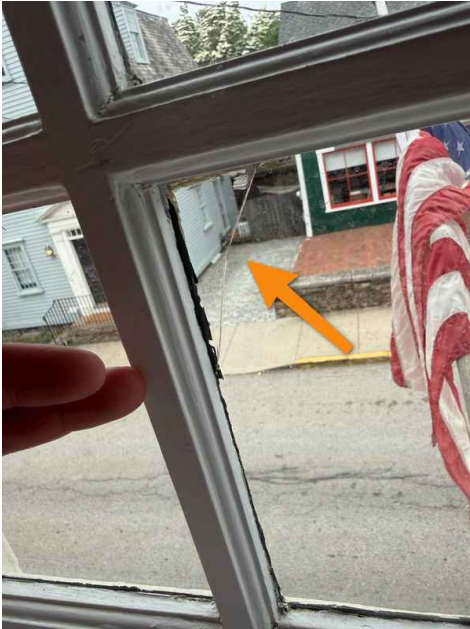
### 3.6.1 Windows

#### **CRACKED PANE**

I observed one or more cracked window panes. I recommend they be replaced.

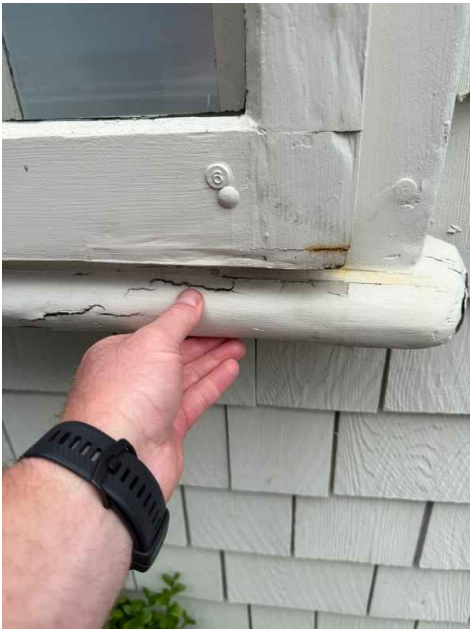
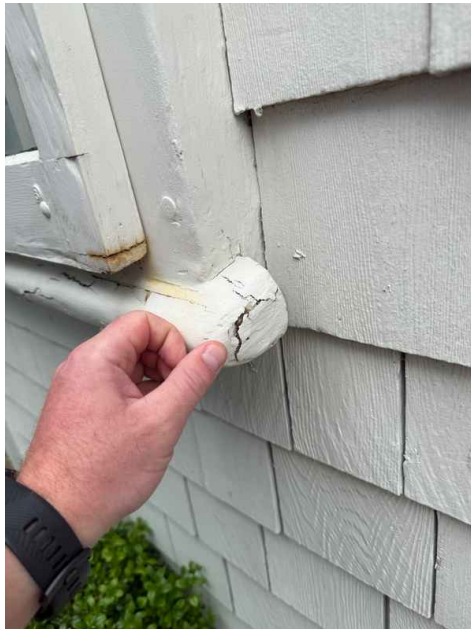
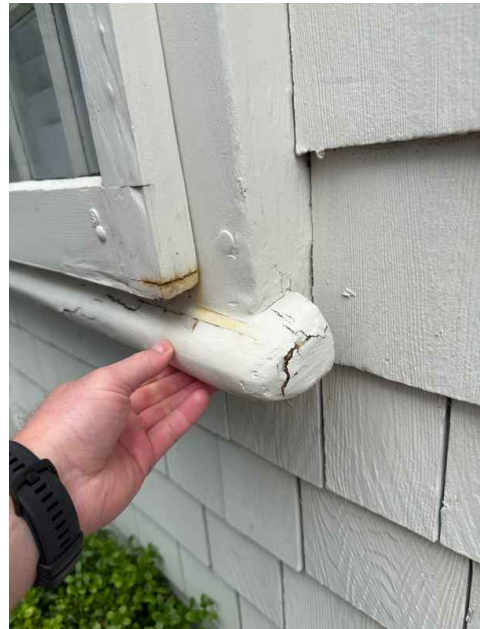
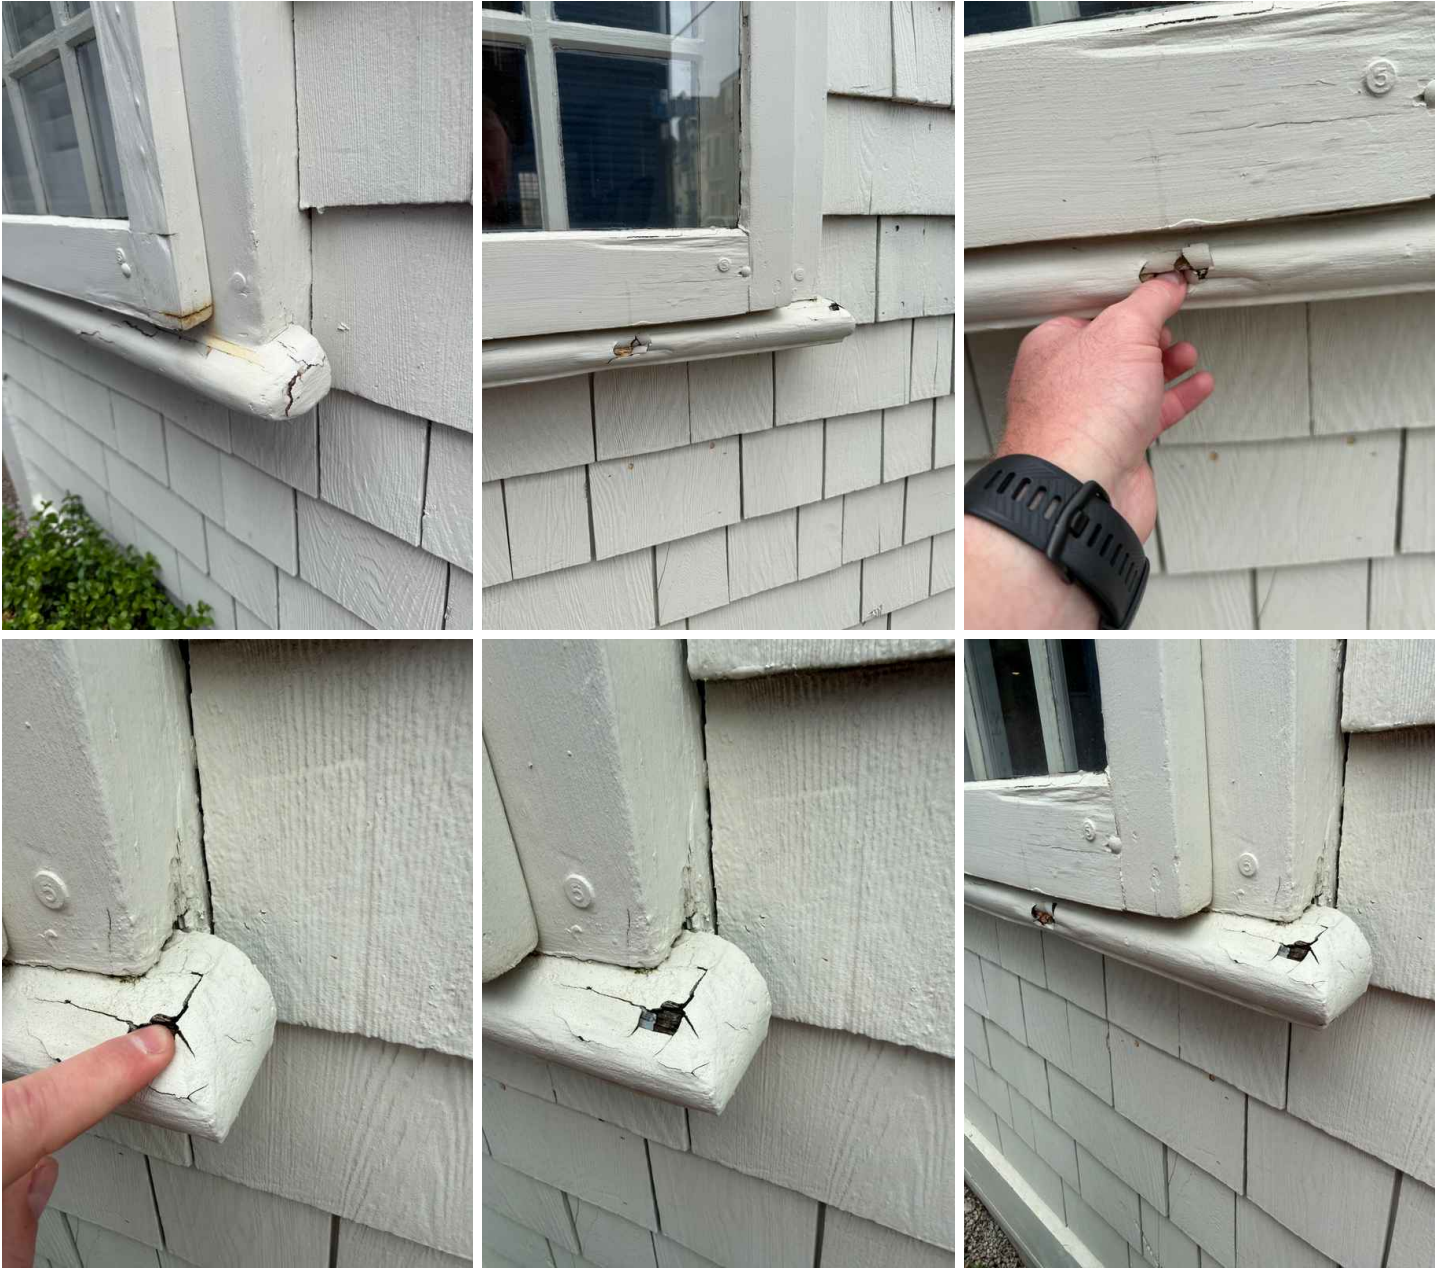
## 3.6.2 Windows

**WINDOW TRIM: WOOD ROT**

The window trim exhibits wood rot, with visibly decayed areas indicating prolonged moisture exposure. This deterioration can compromise the weather seal and affect the integrity of adjacent framing. I recommend replacement of the rotted trim by a qualified contractor to restore proper protection and appearance.

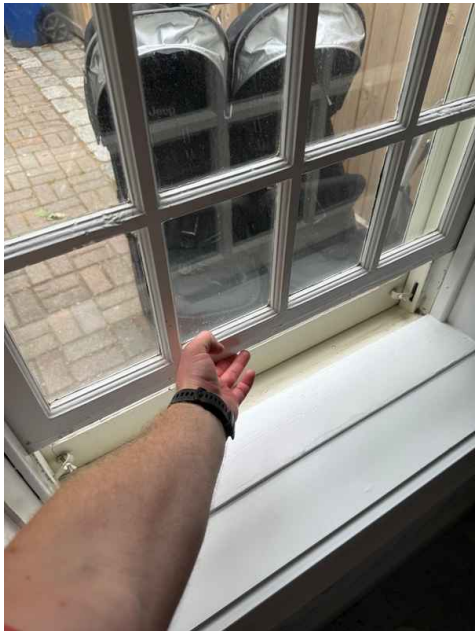
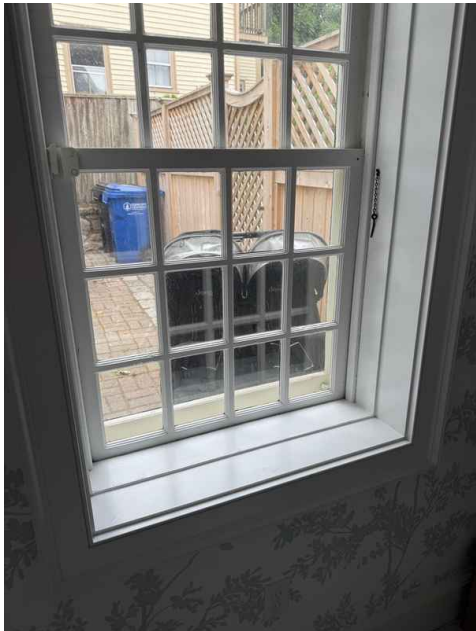
### 3.6.3 Windows

#### **HISTORIC WINDOWS: MISSING BALANCES AND LATCH COMPONENTS**

Several historic double-hung windows are missing functional balance systems and latch/keeper hardware, limiting their ability to stay open securely or lock properly. These deficiencies affect both usability and safety, particularly in upper-story areas. I recommend having a qualified contractor repair or retrofit the affected windows to restore proper operation and security.

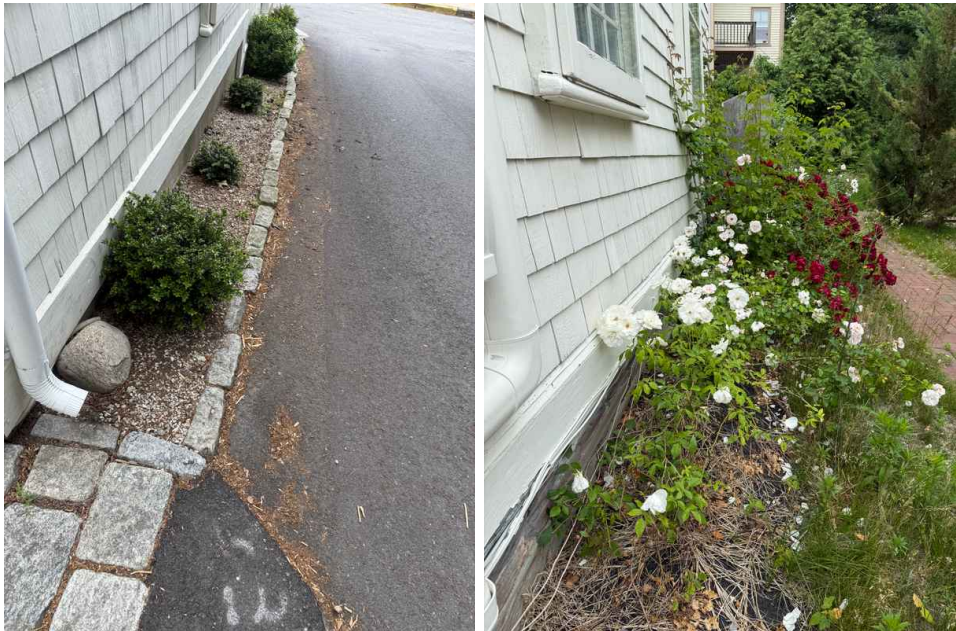
Vegetation is in direct contact with the exterior of the house. This can lead to moisture retention, pest infestation, and potential damage to the siding and foundation. I recommend removing the vegetation to prevent damage and maintain proper clearance around the house.

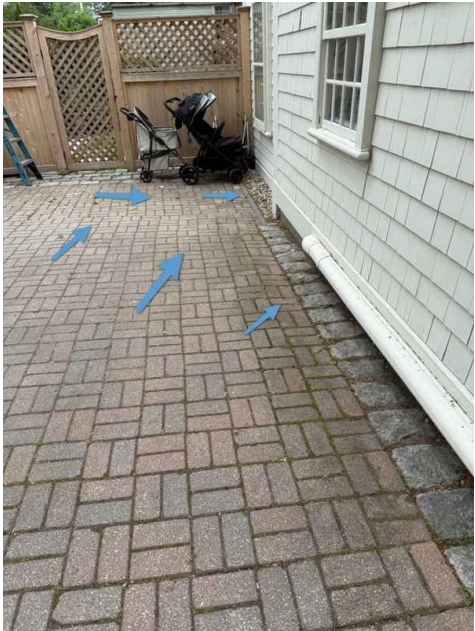
4.5.2 Vegetation, Grading, Drainage & Retaining Walls

**NEGATIVE GRADING**

Negative grading directs water back toward the foundation. I recommend regrading the soil to direct water away from the home.

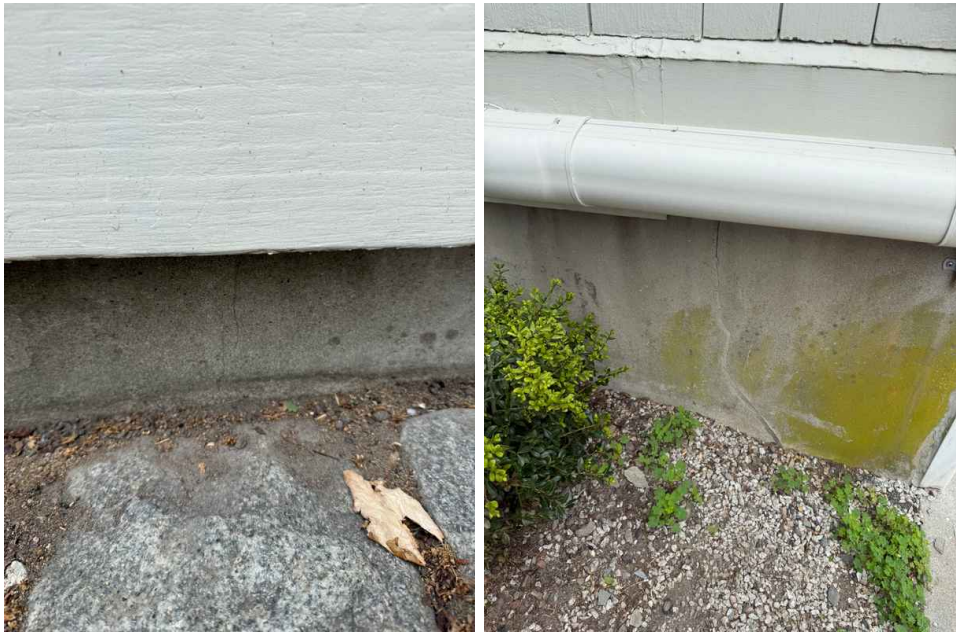
6.1.1 Foundation

SKIM COAT CRACKING

Cracks were observed in the skim coat of the wall surfaces, likely due to minor settling, temperature fluctuations, or material shrinkage. While this is typically a cosmetic issue, unattended cracks may expand over time or allow moisture intrusion. I recommend repairing the cracks with appropriate patching material, followed by repainting, to restore the surface and prevent further deterioration.

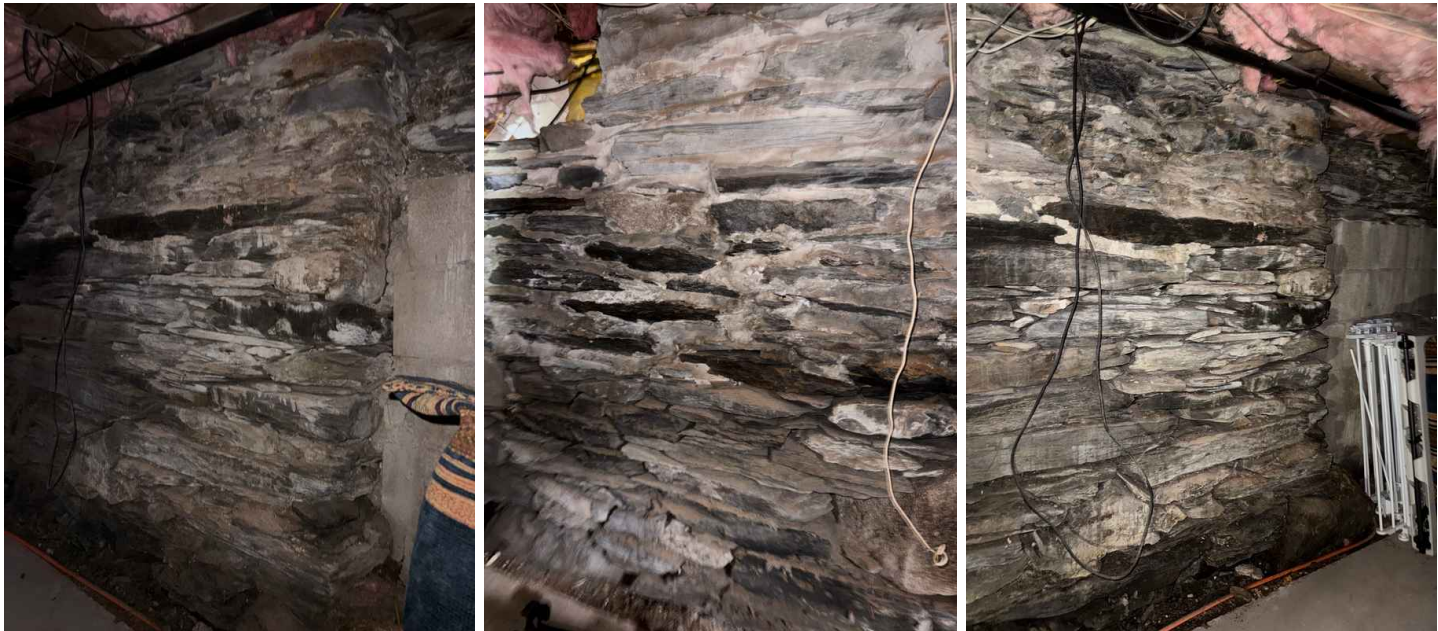
6.1.2 Foundation

STONE FOUNDATION: SKIM COAT OR PARGING RECOMMENDED (INTERIOR)

The interior surface of the stone foundation shows uneven or exposed mortar joints, and would benefit from a skim coat or parging application. Applying a proper finish can help improve moisture resistance, reduce dust, and enhance appearance. I recommend having a qualified masonry contractor apply a parging coat to protect and preserve the interior foundation walls.

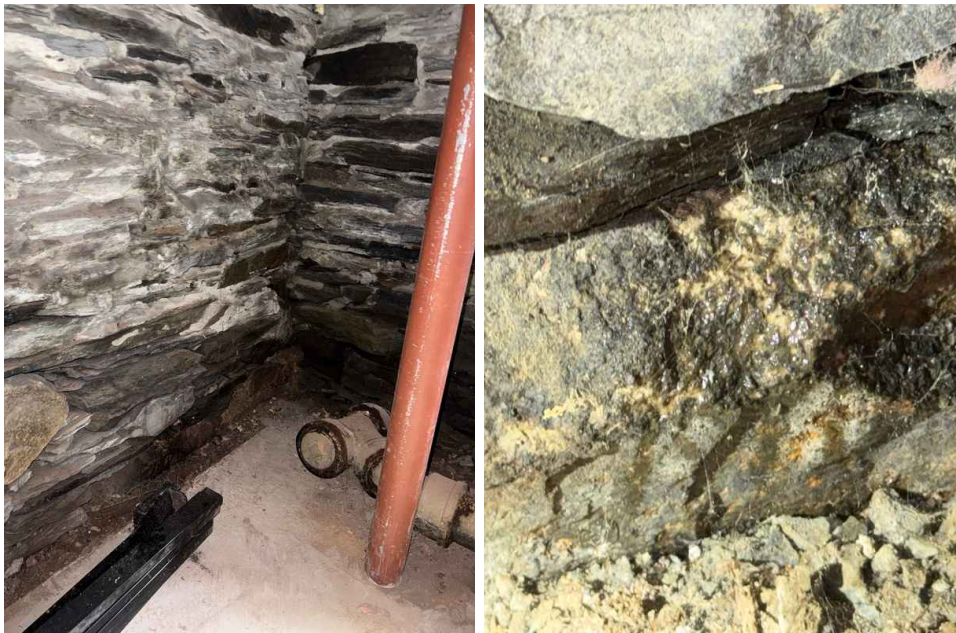
6.1.3 Foundation

**WATER INTRUSION AT FOUNDATION CORNERS**

Evidence of water intrusion was observed in the corners of the stone foundation during inspection. This indicates moisture is penetrating the foundation walls, which can lead to basement dampness, mold growth, and structural deterioration over time. Redirecting downspouts away from the foundation and applying a skim coat to seal the corners are recommended to prevent further moisture intrusion.

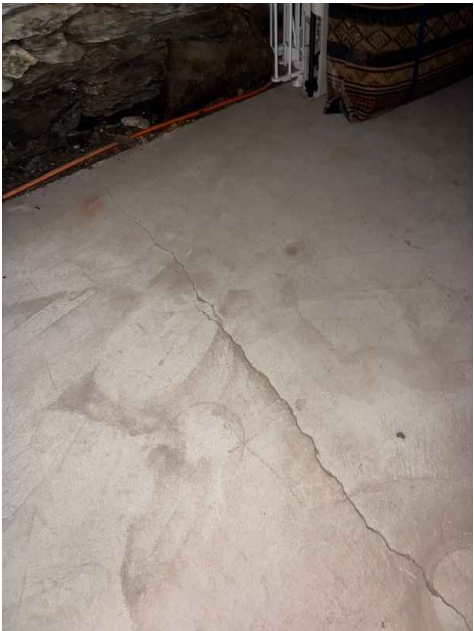
6.2.1 Floor Structure

**CRACKING CONCRETE FLOOR**

Cracks were observed in the concrete floor during inspection. These cracks can allow radon gas and moisture to enter the home, potentially affecting indoor air quality and creating health concerns. Sealing the cracks is recommended as part of radon gas mitigation efforts to reduce radon infiltration.

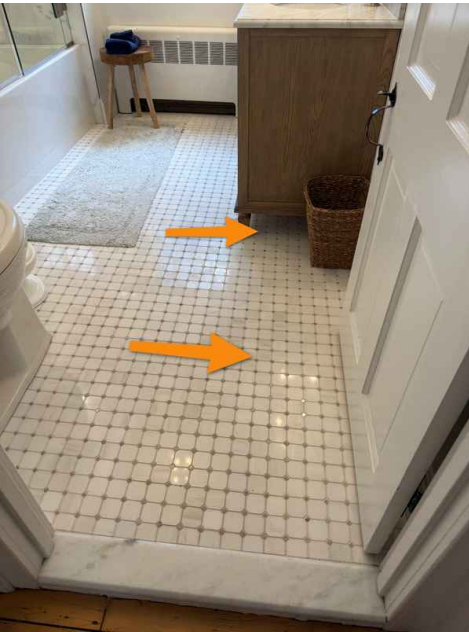
6.2.2 Floor Structure

FLOOR STRUCTURE: DEFLECTION

I observed deflection in the floor structure, likely due to settling, normal material movement, age, or framing span. While not currently affecting functionality, it may be perceptible underfoot and could worsen over time. I recommend monitoring the condition and consulting a qualified contractor if changes or concerns develop.

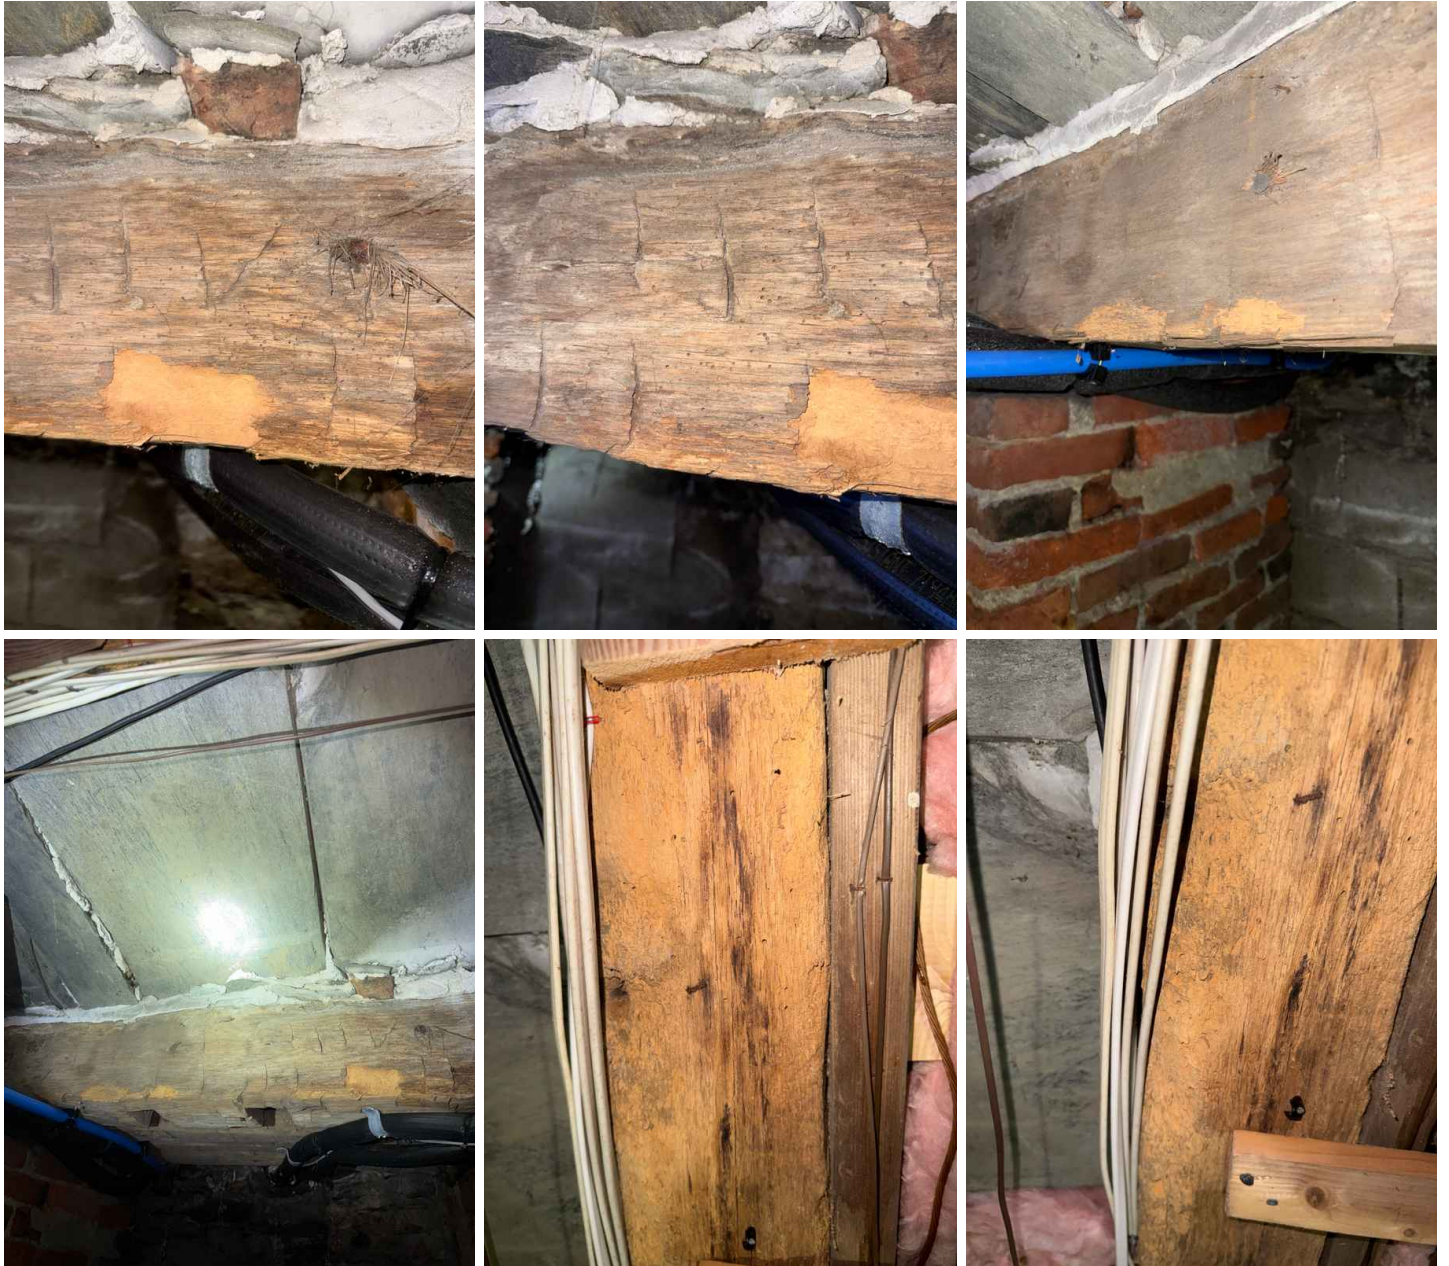
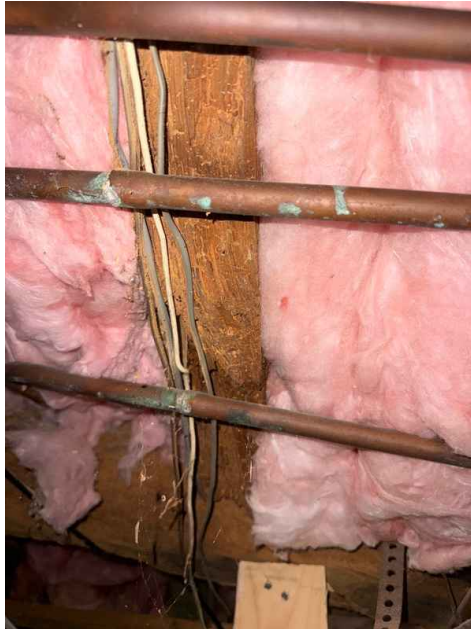
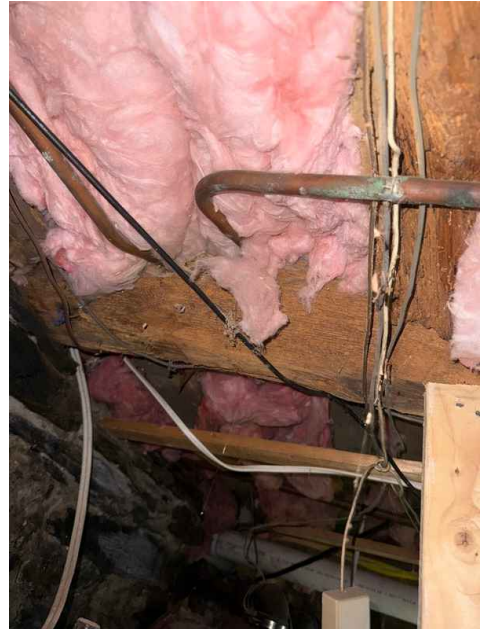
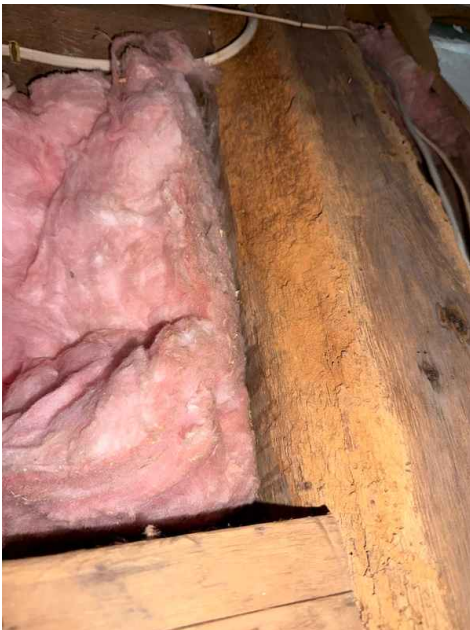
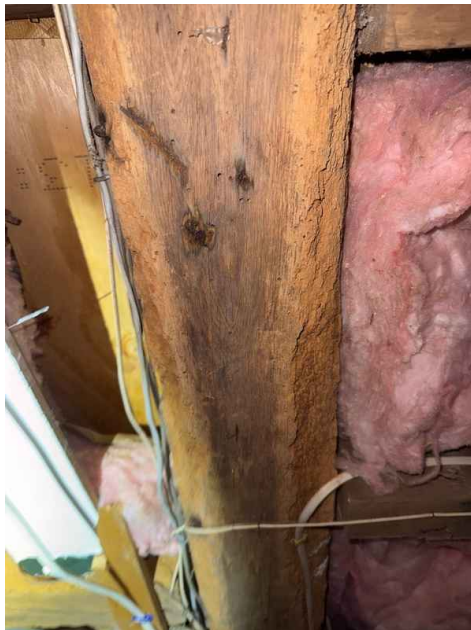
POWDER POST BEETLE DAMAGE

I observed powder post beetle damage and exit holes at structural members within the floor system. This condition may reduce the strength of affected wood components and could indicate past or current wood-destroying insect activity. I recommend further evaluation and preventative treatment by a qualified pest control professional, and evaluation of affected structural members not already addressed by a qualified structural contractor out of an abundance of caution, with corrective measures completed as needed.

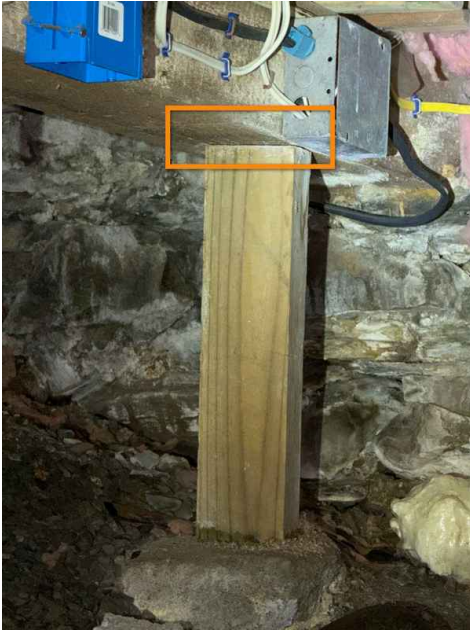
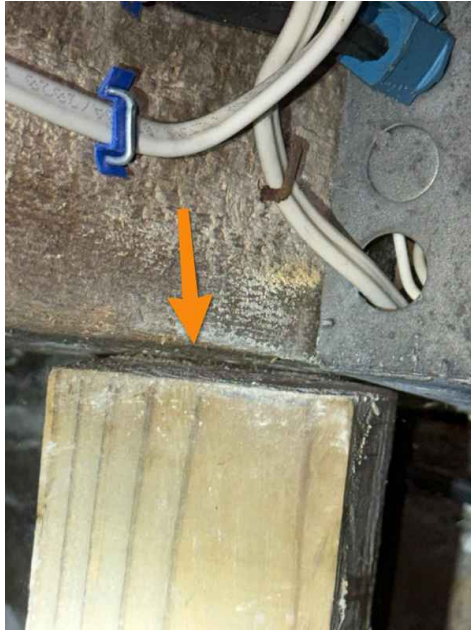
#### 6.2.4 Floor Structure

##### **UNSECURED SUPPORT POST**

An unsupported or inadequately secured structural support post was observed during inspection. This compromises the structural integrity of the floor system and creates a potential safety hazard. A qualified structural professional should evaluate the post's attachment, bracing, and load-bearing capacity to determine if reinforcement or replacement is necessary.
