## HISTORIC HOME INSPECTIONS REPORT

1234 Main Street  
Newport, RI 02840

08/18/2026 9:00AM

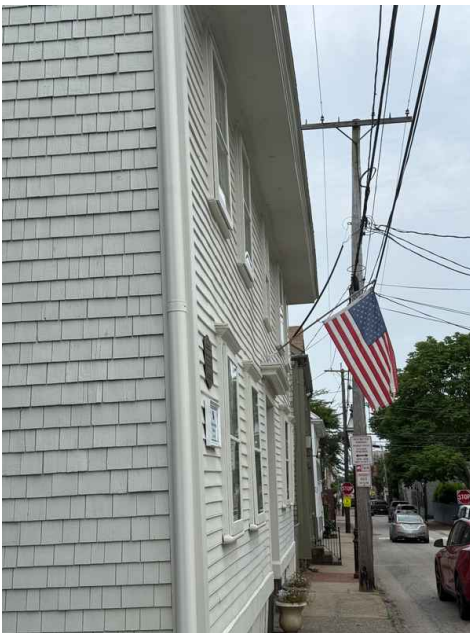
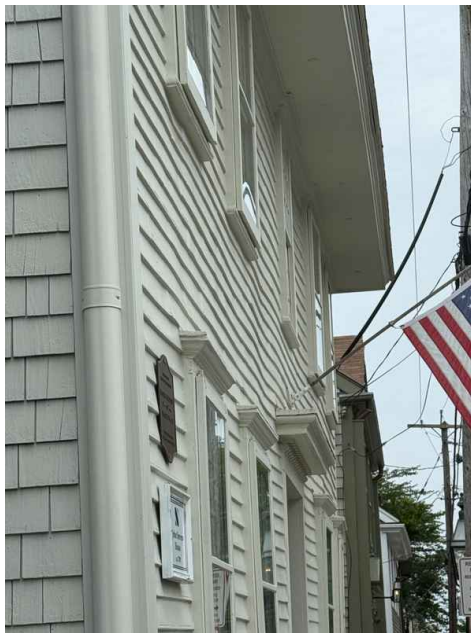
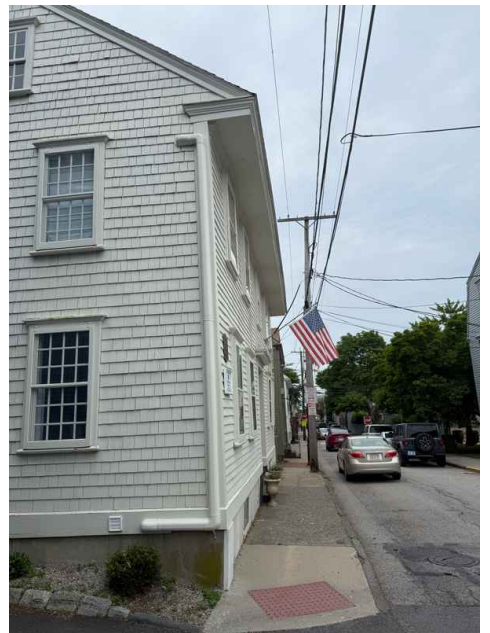
### 6.3.1 Wall Structure

#### WAVY EXTERIOR WALL STRUCTURE

The west exterior wall exhibits waviness consistent with foundation settling. Given the home's age of over 300 years, some settling is normal and expected. However, continued movement should be monitored, and a structural engineer should evaluate the property if signs of ongoing settlement are observed.

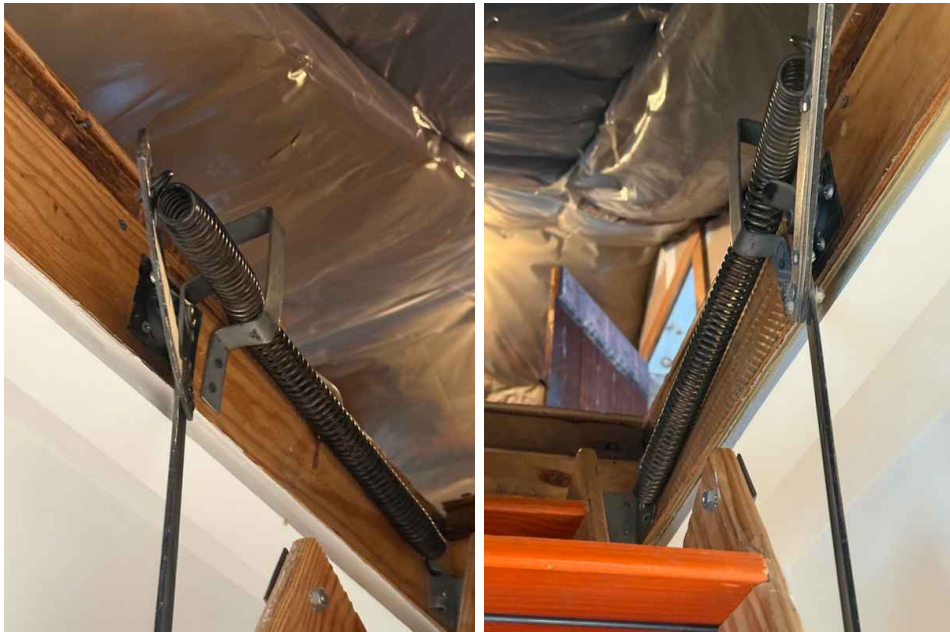
### **OBSTRUCTED ATTIC ACCESS LADDER SPRINGS**

The pulldown ladder springs are obstructed and under significant tension. If a spring breaks under this stress, it could become a projectile, creating a safety hazard for anyone in the vicinity. The springs should be inspected and cleared of obstructions, and tension should be relieved or adjusted by a qualified professional to ensure safe operation.

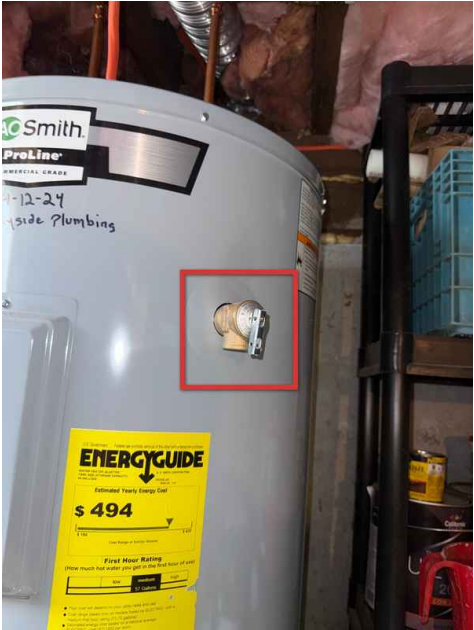
MISSING TPR DISCHARGE PIPE

I observed the temperature and pressure relief valve at the water heater to be missing a discharge pipe. This condition can allow hot water or steam to discharge improperly, posing a potential burn hazard and risk of damage to the surrounding area. I recommend installation of a proper discharge pipe by a qualified plumber.

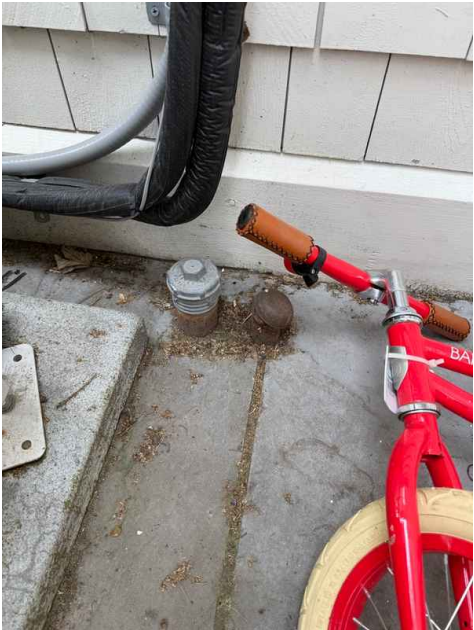
8.6.3 Fuel Storage Systems

OIL TANK: FILL AND VENT PIPES TOO SHORT

The oil tank’s fill and vent pipes were noted to be shorter than recommended clearances. Insufficient pipe height can hinder proper filling, increase the risk of spillage, and may not meet standard safety guidelines. I recommend correction by a licensed oil heating technician to ensure safe and compliant installation.

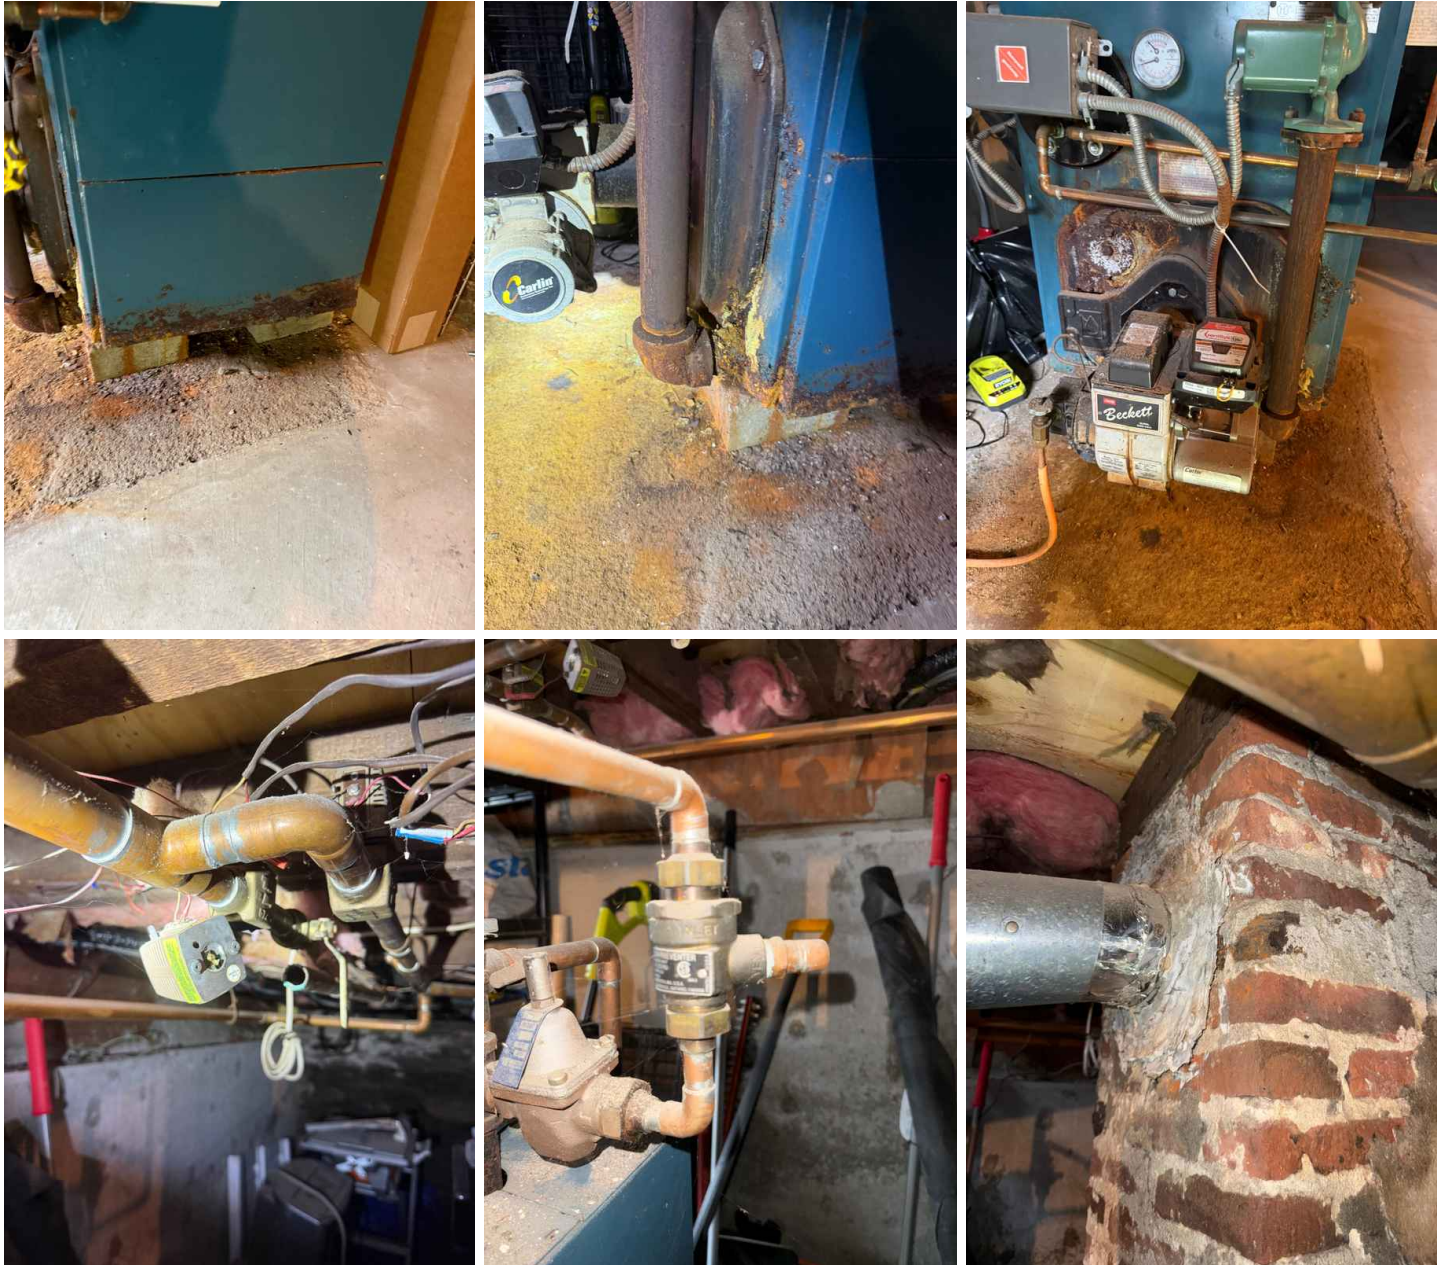
#### 9.2.1 Boiler

### MULTIPLE BOILER DEFECTS

Several significant issues were identified during boiler inspection: the unit is near or beyond its expected service life, corrosion is visible on the jacket, the vent plug is missing from the flue, the seal between the flue and chimney connection has deteriorated, the backflow preventer discharge pipe is capped, and the zone valve switch is broken. These conditions collectively indicate the boiler system requires immediate professional assessment (if it is desired to reinstall and utilize) to determine safety and functionality, as missing vent components and deteriorated connections can affect combustion safety and system performance. A qualified HVAC contractor should evaluate whether repairs are feasible or if replacement is necessary.

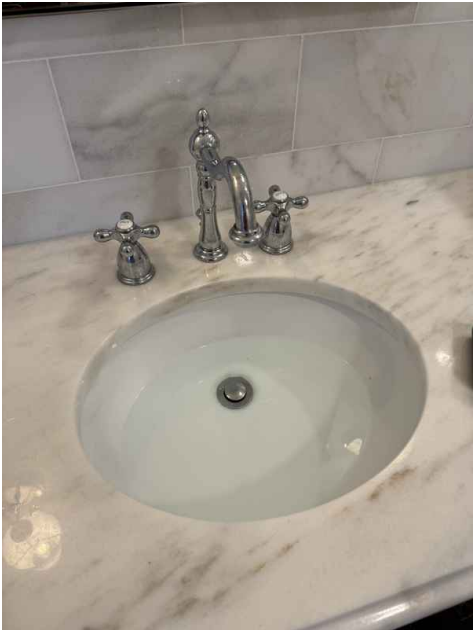
SLOW DRAIN

I observed the bathroom sink to drain slowly. This condition typically indicates a partial blockage or buildup within the drain line, which may worsen over time and lead to complete obstruction. I recommend cleaning and further evaluation of the drain by a qualified plumber.

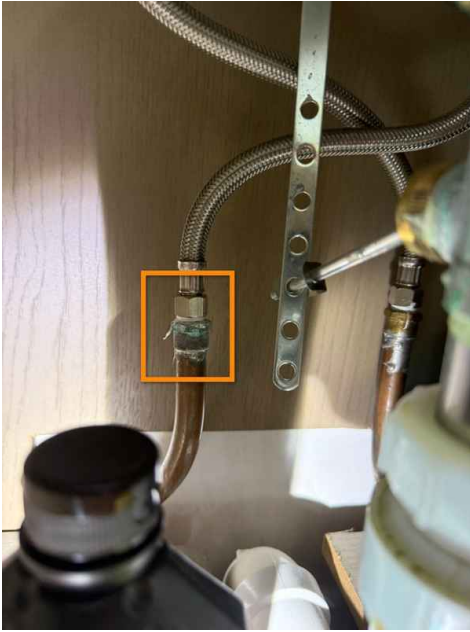
10.1.2 Bathroom Sink(s)

SUPPLY LINES: CORRODED

I observed minor oxidation and corrosion present on the bathroom water supply lines. This condition can weaken the piping and may lead to leaks or failure over time. Have a qualified plumber replace the affected supply lines.

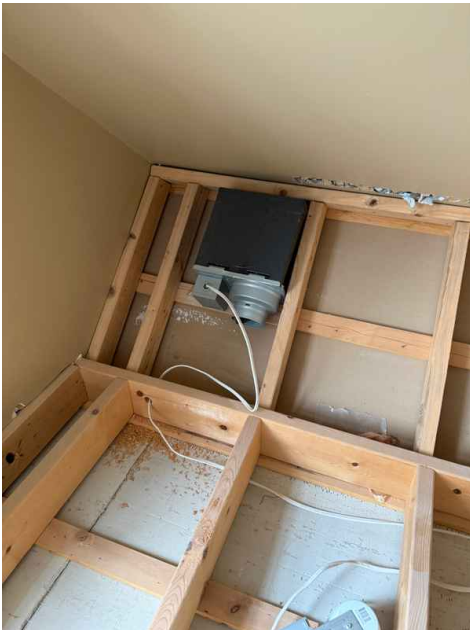
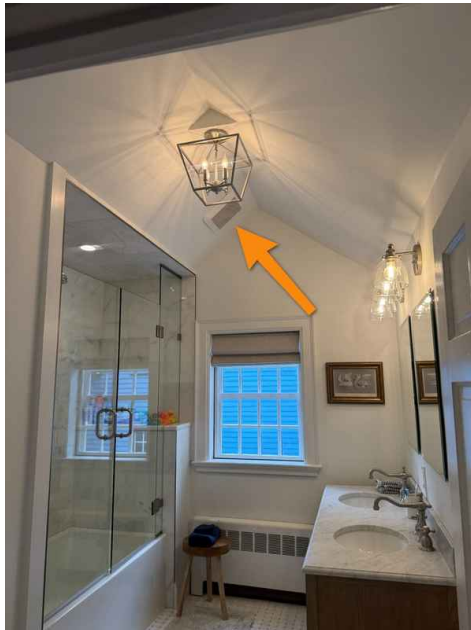
#### 10.5.1 Bathroom Venting Systems

Bathroom vents terminate in the attic, rather than the exterior.

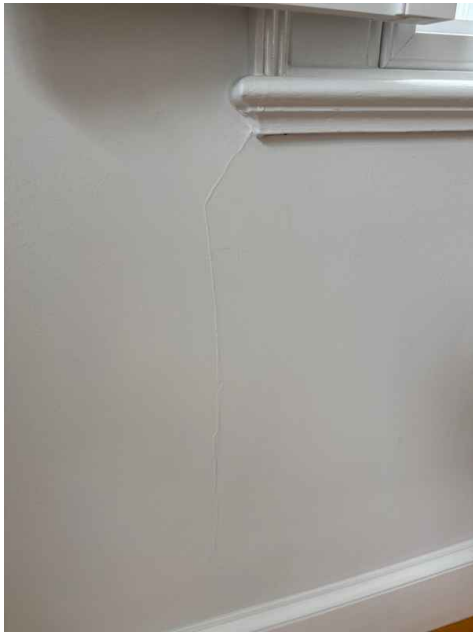
I observed cracks at the corners of walls in some areas. These appear to be cosmetic and not indicative if long-term settling. I recommend consulting a qualified drywall contractor to repair or replace.

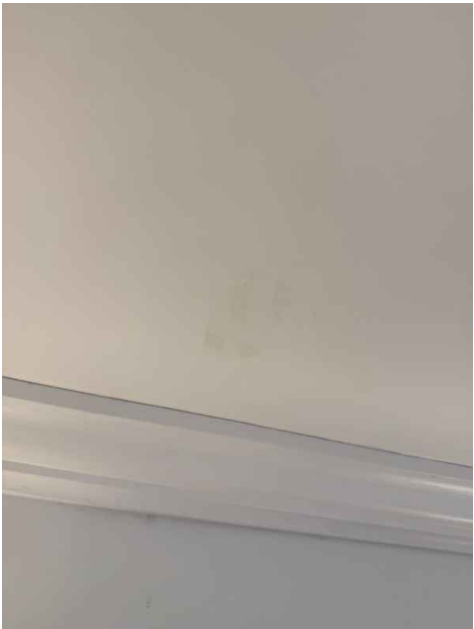
Staining was observed on the ceiling surface, but no signs of an active leak were detected at the time of inspection. The discoloration may be from a past moisture intrusion or leak that has since been resolved. I recommend having a qualified contractor evaluate the area further and repair or refinish the ceiling as needed.

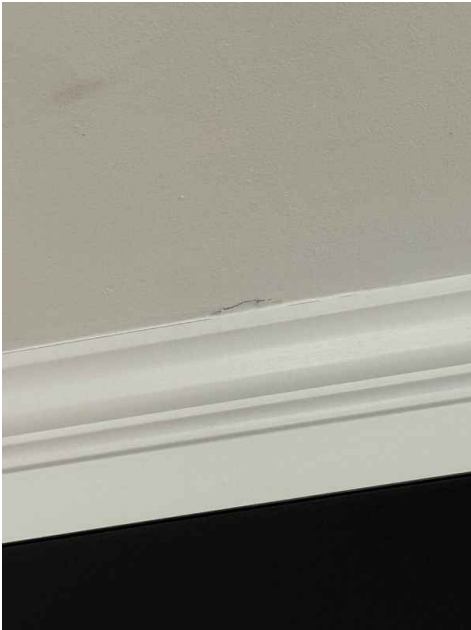
12.4.2 Ceilings

Bubbling paint was noted on the ceiling drywall, which may indicate underlying moisture issues or improper surface preparation. This condition could lead to further damage, such as peeling paint or compromised drywall. I recommend having the affected area evaluated and repaired by a qualified contractor to address any underlying causes and restore the ceiling's finish.

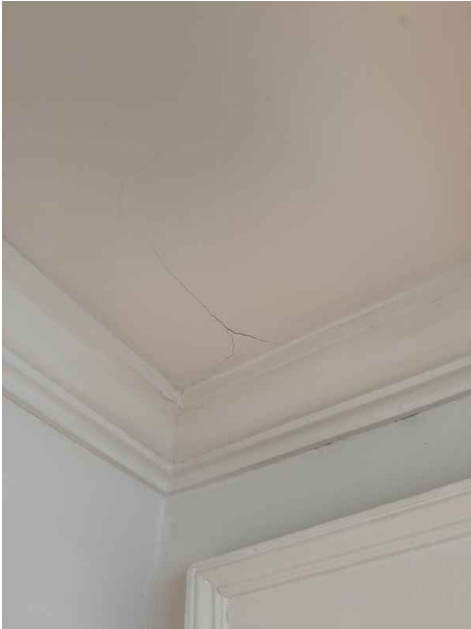
I observed cracking in the drywall. These cracks appear to be cosmetic and are a common and ongoing maintenance consideration. I recommend having a qualified contractor repair the cracks to improve the appearance of the walls.

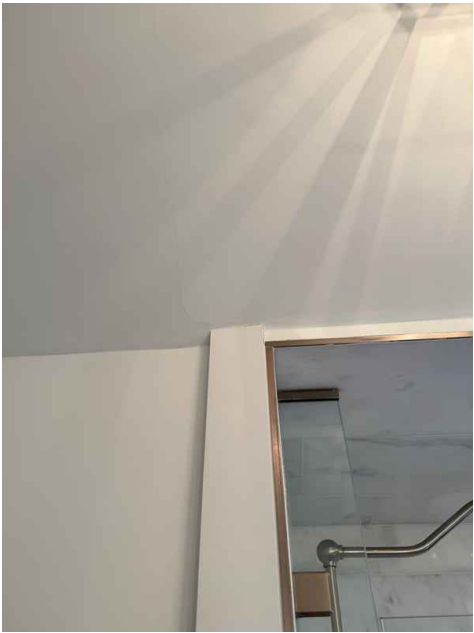
**DRYWALL: VISIBLE SEAMS**

I observed visible seams in the drywall, likely due to insufficient finishing or shifting over time. While this is a cosmetic issue, it can affect the overall appearance of interior surfaces. I recommend repair and refinishing by a qualified drywall or painting contractor to improve aesthetics.

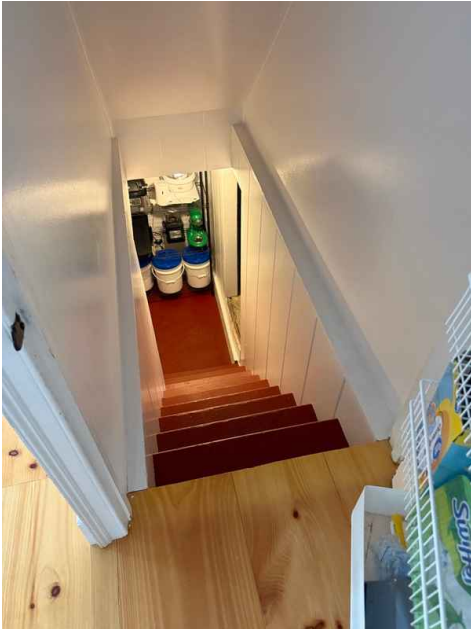
12.5.1 Steps, Stairways & Railings

**MISSING HANDRAIL**

Staircase is missing handrails in some sections, which poses a safety hazard. I recommend a qualified contractor install a handrail.
