# HISTORIC HOME INSPECTIONS

## HISTORIC HOME INSPECTIONS - MULTIFAMILY REPORT

1234 Main Street  
Newport, RI 02840

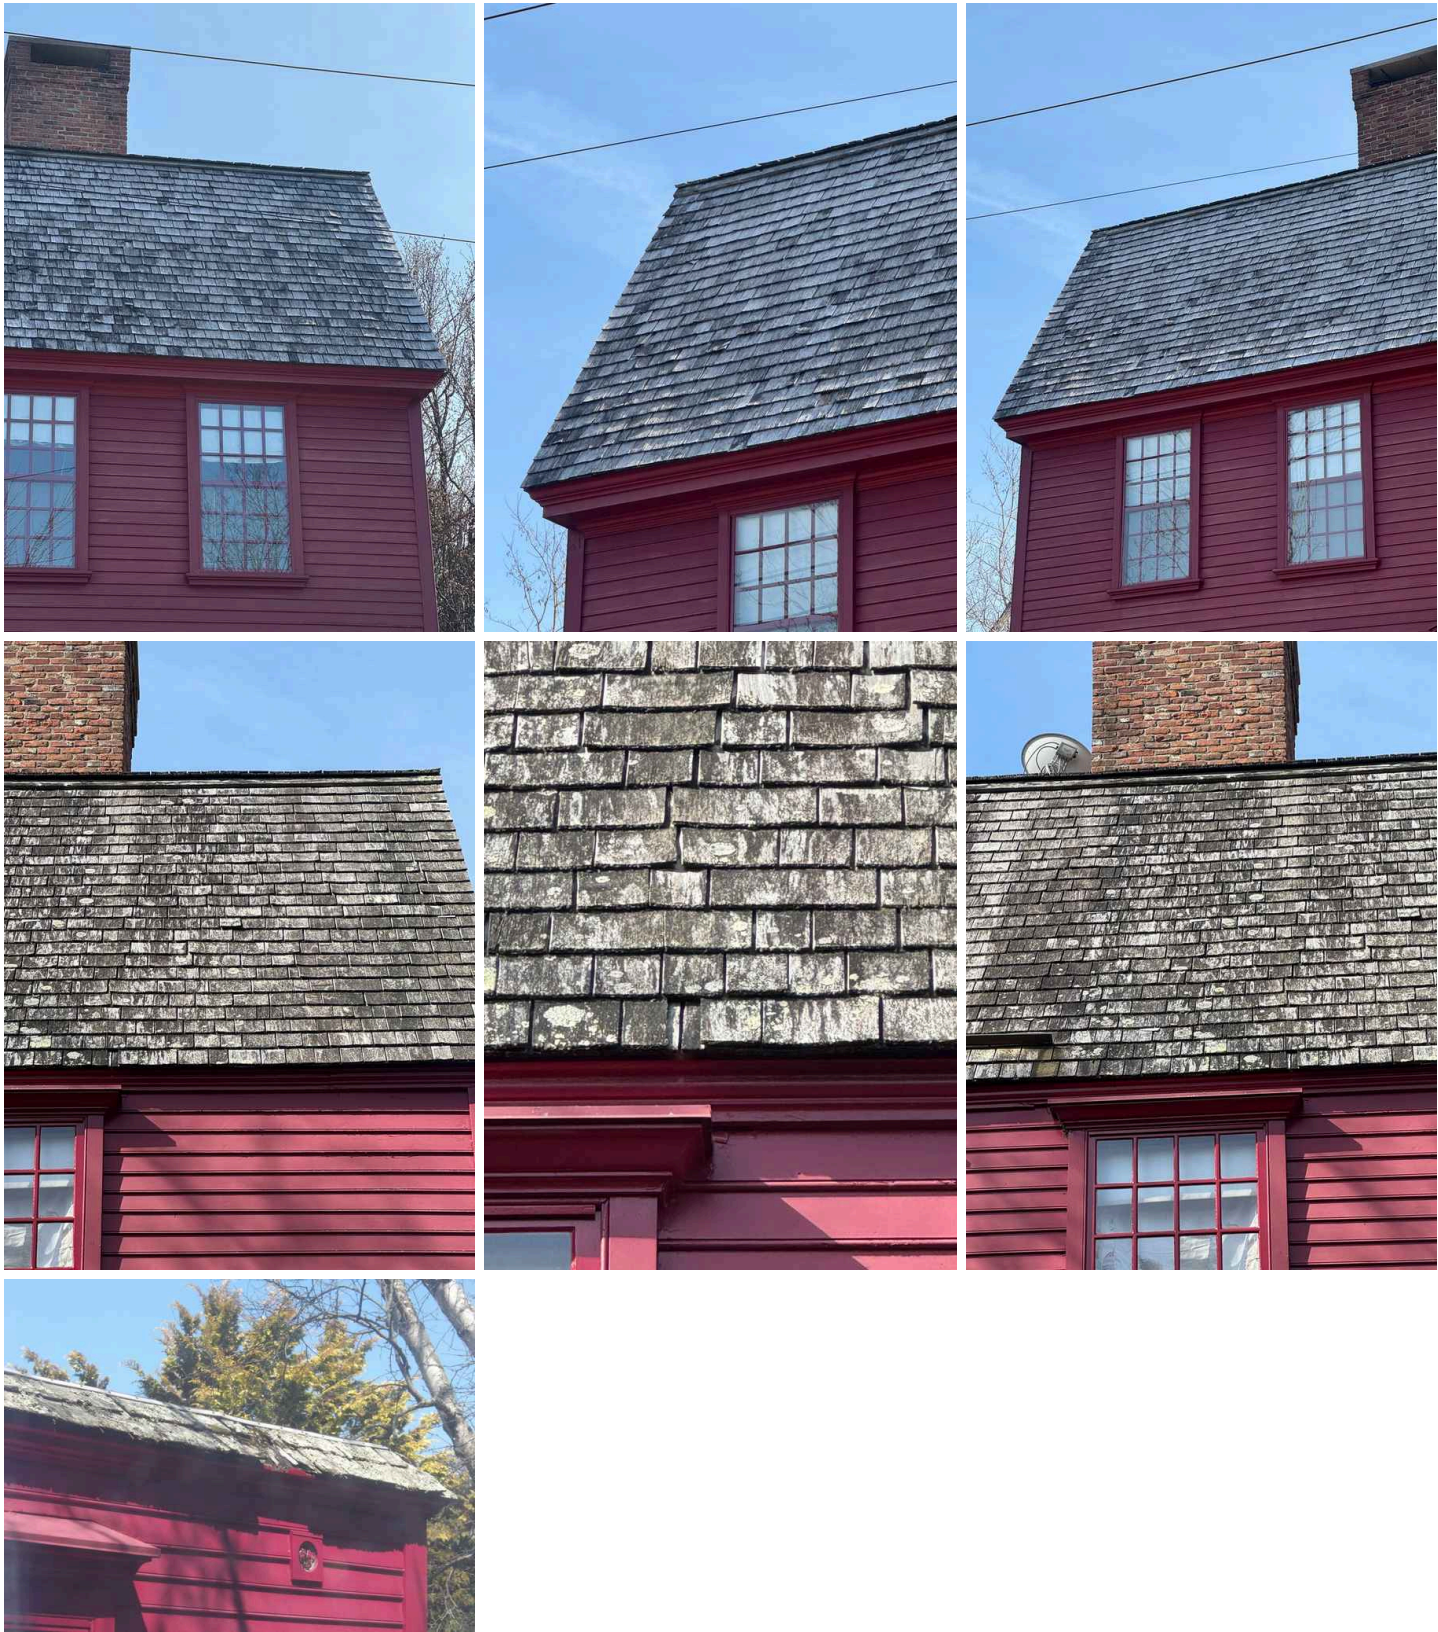
I observed the wood shake roof covering is near or beyond its typical service life, which is generally 30 to 50 years depending on quality of the shakes, proper installation, and exposure to elements. Signs such as missing, splitting, curling, and cupping shingles indicate aging materials and a roof which is susceptible to water intrusion and continued deterioration. I recommend having a qualified roofing contractor evaluate the roof, perform necessary repairs, and plan for replacement in the near future.

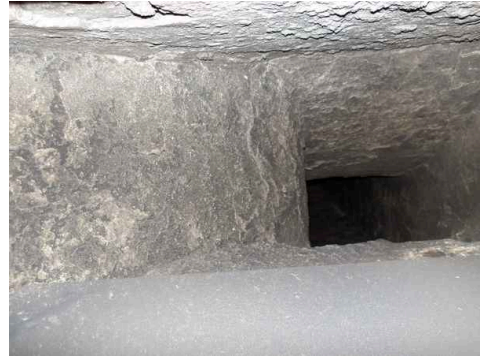
I was unable to confirm the presence of a chimney liner. Safe access to the roof was not available to view down the flue, and no liner was visible when observing upward past the damper. I recommend having a qualified chimney professional perform a Level II inspection to verify liner presence and condition.

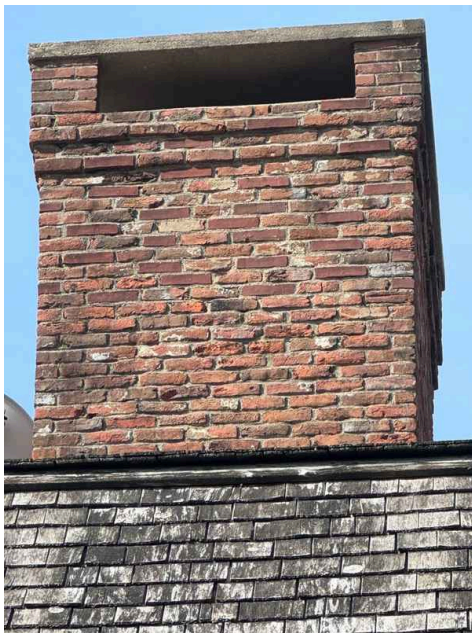
I observed spalling at the chimney brick surfaces. This condition indicates deterioration of the masonry and can lead to further material loss and moisture intrusion over time. I recommend having a qualified masonry contractor repair or replace the affected brick to restore the chimney's integrity.

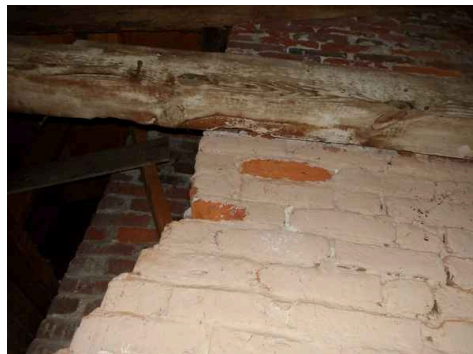
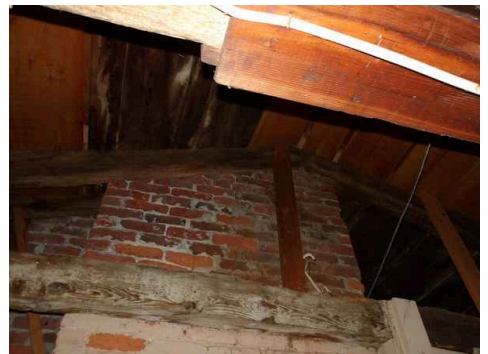
## 2.5.2 Chimney

**CHIMNEY BRICK: SPALLING**

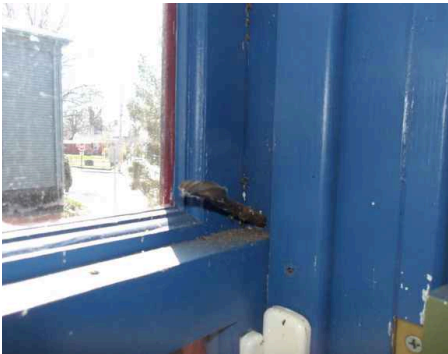
Windows: Windows: Peg-Supported Operation

I observed the historic double-hung windows operate using pegs or keys to hold the lower sash in position. This is a typical design for older window systems and differs from modern counterbalance mechanisms. I recommend ensuring the pegs are properly fitted and maintained to allow safe and reliable operation.

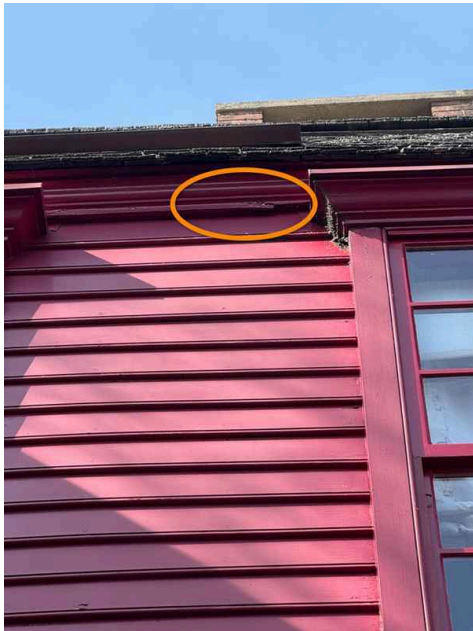
3.2.1 Exterior Trim

TRIM: DAMAGE

The trim is damaged, with visible cracks, warping, or displacement in certain areas. Damaged trim can compromise weather resistance and may allow moisture intrusion or pest access. I recommend repair or replacement of the affected sections by a qualified contractor to maintain proper protection and appearance.

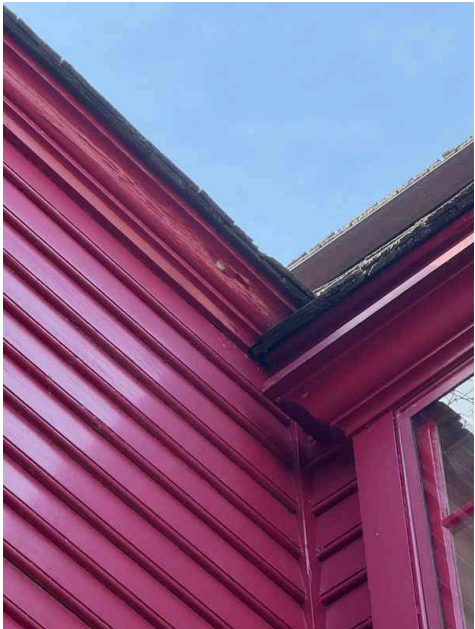
3.2.2 Exterior Trim

**TRIM: DETERIORATED PAINT**

Repair or Replace

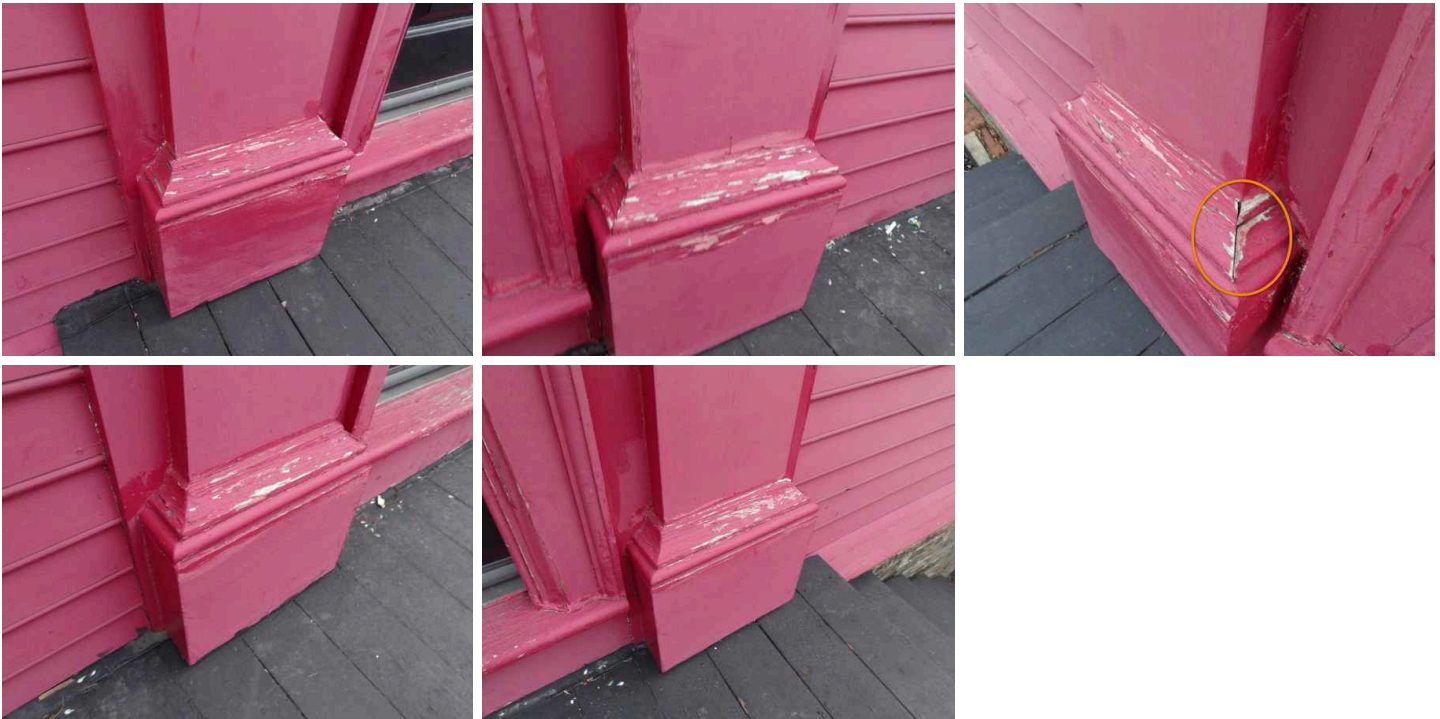
3.4.1 Conventional Exterior Doors

**FRONT DOOR COLUMNS: DETERIORATED AND ROTTED**

I observed the front door columns have paint deterioration and areas of wood rot. This condition can lead to further structural deterioration and reduced support if not addressed. I recommend having a qualified contractor repair or replace the affected wood and refinish the columns to restore proper protection and integrity.

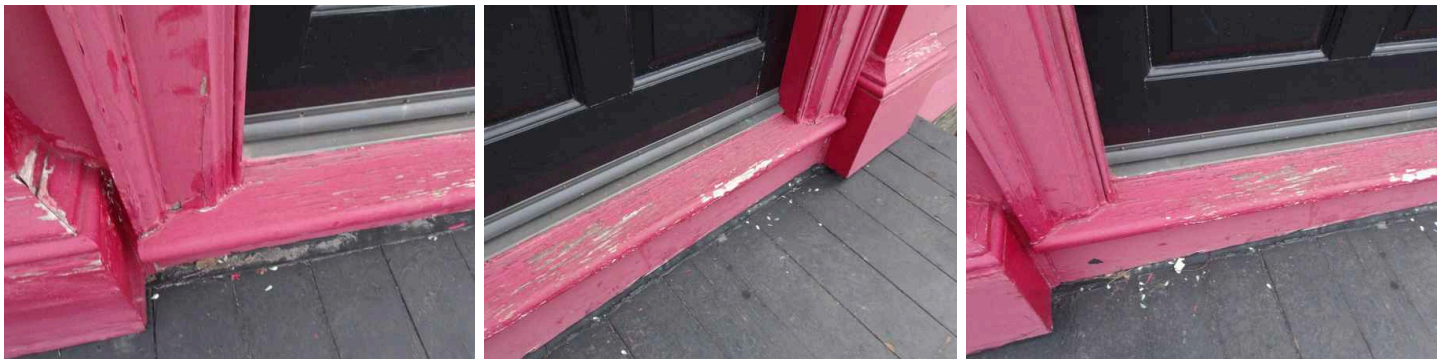
3.4.2 Conventional Exterior Doors

**DOOR THRESHOLD: WORN AND WEATHERED**

I observed the door threshold is worn and weathered. This condition can allow moisture intrusion and may affect the seal at the base of the door. I recommend having a qualified contractor repair or replace the threshold to restore proper function and protection.

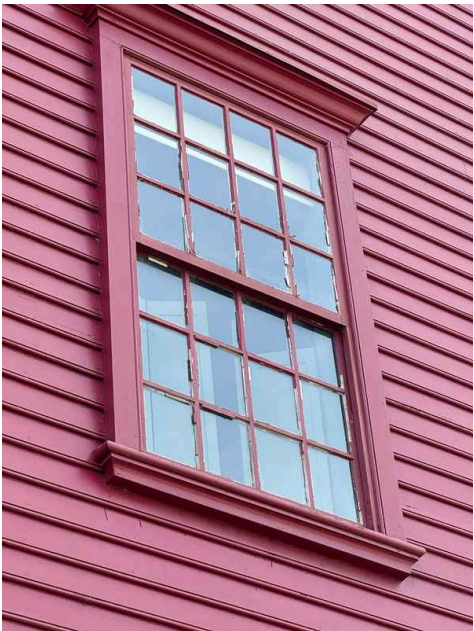
3.5.1 Windows

**MISSING SCREEN(S)**

Repair or Replace

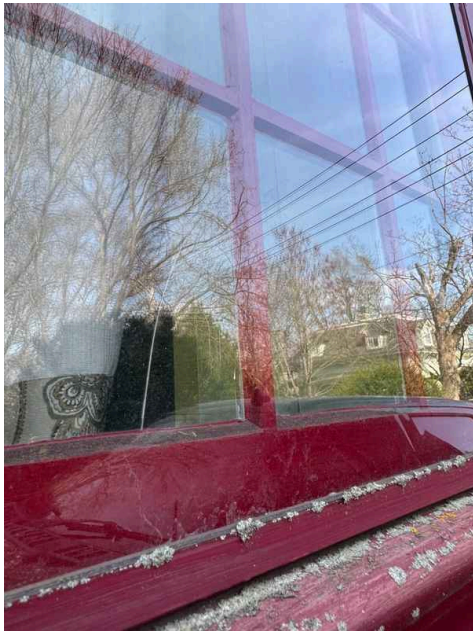
3.5.2 Windows

**CRACKED PANE**

Repair or Replace

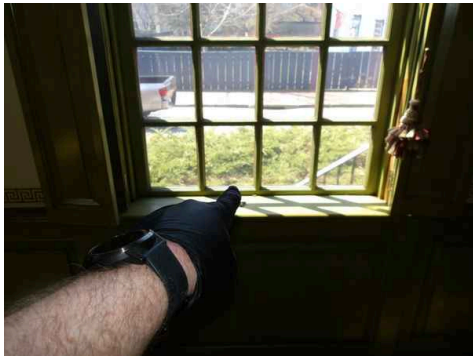
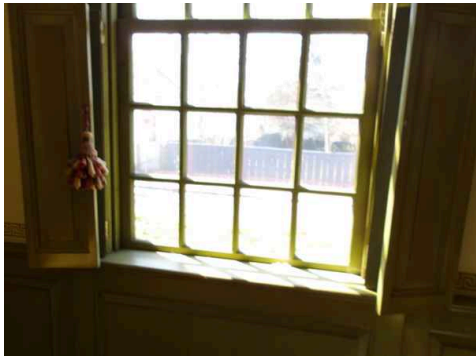
3.5.3 Windows

I observed that some windows are sticking, making them difficult to open or close. This can affect ventilation and ease of use. I recommend having a qualified contractor assess and adjust the windows to ensure they operate smoothly and efficiently.

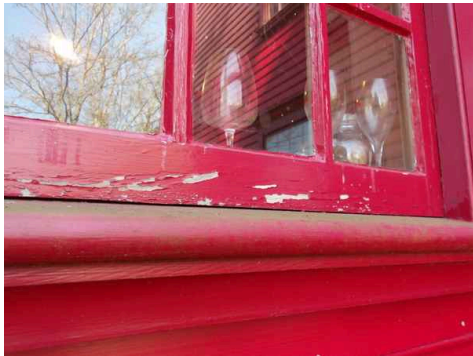
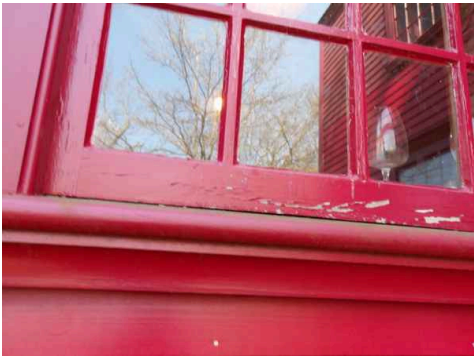
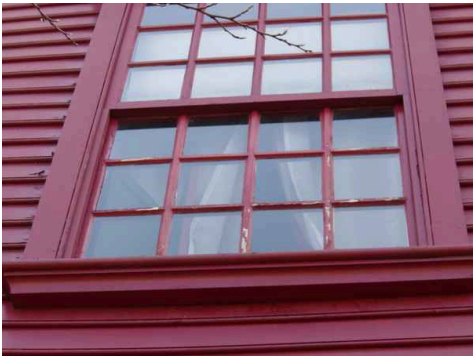
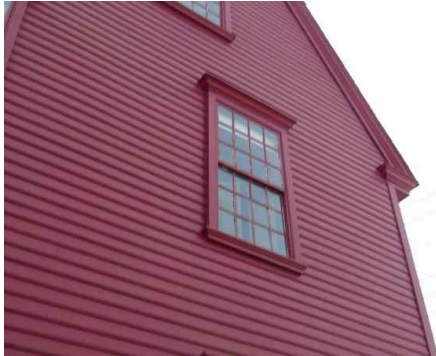
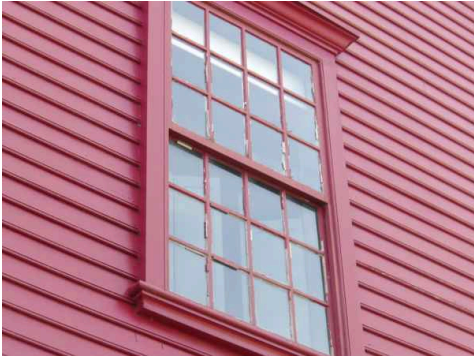
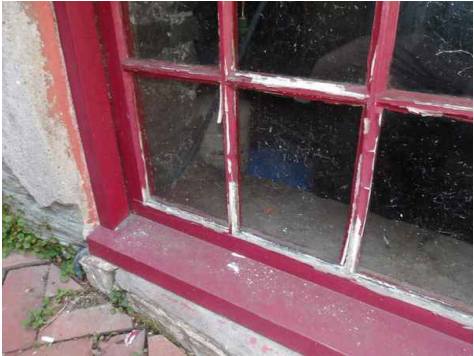
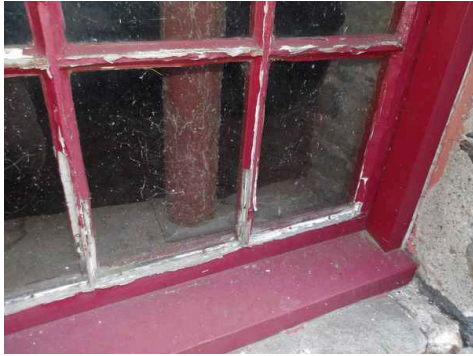
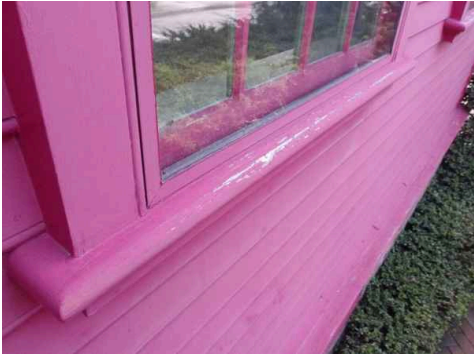
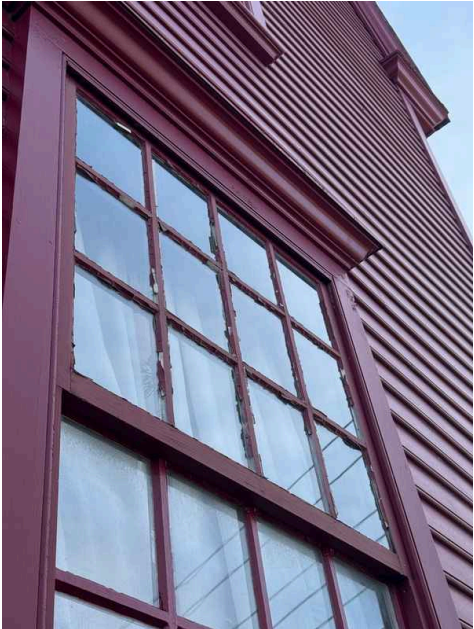
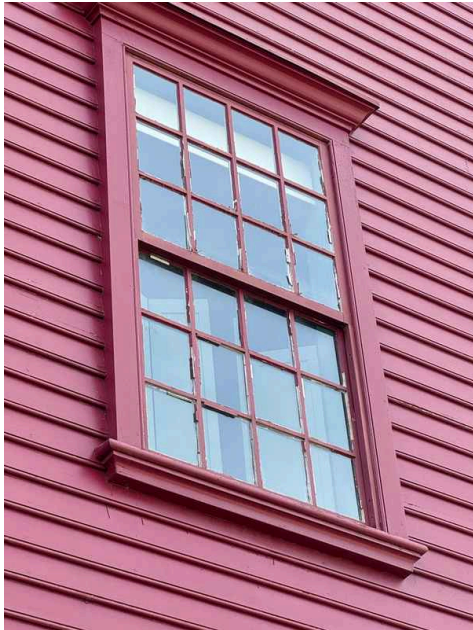
3.5.4 Windows

WINDOW: SCRAPING/PAINTING

Multiple windows have deteriorated paint on the trim, casing, muntins, and mullions. I recommend it be scraped and repainted.

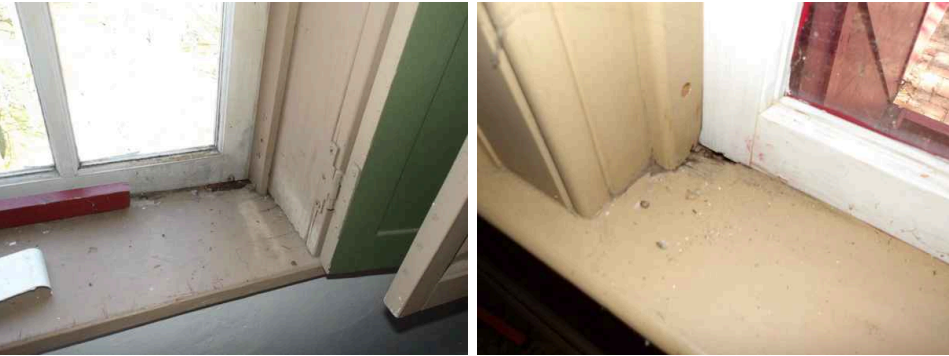
3.5.5 Windows

WOOD ROT AT WINDOW SILL

Wood rot was noted at the window sill. This condition can compromise the structural integrity of the window frame and may allow moisture intrusion, potentially leading to further damage. I recommend having a qualified contractor assess the extent of the rot and perform necessary repairs or replacements to restore the window sill's condition and protect against moisture.

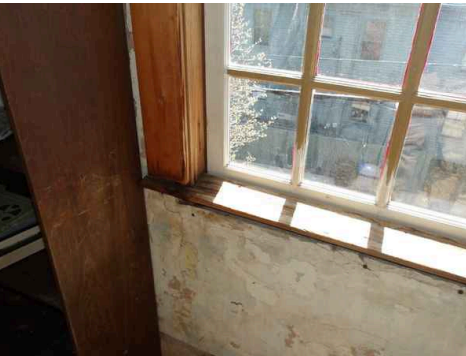
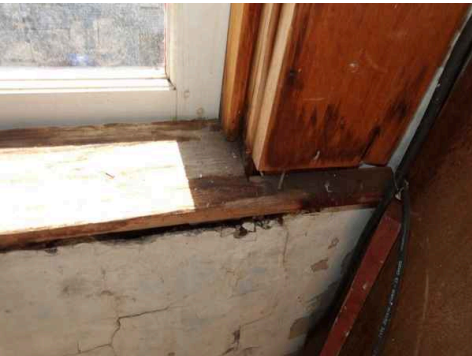
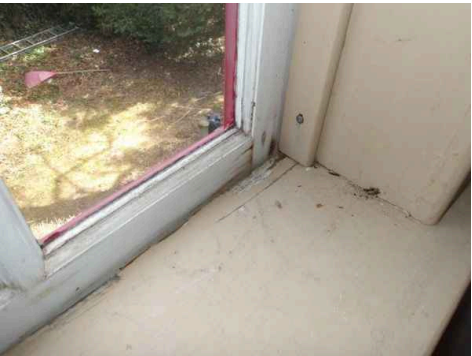
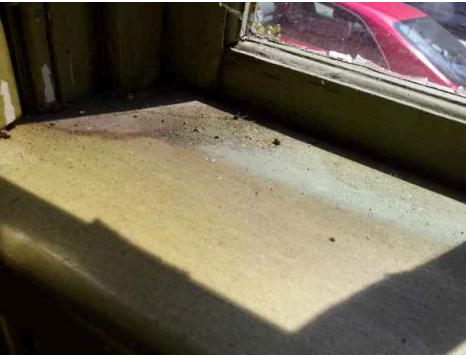
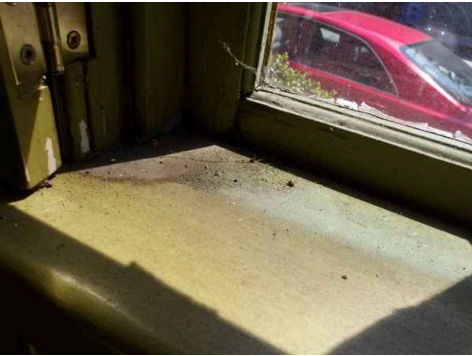
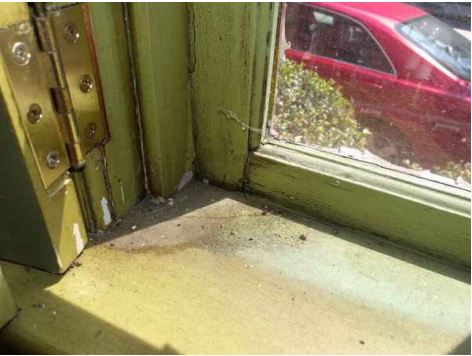
Water staining was noted on the window sill, indicating past or active moisture intrusion. This can lead to wood deterioration, mold growth, or further damage if the source of moisture is not addressed. I recommend having a qualified contractor evaluate the area to identify and repair any leaks, followed by refinishing the sill as needed.

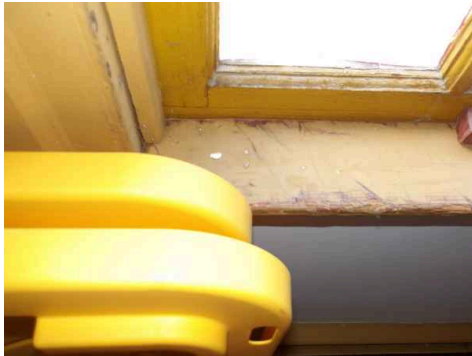
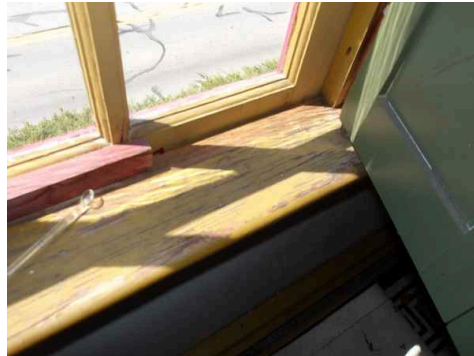
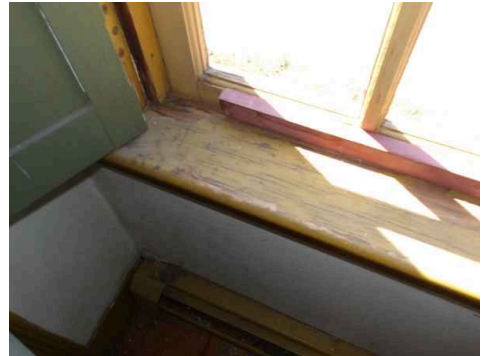
## 3.5.7 Windows

Repair or Replace**INTERIOR WINDOW SILL: COSMETIC DEFECTS**

The interior window sill displays minor cosmetic imperfections such as scuffs, chips, or surface wear. These blemishes do not impact function but may detract from the overall appearance. I recommend refinishing or touch-up by a qualified painting or carpentry professional for improved aesthetics.

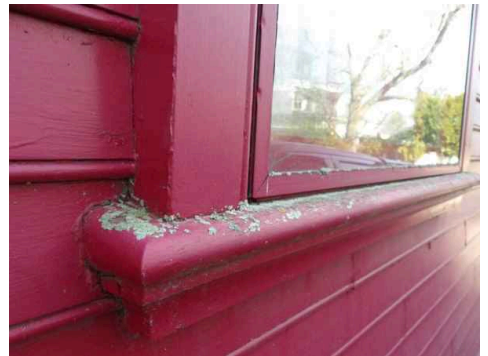
## 3.5.8 Windows

**WINDOW SILLS: ORGANIC DEBRIS**

I observed organic matter accumulated on the window sills. This condition can retain moisture and contribute to deterioration of the surrounding materials over time. I recommend cleaning the affected areas and maintaining them to reduce moisture exposure.

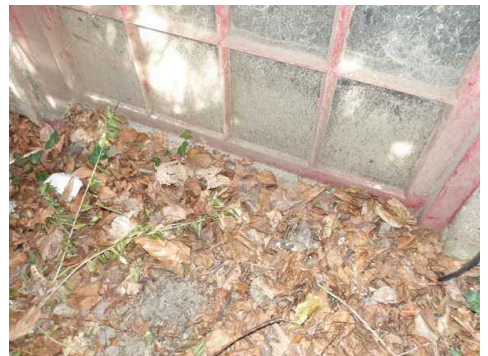
## 3.5.9 Windows

**WINDOW SILL: SOIL CONTACT**

I observed the window sill is in direct contact with the surrounding soil. This condition can promote moisture exposure and increase the risk of wood deterioration or water intrusion over time. I recommend having a qualified contractor regrade the area to provide proper clearance and reduce moisture contact.

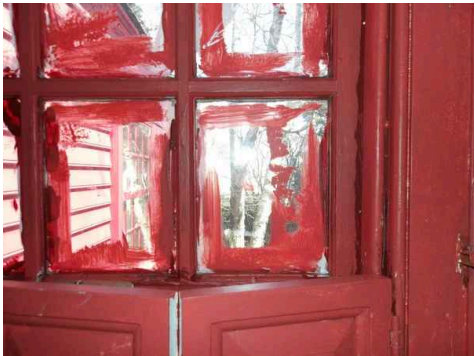
3.5.11 Windows

I observed paint applied to the window glass. This condition can reduce visibility and may affect proper window operation or cleaning. I recommend having a qualified contractor remove the paint from the glass to restore clarity and function.

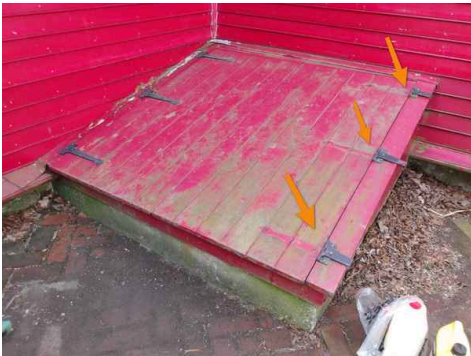
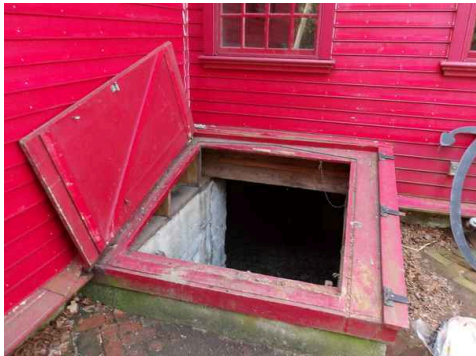
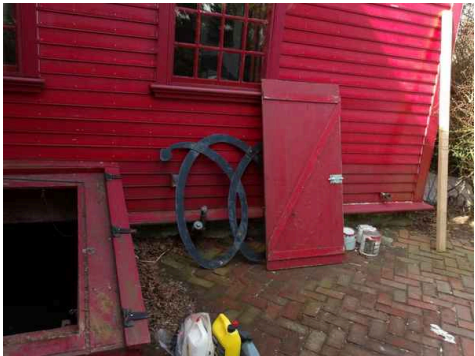
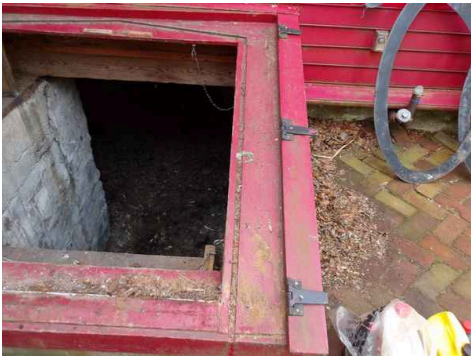
3.6.1 Emergency Egress Doors

**BULKHEAD DOOR HINGES: BROKEN**

I observed the bulkhead door hinges are broken. This condition can prevent proper operation and may lead to instability or failure of the door assembly. I recommend having a qualified contractor replace the hinges to restore safe and functional operation.

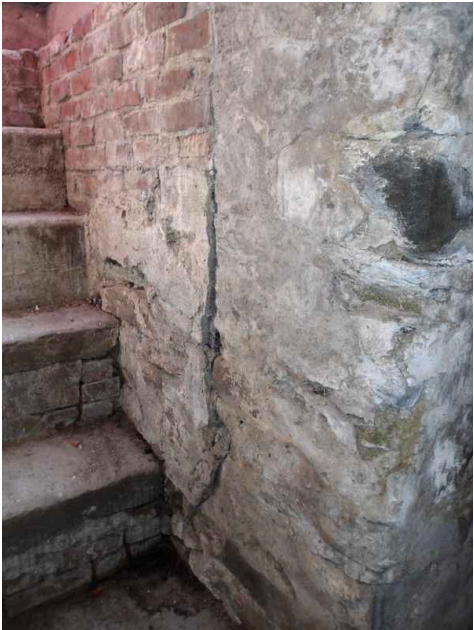
3.6.2 Emergency Egress Doors

**BULKHEAD FOUNDATION:  
MOVEMENT NOTED**

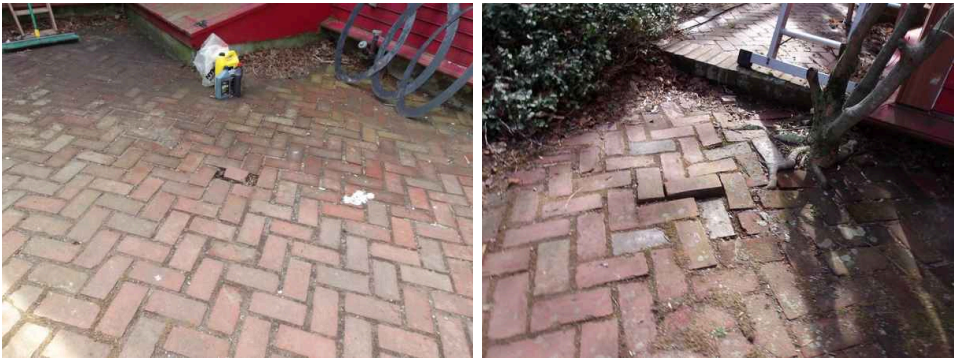
I observed sections of brick at the patio are dislodged and heaving. This condition may be caused by underlying factors such as tree root activity or deterioration of the base material or mortar. I recommend having a qualified contractor evaluate and reset the affected areas to restore a stable and even surface.

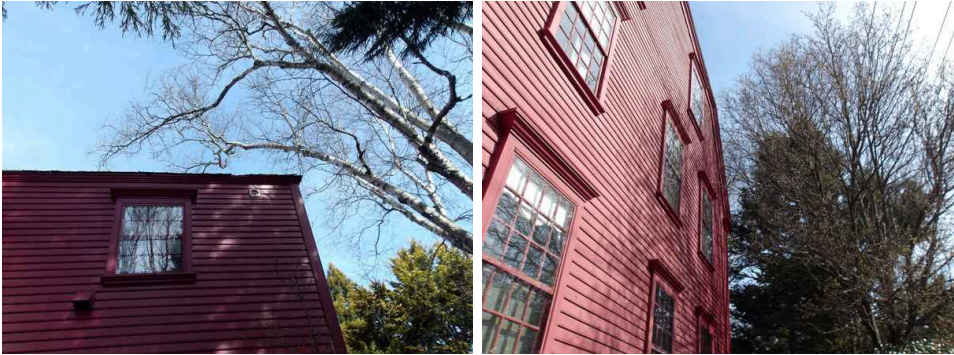
Trees observed overhanging the roof. This can cause damage to the roof and prevent proper drainage. Recommend a qualified tree service trim to allow for proper drainage.

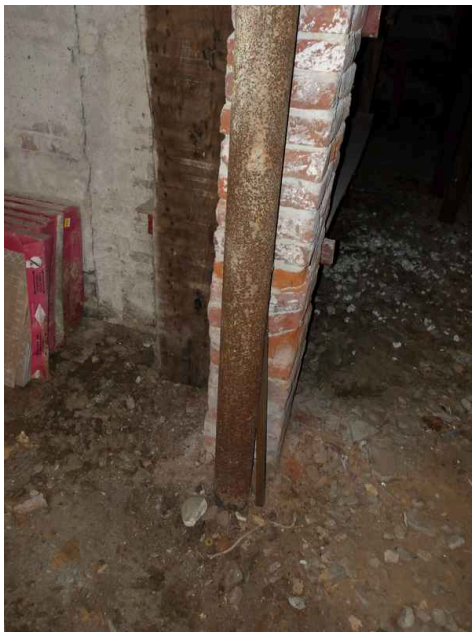
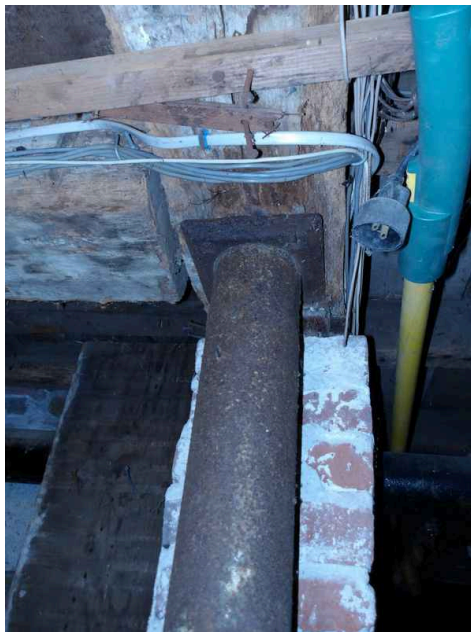
## 6.2.1 Floor Structure

**LALLY COLUMN: CORROSION/RUST**

I observed corrosion and rust at the base of the lally column. Significant corrosion can weaken the column's structural integrity, potentially compromising the support it provides. I recommend monitoring the area for worsening conditions and consulting a qualified contractor if deterioration progresses.

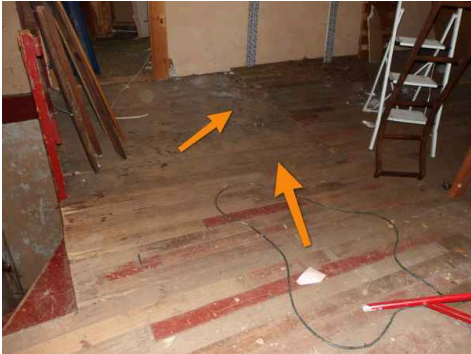
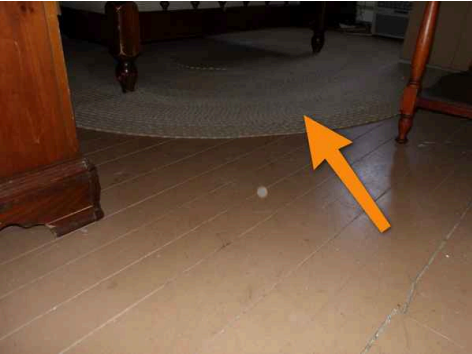
I observed deflection and sagging in the floor, which appears to indicate some settling. While this condition may be stable, it should be monitored as further movement could suggest underlying structural concerns. I recommend consulting a structural contractor or engineer if the condition worsens to evaluate and address any necessary repairs.

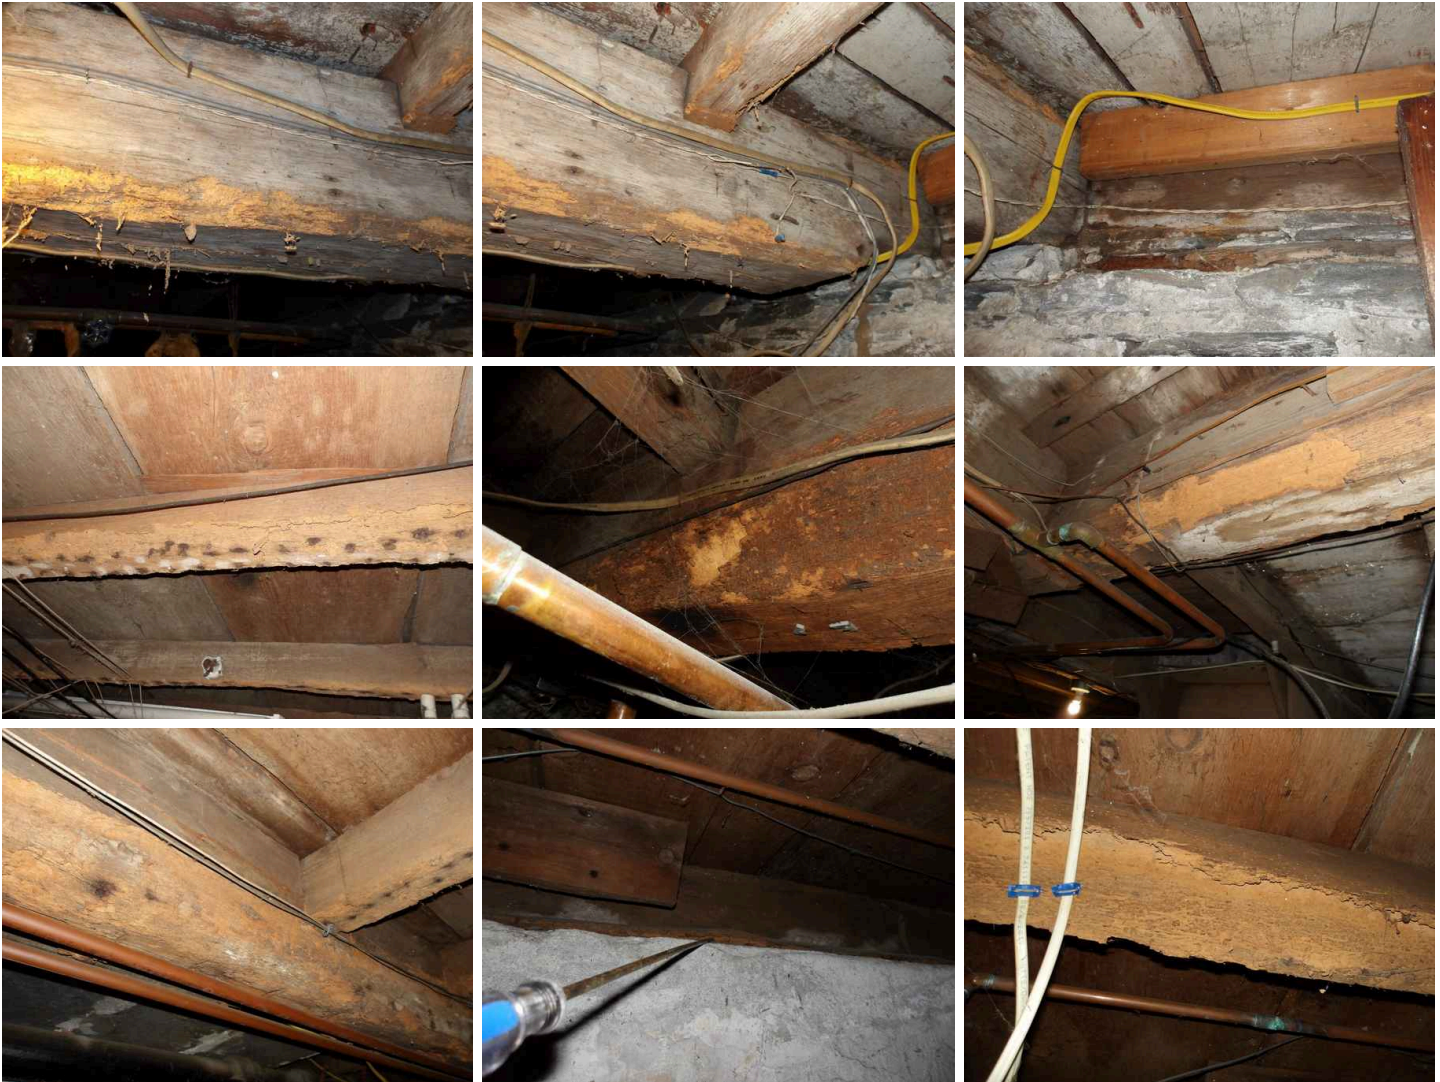
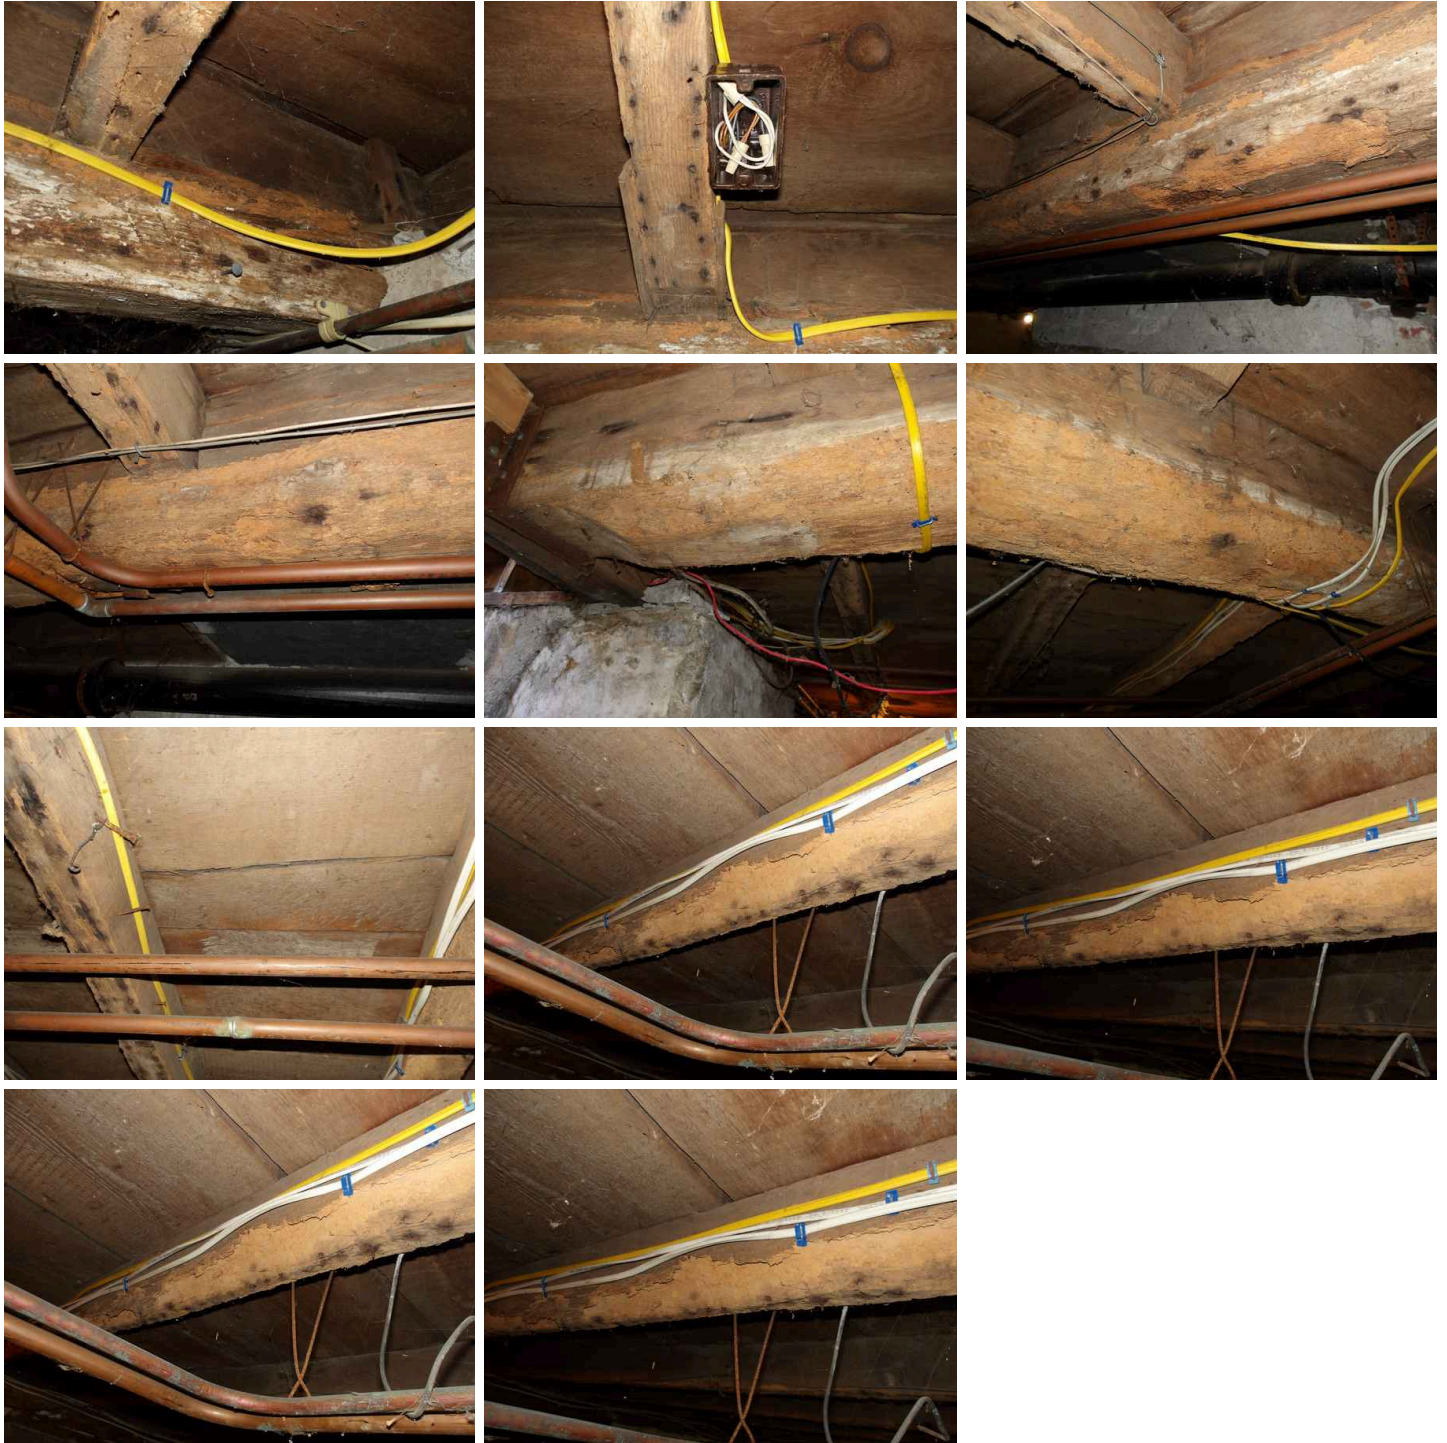
Damage consistent with powder post beetle was observed at the girders, floor joists, and sill plate. I did not observe evidence of an active infestation. This type of damage can weaken the structural integrity of the affected areas if left unaddressed. I recommend consulting a qualified pest control professional for treatment and structural contractor to assess and repair the structural components as necessary.

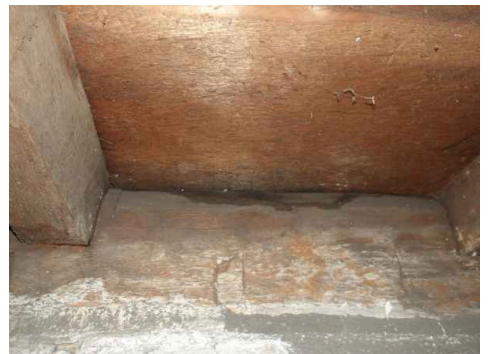
I observed signs of past water intrusion beneath the kitchen and bathroom fixtures, commonly associated with prior installations or repairs. No active leaks were present at the time of inspection, and the affected areas appeared dry. I recommend monitoring these locations periodically for any signs of renewed moisture or leakage.

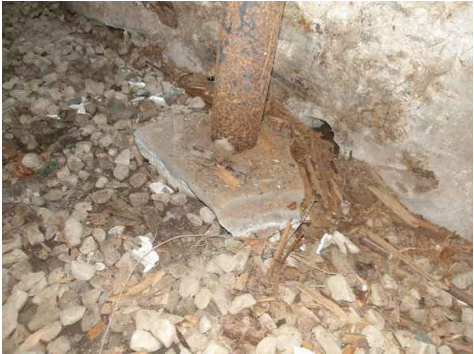
I observed the concrete footing for the lally column is exposed and appears insufficient in depth. This condition can affect the load-bearing support and long-term stability of the column. I recommend having a qualified structural contractor evaluate and correct the footing to ensure proper support.

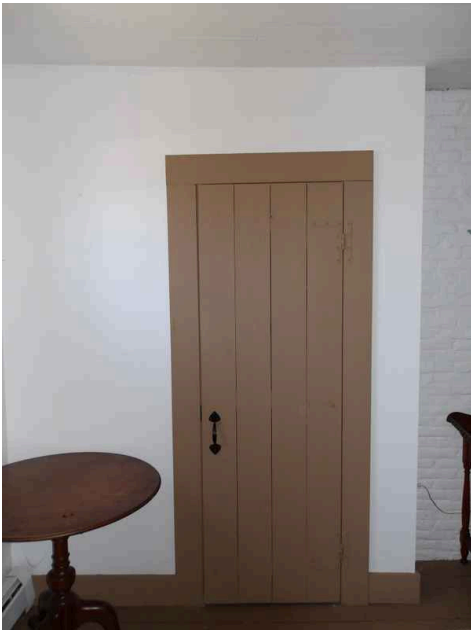
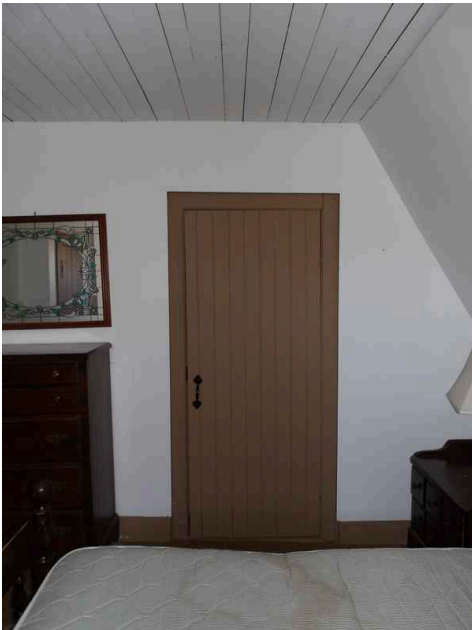
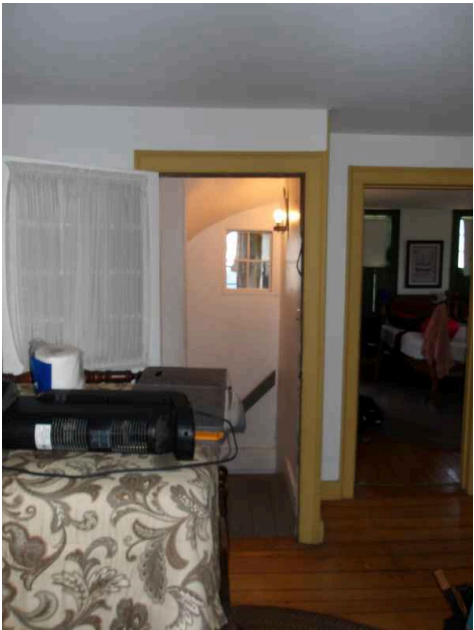
I observed a sagging door frame, which may be indicative of underlying structural issues and settling. This condition can affect the functionality of the door and potentially point to broader structural concerns. I recommend having a structural contractor or qualified contractor evaluate the situation to determine the cause and recommend appropriate corrective measures to ensure the stability and integrity of the structure.

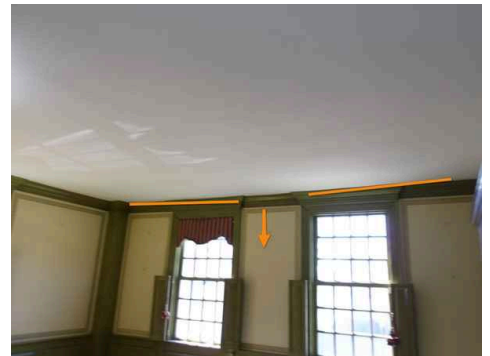
#### 6.4.1 Ceiling Structure

### SAGGING IN CEILING STRUCTURE

Repair or Replace

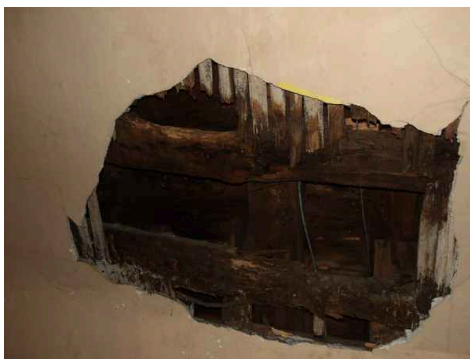
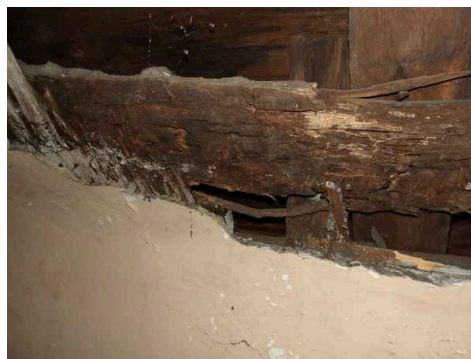
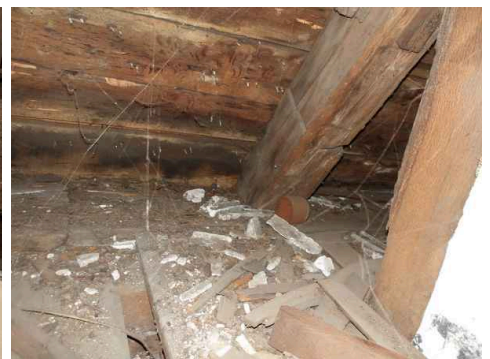
I observed evidence of previous moisture intrusion, though no active leaks were identified during the inspection. I recommend repairing these areas and monitoring the area for any signs of recurrence and ensuring that proper measures are in place to prevent future moisture issues.

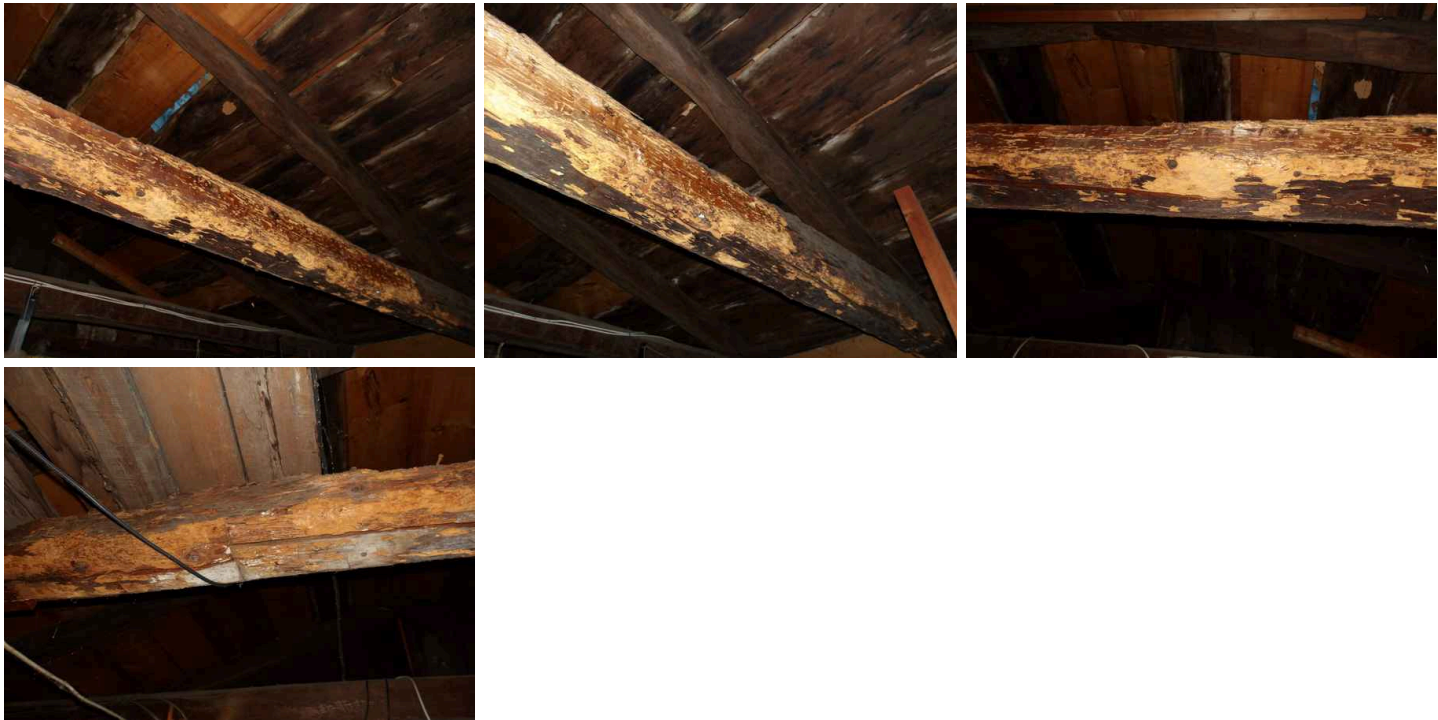
6.5.2 Roof Structure & Attic

**POWDER POST BEETLE**

Damage consistent with powder post beetle was observed at the rafter ties and rafters. I did not observe evidence of an active infestation. This type of damage can weaken the structural integrity of the affected areas if left unaddressed. I recommend consulting a qualified pest control professional for treatment and structural contractor to assess and repair the structural components as necessary.

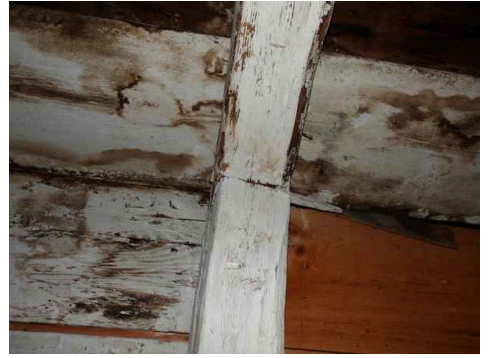
6.5.3 Roof Structure & Attic

**ROOF FRAMING: MISSING PEGS AT JOINTS**

I observed the timber frame mortise and tenon joints at the rafters and rafter ties are missing pegs. This condition can reduce the intended structural connection strength and may allow movement at the joints over time. I recommend having a qualified structural contractor evaluate and install appropriate pegs to restore proper joint integrity.
