# HISTORIC HOME INSPECTIONS

## HISTORIC HOME INSPECTIONS - MULTIFAMILY REPORT

1234 Main Street  
Newport, RI 02840

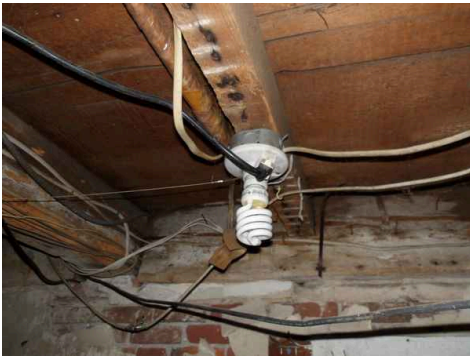
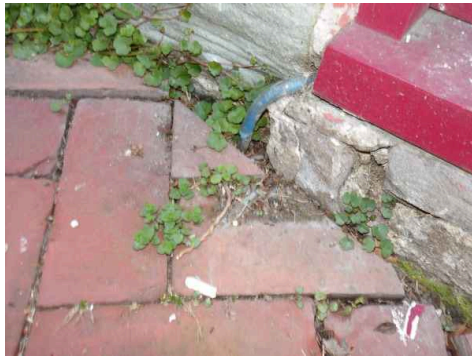
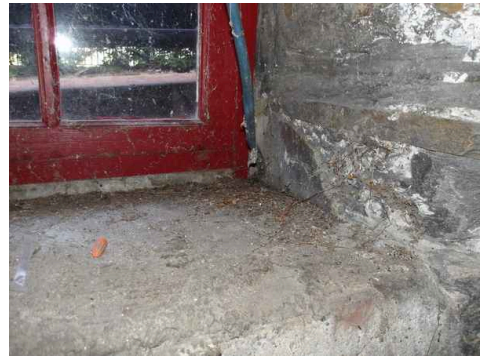
An extension cord was observed being used as a substitute for permanent branch circuit wiring, which is not a safe or code-compliant practice. Extension cords are not designed for continuous use and may pose a fire hazard due to overheating or damage over time. Correction by a qualified electrician is recommended to install proper wiring that meets electrical safety standards.

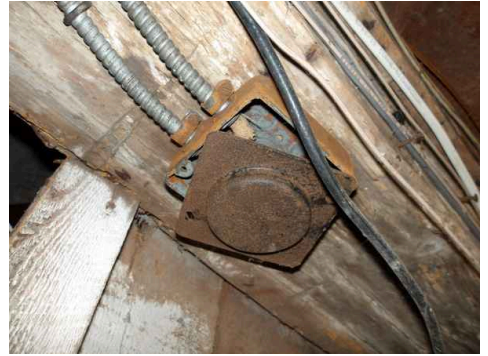
I observed a junction box cover is not securely fastened. This condition can expose wiring and increase the risk of damage or accidental contact. I recommend having a qualified licensed electrician properly secure the cover to ensure safe enclosure.

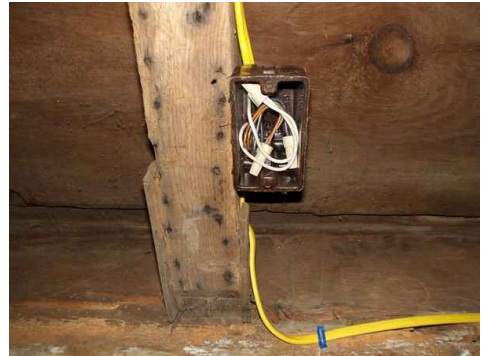
I observed a junction box is missing its cover. This condition leaves electrical connections exposed and presents a safety hazard. I recommend having a qualified licensed electrician install an appropriate cover to properly enclose the wiring.

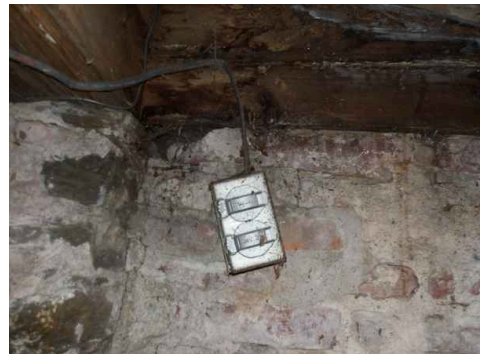
I observed an electrical receptacle is loose and not securely fastened within the wall box. This condition can lead to movement, damaged wiring connections, and potential safety concerns. I recommend having a qualified licensed electrician properly secure the receptacle to ensure safe and stable operation.

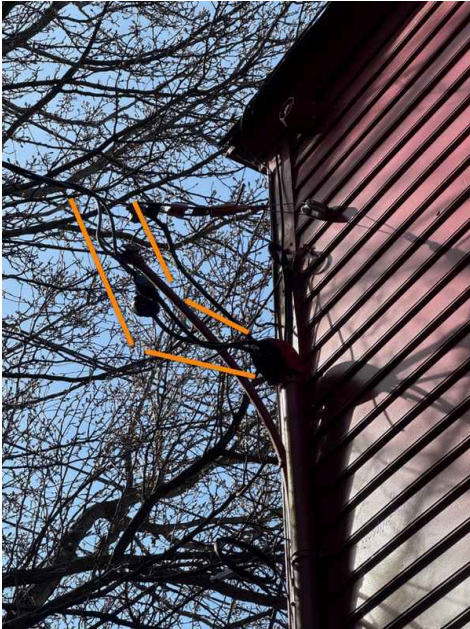
I observed the electrical service drop does not have a pronounced drip loop. This condition can allow water to travel along the conductors and enter the service equipment, increasing the risk of moisture intrusion. I recommend having a qualified licensed electrician correct the service configuration to provide a proper drip loop.

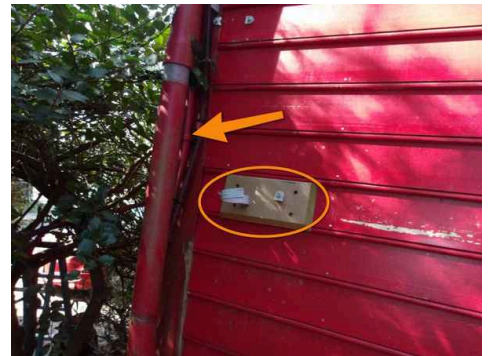
#### 7.1.2 Service Drop

### **SERVICE ENTRY LINE: IMPROPERLY SECURED**

I observed the service entry line is not properly securely fastened to the exterior at all or at the required intervals. This condition can allow movement of the conductors and may lead to strain on connections or potential damage. I recommend having a qualified licensed electrician secure the conductors in accordance with standard spacing requirements to ensure a stable installation.

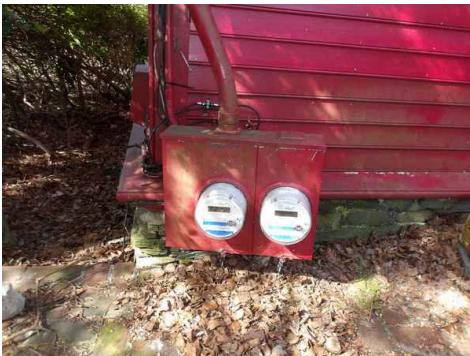
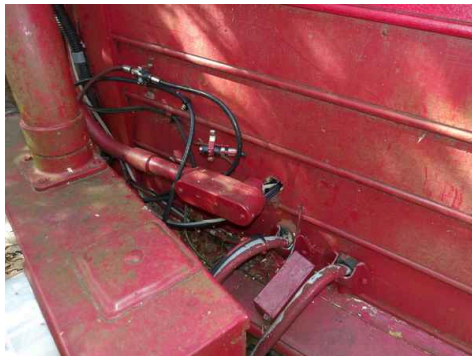
I observed the electrical meter is not properly secured to the exterior wall. This condition can lead to movement, potential damage to electrical connections, and possible water intrusion at the service entry. I recommend having a qualified licensed electrician secure the meter assembly to ensure a stable and weather-resistant installation.

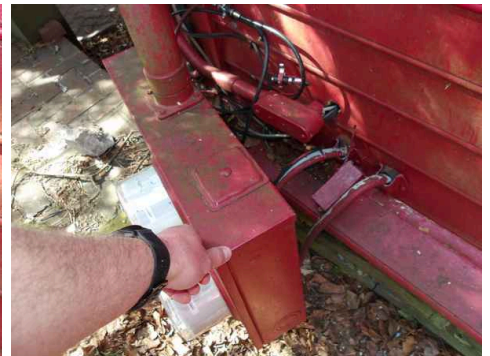
#### 7.2.1 Electric Meter

### **ELECTRIC METER: UNSECURED**

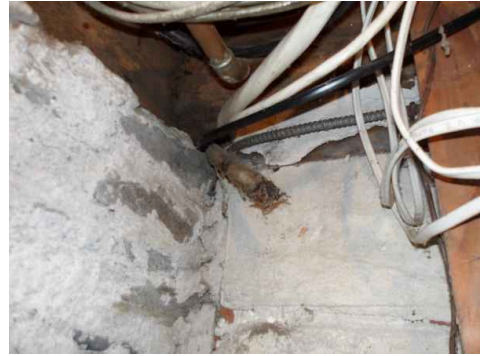
I observed an abandoned electrical service entry line present in the basement. This condition is unnecessary and may create confusion or potential safety concerns. I recommend having a qualified licensed electrician remove the abandoned wiring to ensure a clean and safe installation.

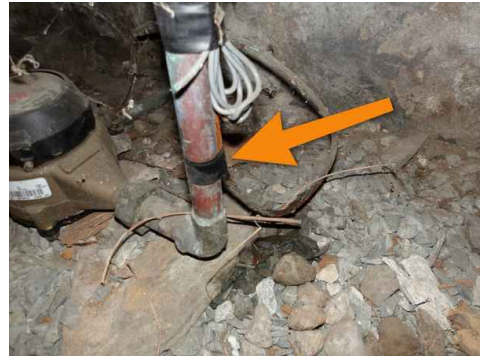
The bonding wire was found to be connected using electrical tape, which is not a proper or secure method. Bonding connections should be mechanically fastened with approved clamps or connectors to ensure a safe and effective grounding system. I recommend correction by a qualified electrician to establish a proper and code-compliant connection.

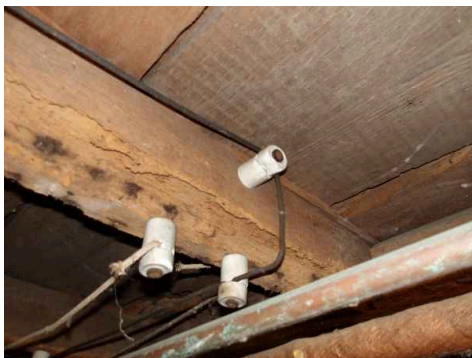
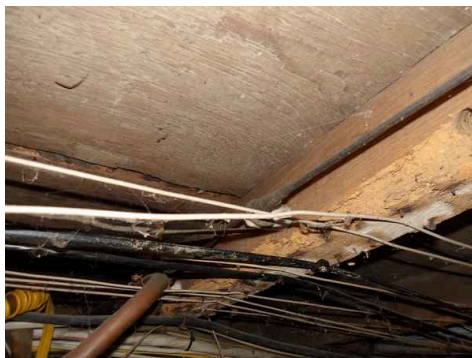
Knob-and-tube wiring was observed in the home, which is an outdated electrical system that may not meet modern safety standards. No active knob and tube was identified at the time of the inspection. This type of wiring can pose potential fire risks, especially if insulation or modifications compromise its integrity. I recommend having a licensed electrician inspect the wiring and upgrade it as needed to ensure safe and reliable electrical service.

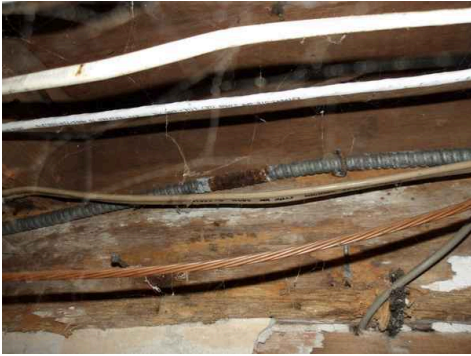
I observed rust present on the armored cable branch circuit wiring. This condition can indicate moisture exposure and may lead to deterioration of the cable sheathing over time. I recommend having a qualified licensed electrician evaluate the affected wiring and address any corrosion to ensure safe operation.

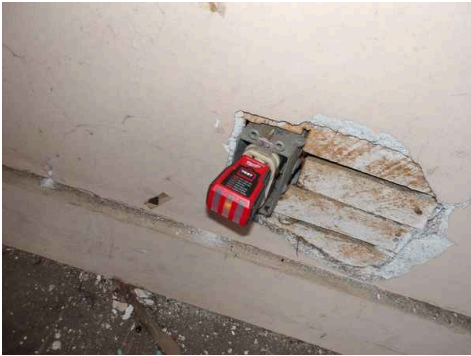
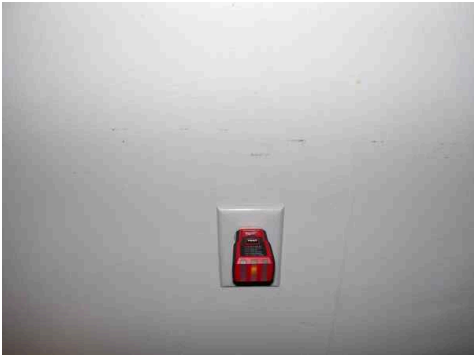
One or more receptacles are ungrounded. To eliminate safety hazards, all receptacles in kitchen, bathrooms, garage & exterior should be grounded.

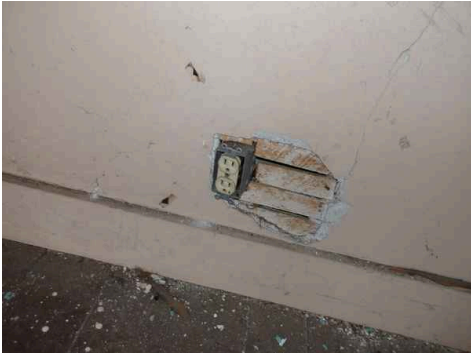
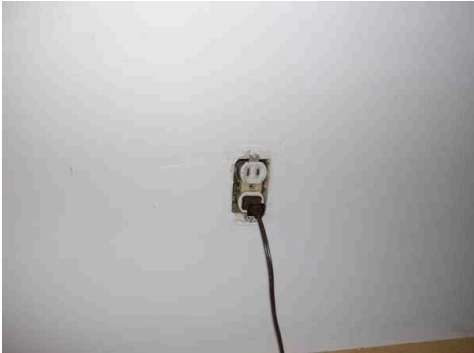
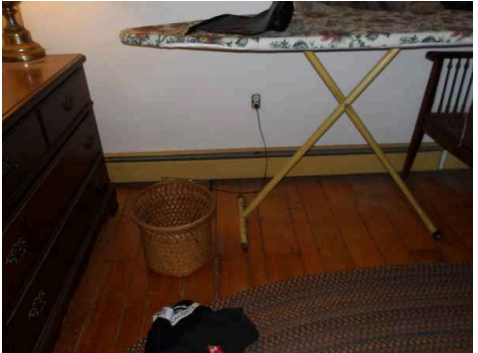
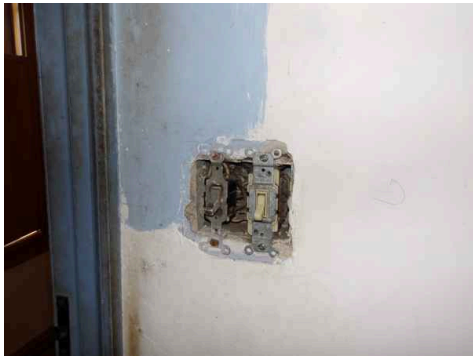
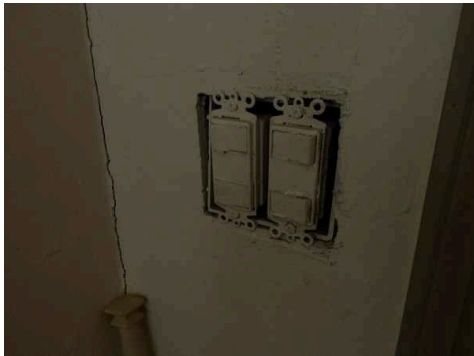
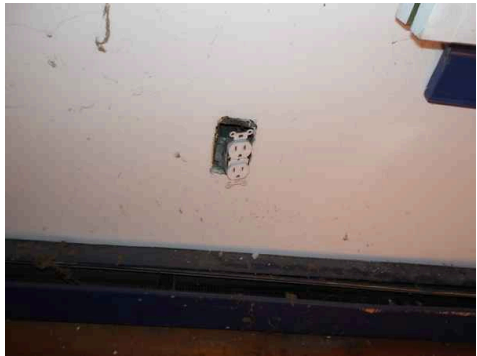
One or more receptacles are missing a cover plate. This causes short and shock risk. I recommend installation of plates.

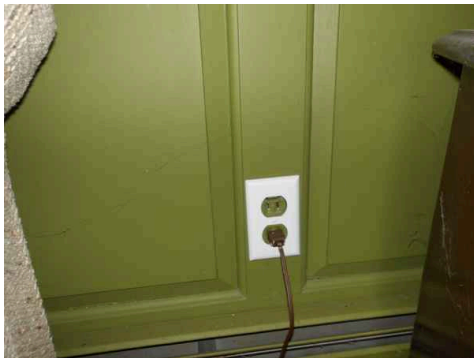
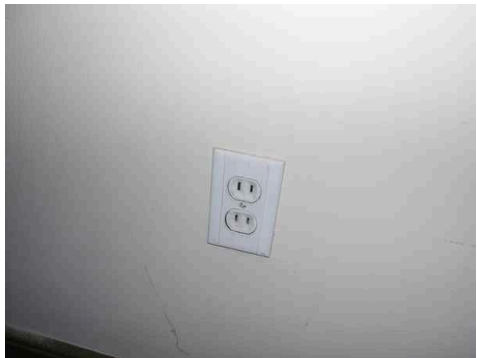
I observed two-prong electrical outlets installed at the property. This condition indicates a lack of grounding, which can increase the risk of electrical shock and may not support modern appliances safely. I recommend having a qualified licensed electrician evaluate and upgrade the outlets to grounded receptacles where appropriate.

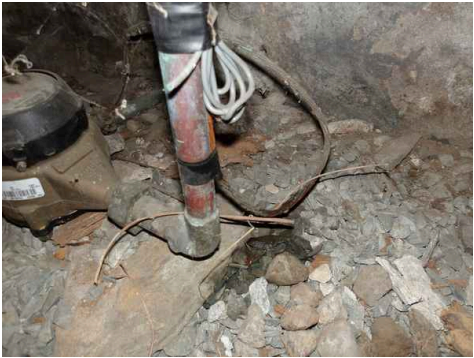
**WATER MAIN AREA: ACTIVE LEAK**

I observed a leak at the plumbing near the water main. This condition can lead to water damage, increased utility costs, and potential deterioration of nearby components. I recommend having a qualified plumbing contractor repair the leak to restore proper system integrity.

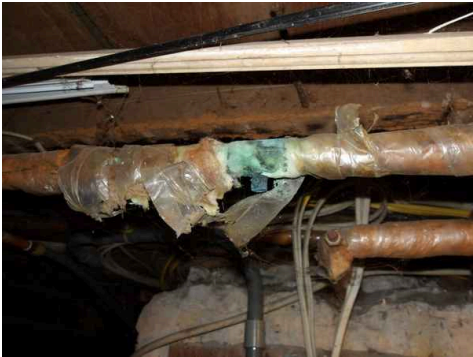
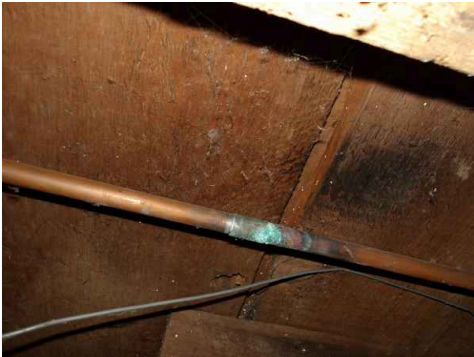
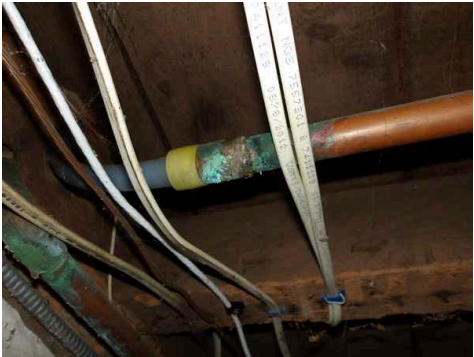
**WATER DISTRIBUTION PLUMBING: CORROSION**

Corrosion was observed on sections of the water distribution piping, likely due to age or prolonged moisture exposure. Corroded pipes may weaken over time and are at increased risk of leaking. I recommend evaluation and repair or replacement by a licensed plumber to maintain system reliability.

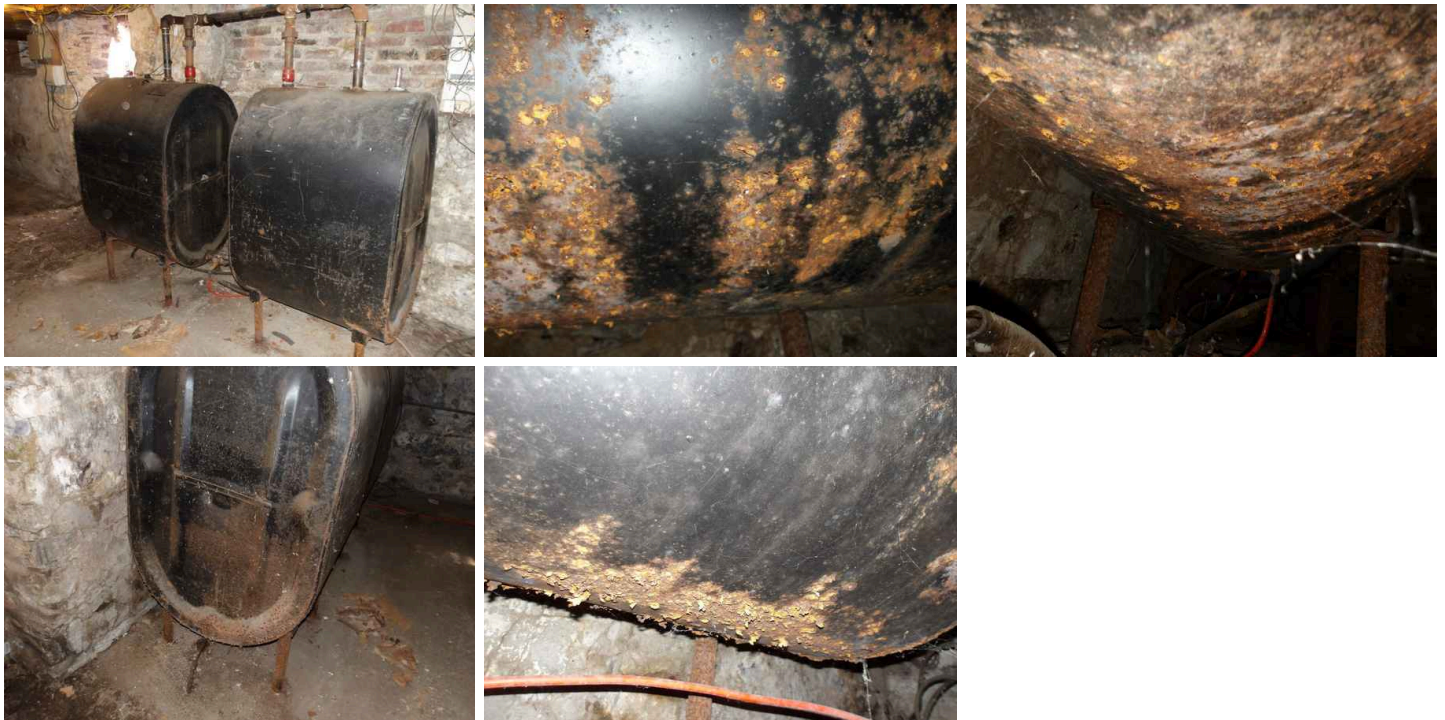
Corrosion was noted on the exterior of the oil tank, which may indicate material degradation over time. If deterioration progresses, it could lead to leaks, environmental contamination, or system failure. Recommend evaluation by a qualified HVAC or fuel tank specialist to determine the extent of corrosion and perform necessary repairs or replacement.

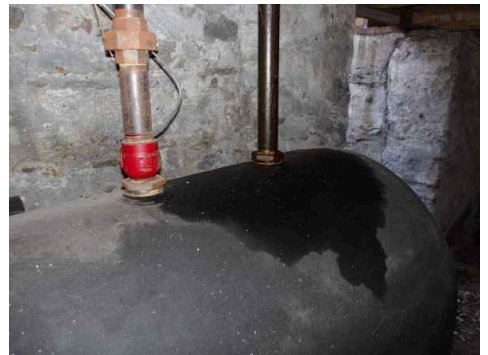
##### **OIL STAINS AT TOP OF TANK**

Oil stains were observed at the top of the tank around the fill plumbing connection, indicating potential spillage or a minor leak during refueling. This condition may lead to environmental concerns or further system issues if not addressed. I recommend having a licensed technician inspect the connection and correct any deficiencies to ensure a secure and clean operation.

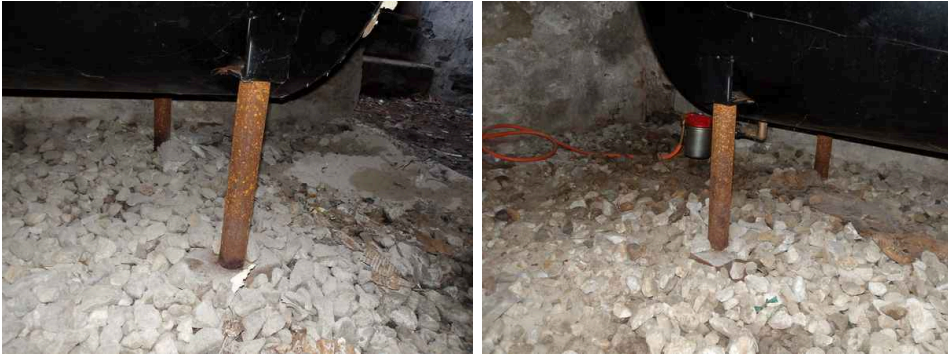
I observed the oil tank support legs are corroded. This condition can weaken the structural support of the tank and may lead to instability or failure over time. I recommend having a qualified oil service contractor evaluate and repair or replace the supports to ensure a secure installation.

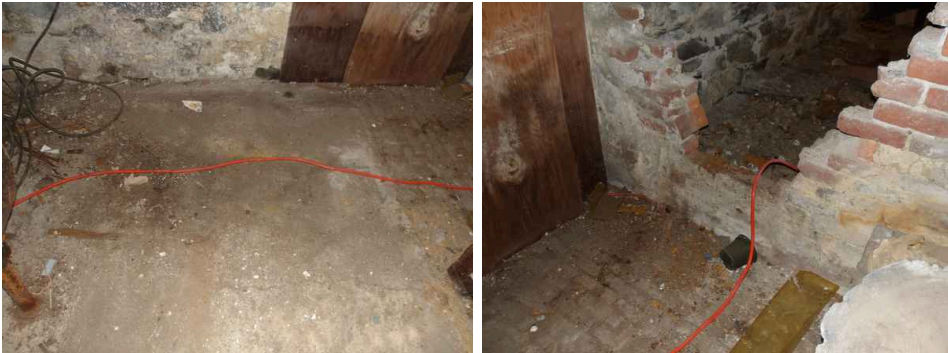
### 8.8.1 Fuel Distribution Plumbing

#### **OIL LINE: UNSECURED**

I observed the oil supply line from the tank to the boiler is not properly secured. This condition can allow it to be stepped on or crushed, increasing the risk of damage or leakage. I recommend having a qualified contractor secure the oil line to the wall or overhead to ensure a stable installation.

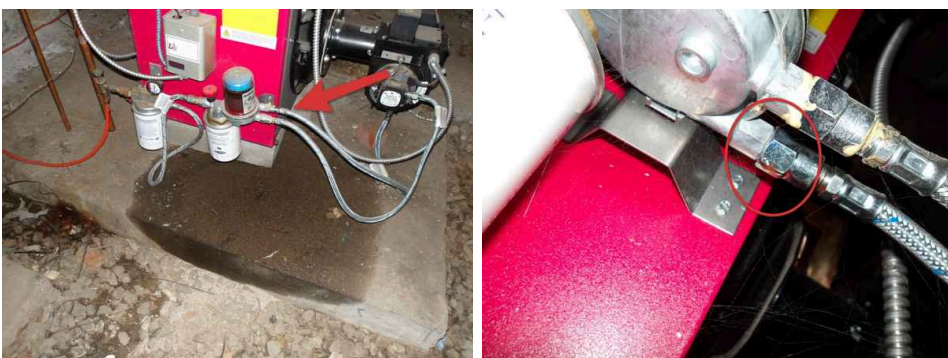
### 8.8.2 Fuel Distribution Plumbing

#### **BOILER CONNECTION: OIL LEAK**

I observed oil leaking at the boiler connection. This condition presents an environmental concern and can lead to contamination if not addressed. I recommend having a qualified HVAC or oil burner technician repair the leak and ensure the system is properly sealed.

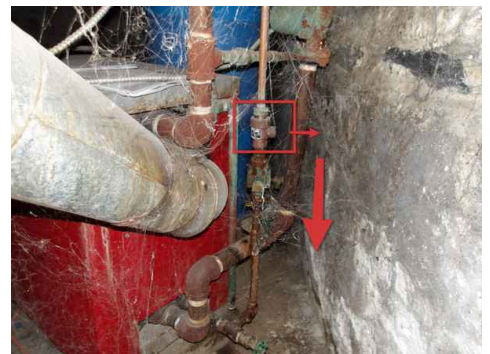
### **BACKFLOW PREVENTER DISCHARGE PIPE: MISSING**

The discharge pipe for the backflow preventer is missing, which can pose a safety concern if the valve releases water. Proper piping helps direct discharge safely away from equipment and living areas. I recommend installation of an appropriate discharge pipe by a licensed plumber.

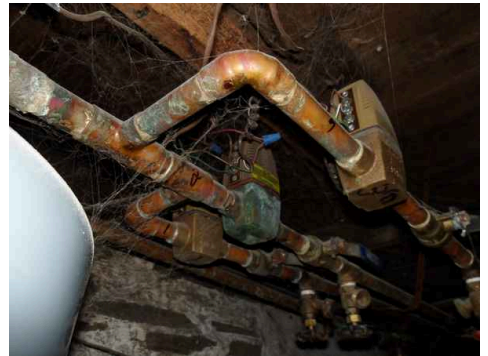
**ZONE VALVE: CORRODED**

Corrosion was observed on the zone valve, likely due to moisture exposure or age-related deterioration. This condition may impair valve operation and affect heating zone performance. I recommend evaluation and replacement of the corroded valve by a licensed HVAC or plumbing contractor to ensure proper system function.

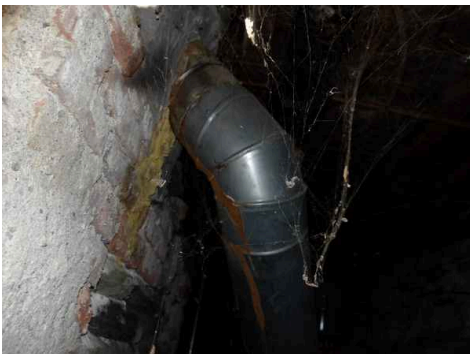
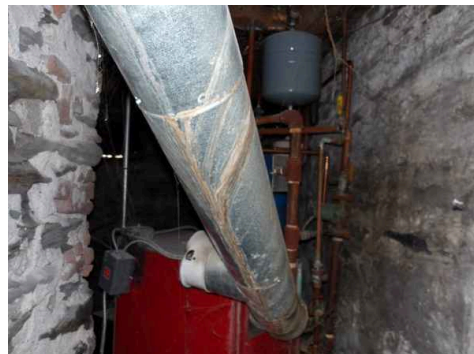
**VENT FLUE: CORROSION**

Corrosion was observed on the boiler vent flue, indicating prolonged exposure to moisture or combustion byproducts. Continued deterioration may affect venting performance and poses a potential safety concern. I recommend evaluation and repair or replacement by a licensed HVAC or plumbing contractor to ensure safe and effective exhaust ventilation.

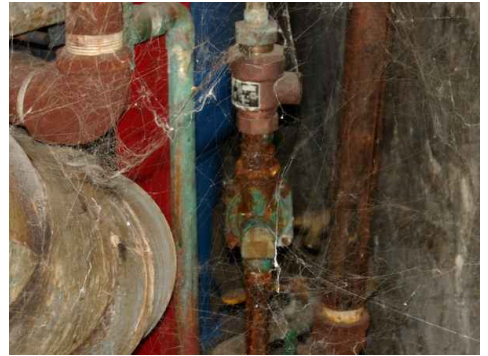
Unit 59

**BOILER SURROUNDING PLUMBING: CORRODED**

I noted corrosion on the plumbing around the boiler. Corroded pipes and fittings can lead to leaks, reduced system efficiency, or eventual failure. I recommend repair or replacement of the affected plumbing by a qualified plumber or HVAC technician to maintain safe and reliable operation.

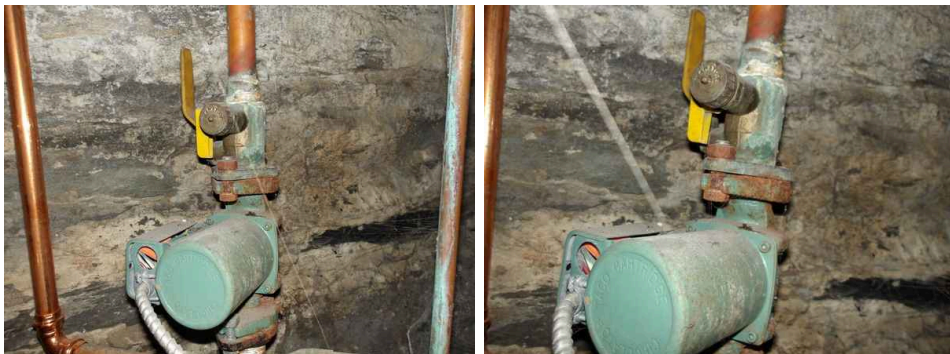
I noted visible corrosion on the circulator pump. Corrosion can lead to leaks, reduced efficiency, or eventual failure of the pump. I recommend repair or replacement by a qualified HVAC technician to maintain proper heating system performance.

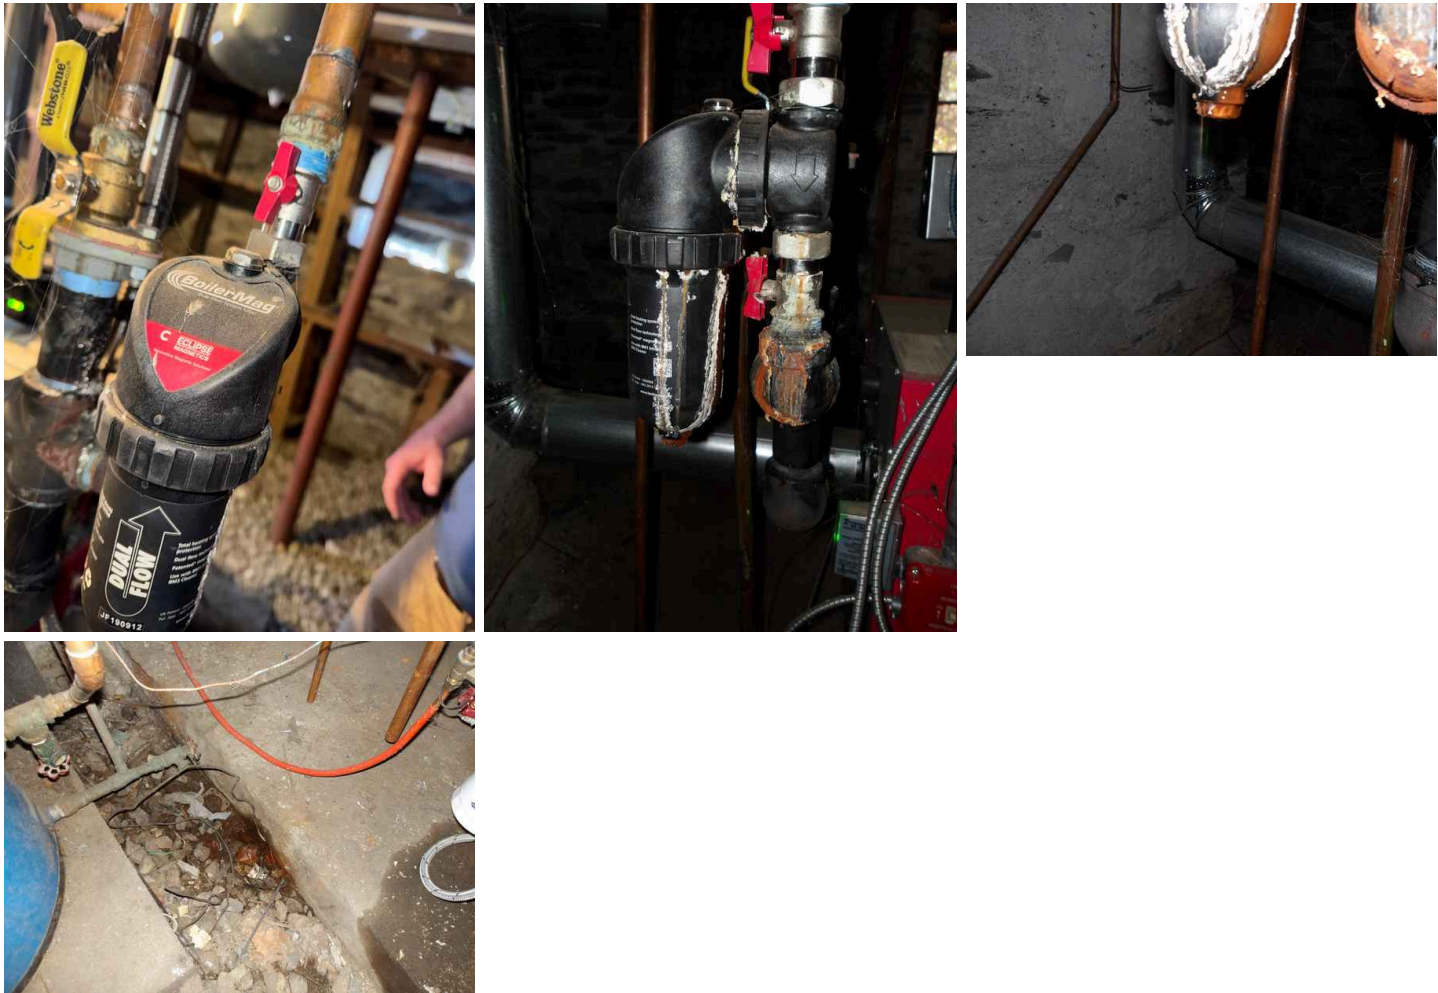
## 9.1.8 Boilers

**MAGNETIC FILTER: LEAKING**

I observed the magnetic filter (BoilerMag) is leaking. This component is designed to capture iron oxide sludge and protect the boiler system, and leakage can reduce its effectiveness and contribute to system inefficiency or water loss. I recommend having a qualified HVAC contractor repair or replace the filter to ensure proper operation and system protection.

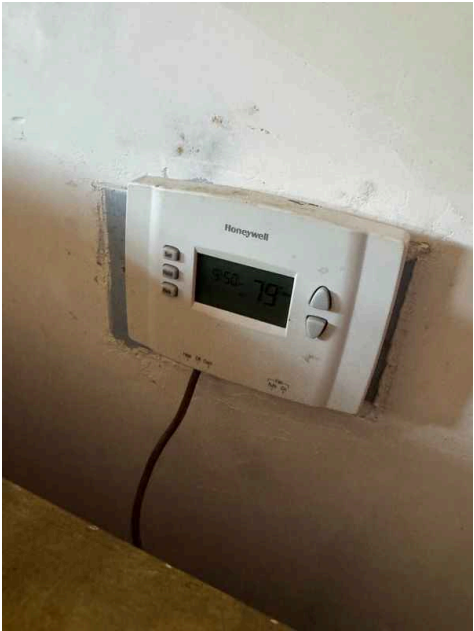
9.3.1 HVAC Thermostats / Operating Controls

**THERMOSTAT WIRING: EXPOSED**

Repair or Replace

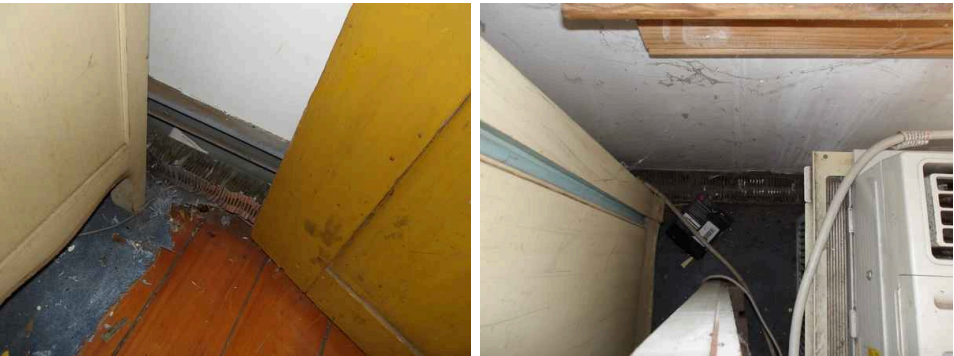
9.4.1 HVAC Distribution Systems

**MISSING BASEBOARD COVER**

A baseboard cover is missing, leaving the area unfinished and potentially exposing sharp edges or rough surfaces. This condition can detract from the room’s appearance and may present a minor safety concern. I recommend installing a new baseboard cover.

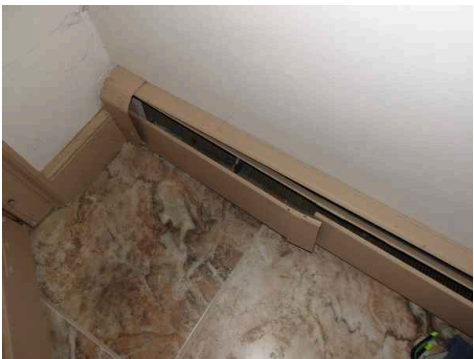
Unit 59 2nd Floor

**BASEBOARD RADIATOR: UNSECURED COVERS**

The baseboard radiator covers were observed to be unsecured, which could pose a safety risk, especially in high-traffic areas. Loose covers may also lead to accidental damage or reduced efficiency of the heating system. I recommend securing the covers properly to enhance safety and maintain the system’s functionality.

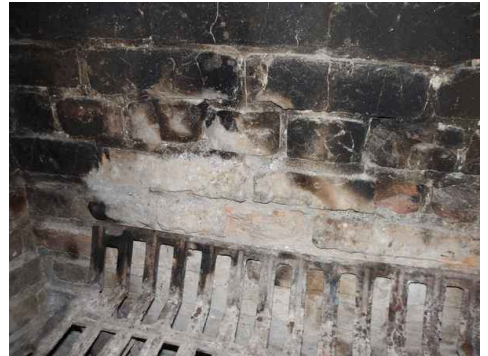
Unit 59 1st Floor

#### **SPALLING BRICK IN FIREBOX**

I observed that the brick inside the firebox is experiencing spalling, indicating that the bricks are deteriorating and flaking. This condition can worsen with heat exposure, potentially impacting the fireplace's safety and functionality. I suggest having a qualified mason evaluate and repair the firebox to ensure safe operation.

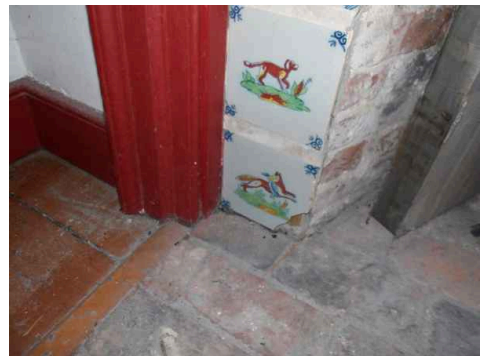
Unit 59 2nd Floor

#### **CRACKS IN FIREPLACE SURROUND**

Cracks were observed at the fireplace surround, which may indicate movement or heat-related stress over time. Left unaddressed, these cracks could expand, potentially affecting the structural integrity or aesthetic appeal of the area. I recommend consulting a qualified mason to assess and repair the cracks as needed.

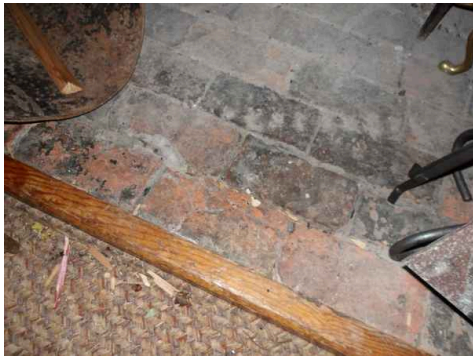
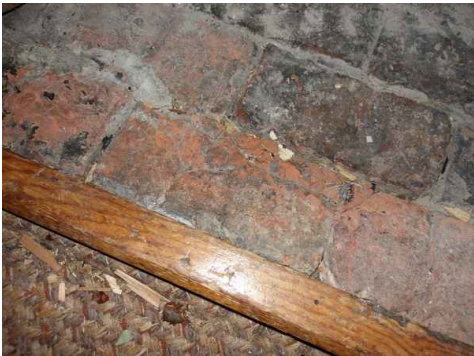
Unit 59 1st Floor

#### **CRACKED HEARTH**

The hearth has visible cracks, which may compromise its structural integrity and heat resistance. Gaps or fractures can allow heat or embers to reach combustible materials, increasing the risk of fire. A qualified masonry contractor should assess the damage and repair or replace the hearth as necessary for safety.

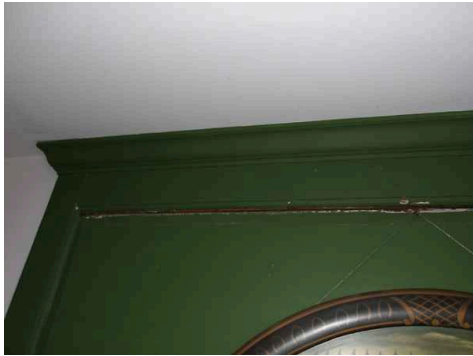
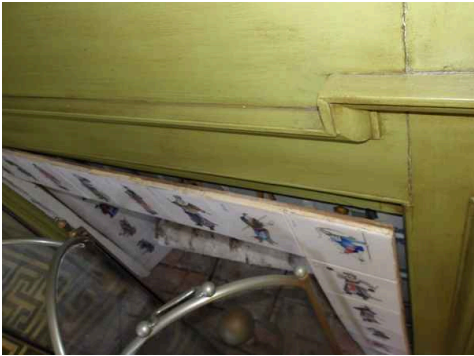
Unit 59 2nd Floor

**FIREPLACE SURROUND: SEPARATED HEADER**

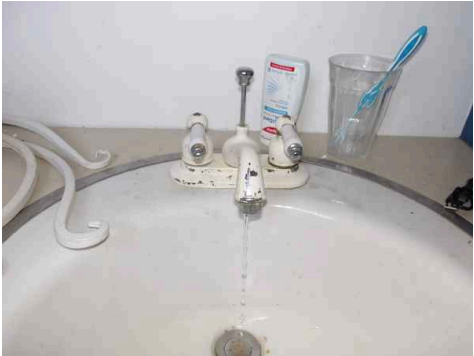
The sink fixture has noticeably low water flow, likely due to a clogged aerator, debris buildup, or internal component wear. Restricted flow can reduce functionality and may indicate minor plumbing issues. I recommend cleaning the aerator first, and if the issue persists, having the fixture evaluated by a licensed plumber.

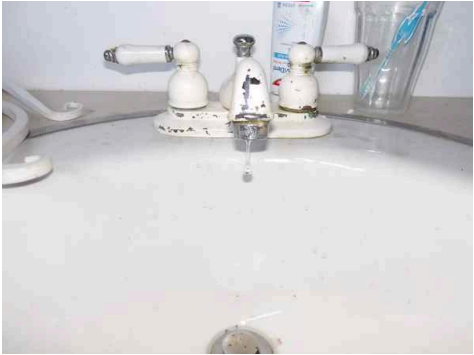
I observed the bathroom sink faucet continues to drip after being shut off. This condition can lead to water waste and may indicate worn internal components. I recommend having a qualified plumbing contractor repair or replace the faucet to restore proper shutoff.

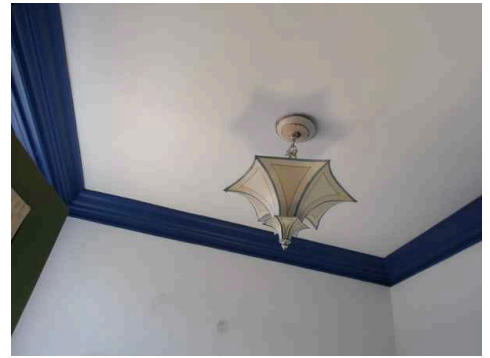
Bathroom vent system(s) were not present at the time of the inspection. The purpose of a bathroom vent is to remove moisture, humidity, and odors from the bathroom.

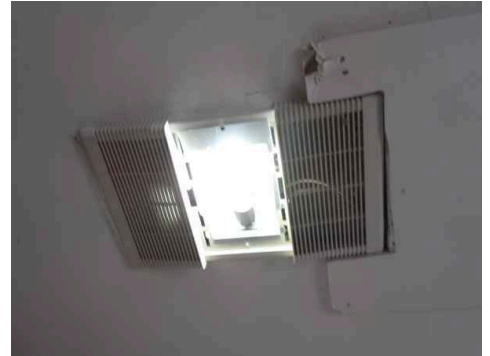
The bathroom vent did not operate at the time of the inspection. The purpose of a bathroom vent is to remove moisture, humidity, and odors from the bathroom.

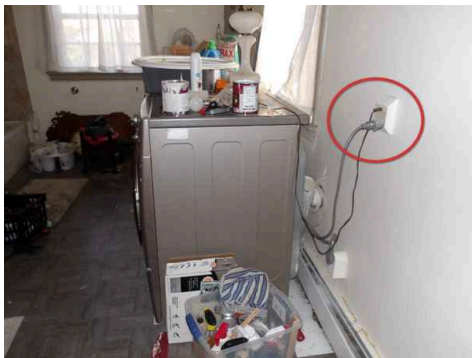
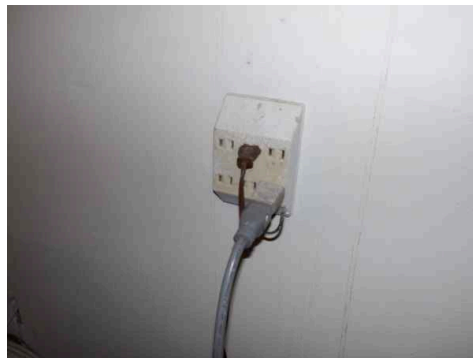
I observed GFCI protection is not present at one or more bathroom outlets. This condition increases the risk of electrical shock in wet locations and does not meet modern safety standards. I recommend having a qualified licensed electrician install GFCI-protected outlets to improve safety.

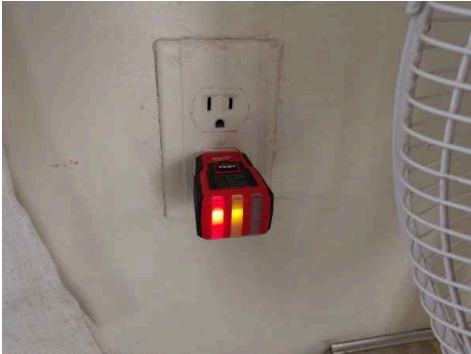
**REVERSE POLARITY**

One or more receptacles have been wired with reverse polarity. This can create a shock hazard. I recommend licensed electrician evaluate & repair.

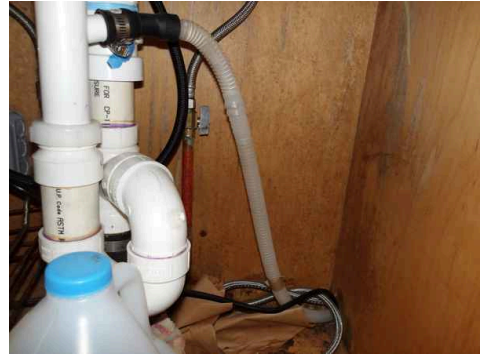
I observed that the dishwasher drain lacks a high loop or air gap, which helps prevent wastewater from backflowing into the dishwasher. This can lead to contamination and affect the appliance's performance. I recommend having a qualified plumber install a high loop or air gap in the drain line to ensure proper drainage and prevent potential backflow issues.

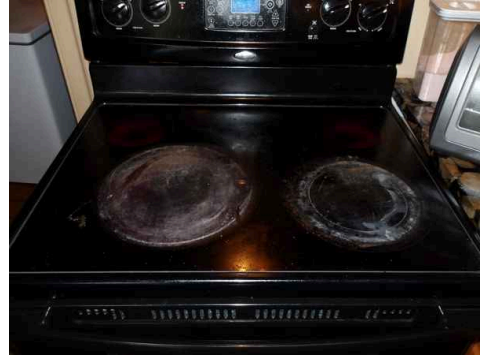
**RANGE BURNER: DIRTY**

I observed the glass burner on the range requires cleaning. This condition can affect burner performance and heat distribution during use. I recommend cleaning the burner surface to maintain proper operation and appearance.

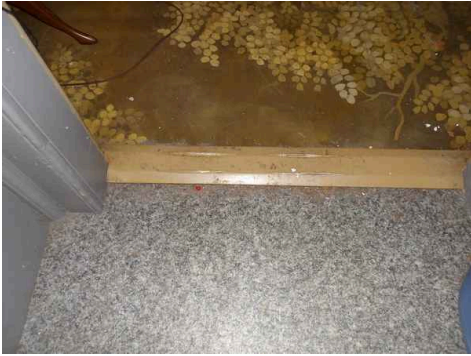
I observed the interior door threshold is worn. This condition can affect the transition between rooms and may lead to further deterioration with continued use. I recommend having a qualified contractor repair or replace the threshold to restore a smooth and durable surface.

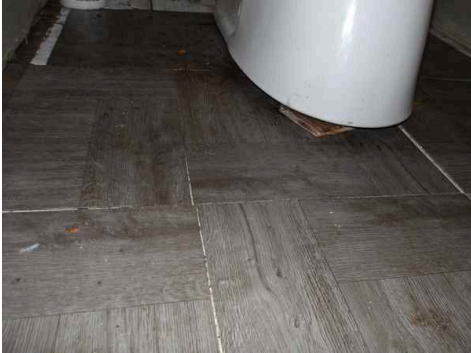
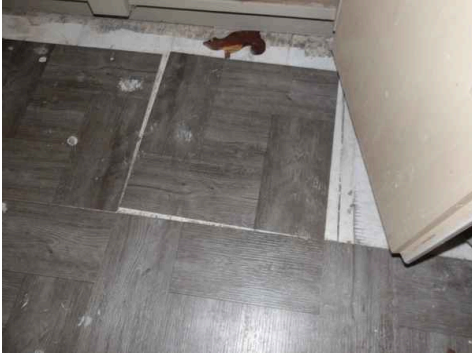
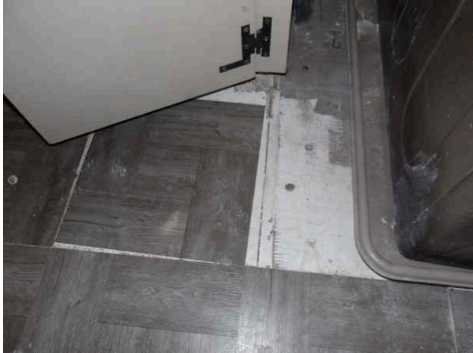
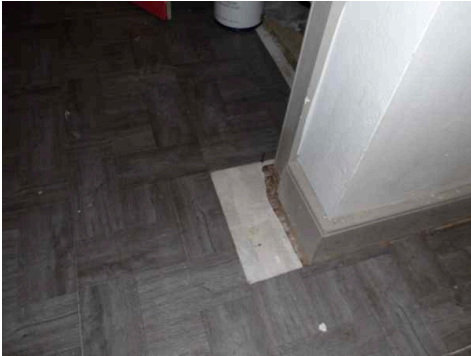
The vinyl tile flooring shows installation imperfections, such as uneven gaps or misaligned tiles. While not affecting function, these flaws detract from the overall appearance and may lead to premature wear. I recommend correction by a qualified flooring contractor if improved finish quality is desired.

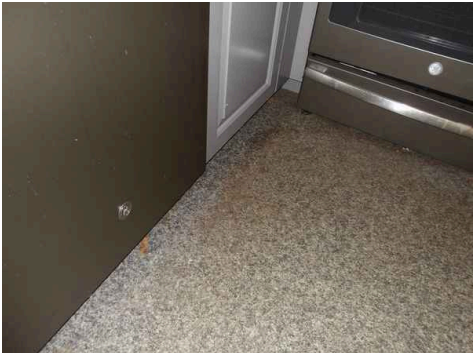
KITCHEN FLOORING: WORN AND DIRTY

I observed the kitchen laminate flooring is worn and soiled from foot traffic. This condition affects appearance and may indicate surface wear over time. I recommend cleaning and evaluating the flooring for repair or replacement as needed to restore condition.

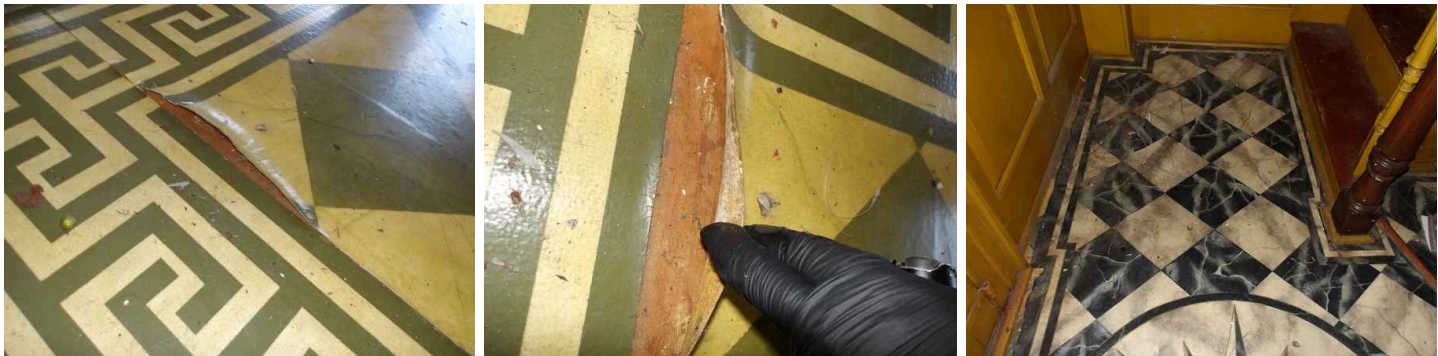
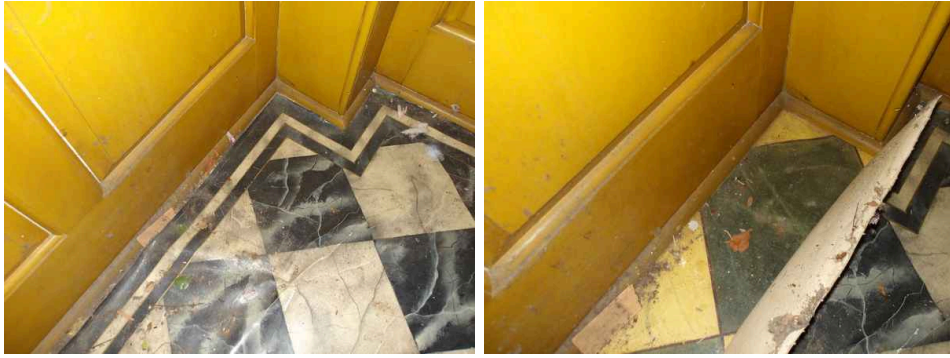
I observed the canvas flooring is significantly deteriorated. This condition can affect durability, sanitation, and overall usability of the surface. I recommend having a qualified contractor replace the flooring to restore proper condition and function.

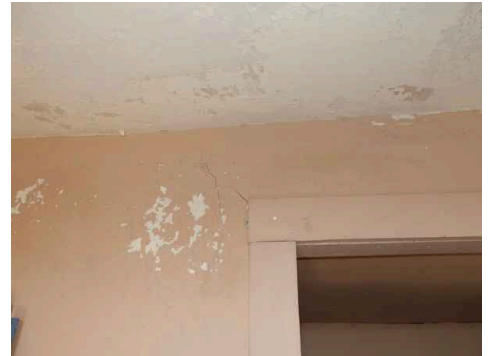
**CRACKING ON WALL/CORNERS**

I observed cracks at the corners of walls in some areas. These appear to be cosmetic and not indicative of long-term settling. I recommend consulting a qualified drywall contractor to repair or replace.

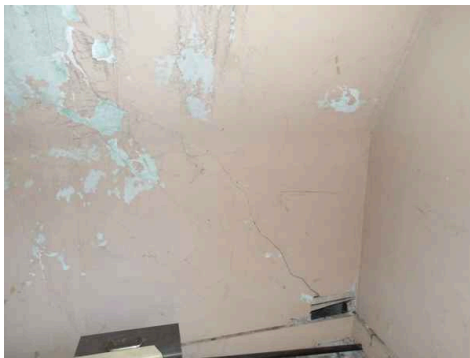
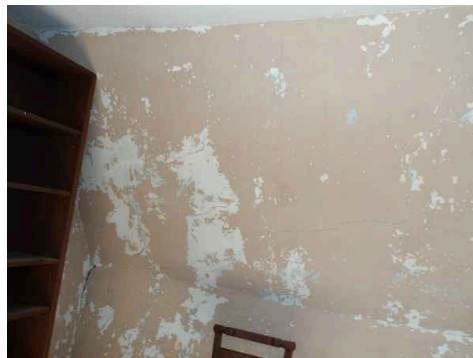
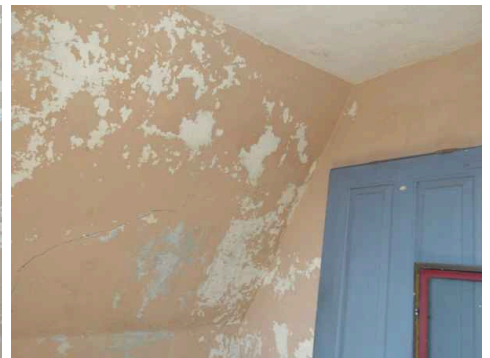
3rd Floor

**INTERIOR WALLS: CRACKED PLASTER**

I observed cracking and deterioration of historic plaster at interior wall surfaces. This condition is commonly associated with settlement, humidity changes, and long-term wear. I recommend having a qualified contractor repair the affected areas to restore the finish and prevent further deterioration.

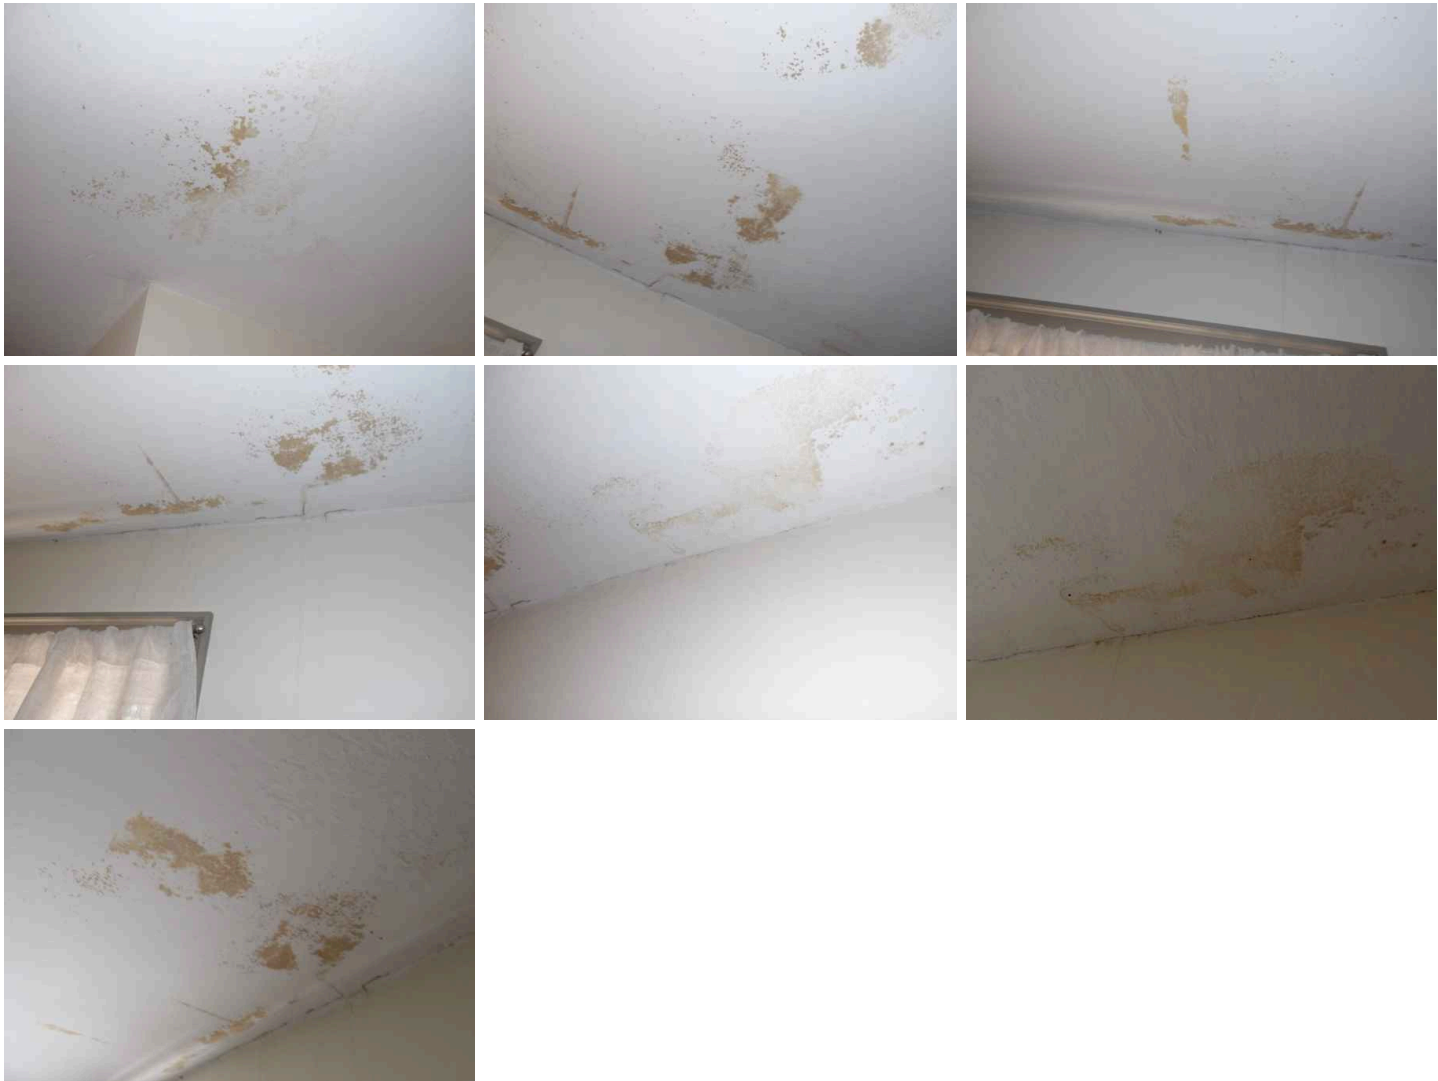
Staining was observed on the ceiling surface, and microbial organisms present, but no signs of an active leak were detected at the time of inspection. This area is below the flat roof and is suspected to be beyond life expectancy, but I was unable to observe. I recommend having a qualified contractor evaluate the area further and repair or refinish the ceiling as needed.

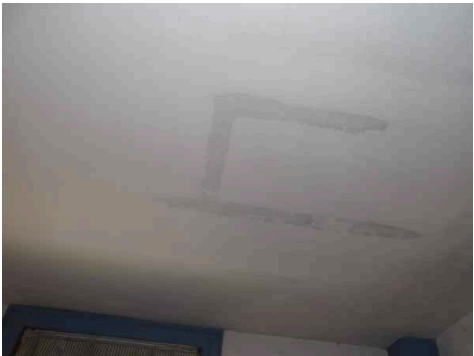
Noticeable patching was observed in one or more locations. I recommend repairing and repainting the affected areas.

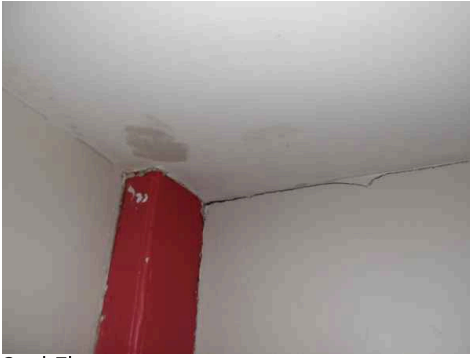
2nd Floor

**CEILING DRYWALL: TAPE BUBBLING OR SEPARATION**

I observed areas where the drywall tape on the ceiling is bubbling or separating from the surface, likely due to age, humidity, or minor settling. This is a cosmetic condition, but can worsen over time if not repaired. I recommend re-taping and refinishing by a qualified drywall contractor to restore a smooth and uniform appearance.

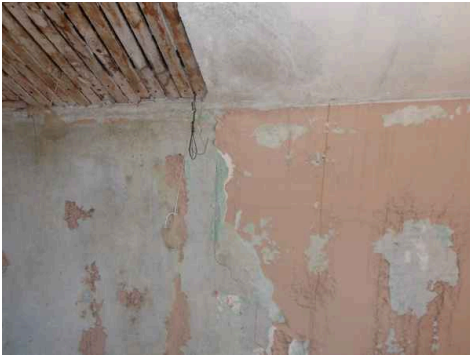
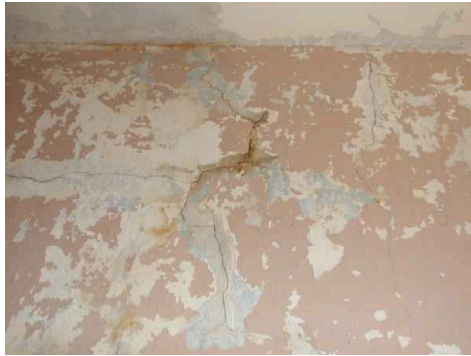
3rd Floor

**CEILINGS: CRACKED PLASTER**

I observed cracking and deterioration of historic plaster at interior ceiling. This condition is commonly associated with settlement, humidity changes, and long-term wear. I recommend having a qualified contractor repair the affected areas to restore the finish and maintain surface integrity.

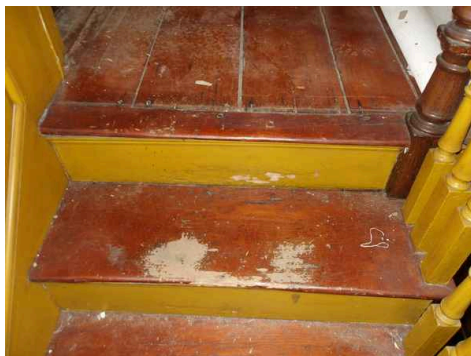
**WORN STEPS**

The steps were observed to have significant wear, including deterioration of the tread surfaces. I recommend having the steps repaired or resurfaced by a qualified contractor to restore their safety and functionality.
