# HISTORIC HOME INSPECTIONS

## HISTORIC HOME INSPECTIONS - MULTIFAMILY REPORT

1234 Main Street  
Newport, RI 02840

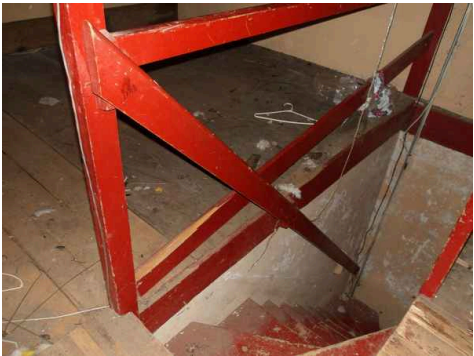
**GUARDRAIL BALUSTER: DAMAGED**

I observed a damaged baluster at the railing. This condition can compromise the integrity of the guard and may create a safety concern. I recommend having a qualified contractor repair or replace the affected baluster to restore proper safety and support.

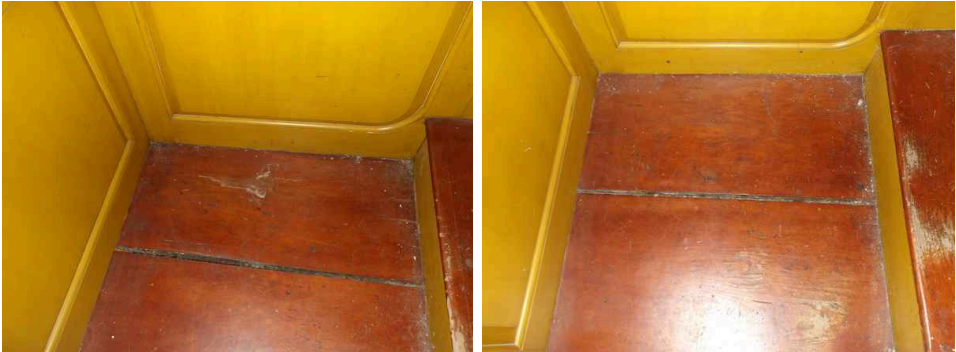
I observed gaps between the wood planks at the landing surface. I recommend having a qualified contractor evaluate and secure or replace the affected boards to improve stability and durability.

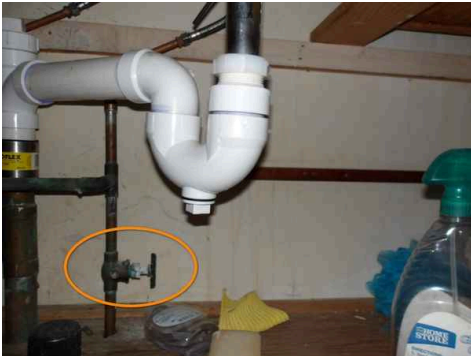
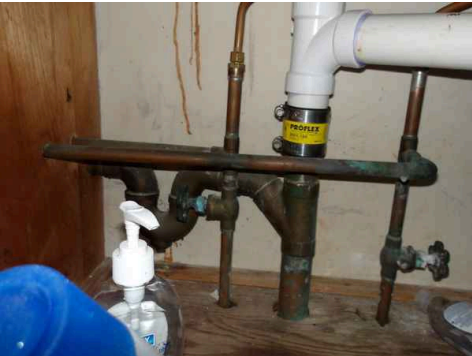
2nd Floor

SINK SUPPLY VALVE: CORRODED

I observed corrosion at the sink supply valve. This condition can lead to restricted operation or potential leakage over time. I recommend having a qualified plumbing contractor replace the valve to ensure reliable performance.

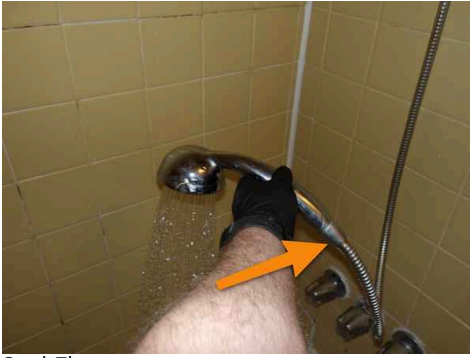
2nd Floor

SHOWER HOSE: LEAKING

I observed that the shower hose is leaking during operation. A leak can lead to water waste and potential moisture damage to surrounding areas. I recommend replacing or repairing the hose by a qualified plumber to restore proper function and prevent further issues.

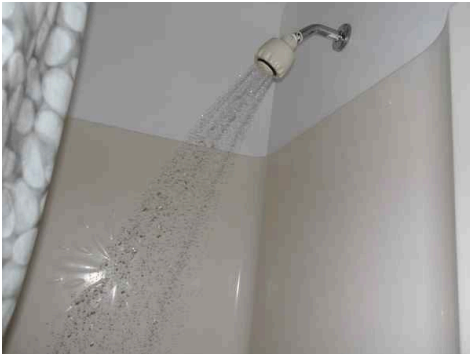
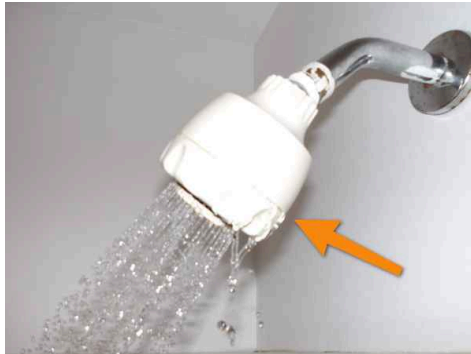
3rd Floor

Repair or Replace**SHOWERHEAD: LEAKING**

I observed that the showerhead is leaking, indicating a repair or maintenance issue. This condition can lead to increased water usage and may signal worn internal components. I recommend repairing or replacing the showerhead to restore proper function, using a qualified plumber.

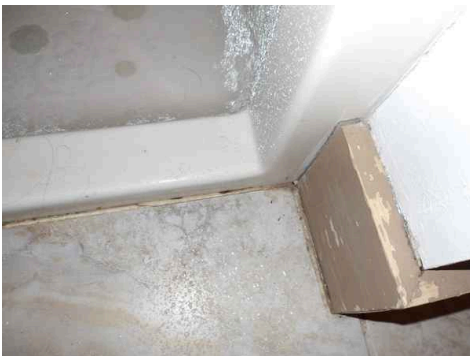
3rd Floor

Repair or Replace**SHOWER CAULKING: DETERIORATED**

I observed the shower caulking is deteriorated. This condition can allow water to penetrate behind finished surfaces and lead to moisture-related damage over time. I recommend having a qualified contractor remove and replace the caulking to restore a proper watertight seal.

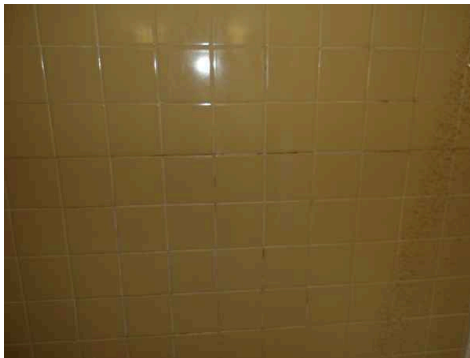
## 2ND FLOOR

I observed the shower tile has a poor finish with irregular surfaces and excessive grout, and areas of the grout appear deteriorated and dirty. This condition can allow moisture retention and contribute to ongoing deterioration and unsanitary conditions. I recommend having a qualified contractor repair or replace the affected tile and grout to restore a proper and watertight installation.

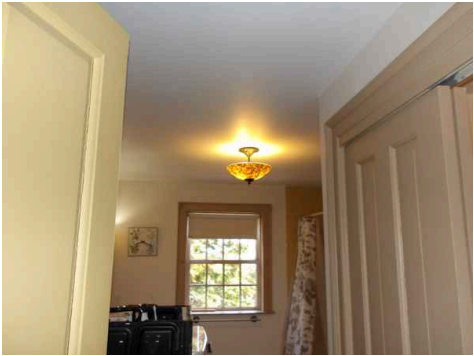
2nd Floor

**MISSING BATHROOM VENT SYSTEM**

Bathroom vent system(s) were not present at the time of the inspection. The purpose of a bathroom vent is to remove moisture, humidity, and odors from the bathroom.

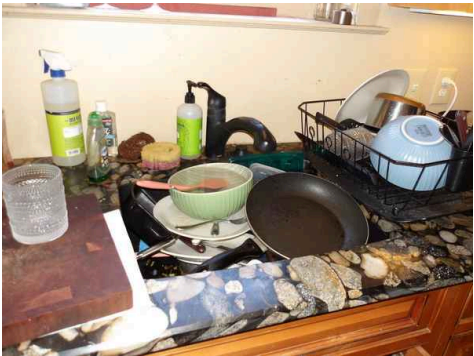
KITCHEN SINK: FILLED WITH DISHES

I observed the kitchen sink was filled with dishes at the time of inspection. This condition limited visibility and restricted a full evaluation of the sink basin, fixtures, and drainage components. I recommend clearing the area to allow for a more complete inspection if concerns are present.

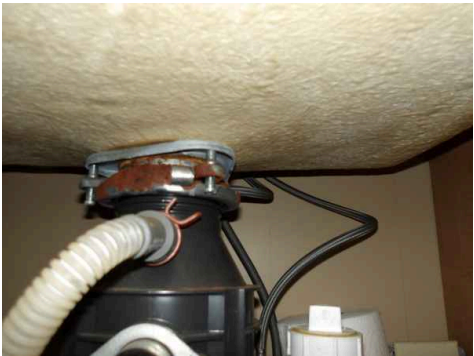
KITCHEN SINK: CORRODED BASKET ASSEMBLY

I observed corrosion at the kitchen sink basket assembly. This condition can lead to leakage, restricted drainage, and further deterioration over time. I recommend having a qualified plumbing contractor replace the basket assembly to ensure proper function and prevent leaks.

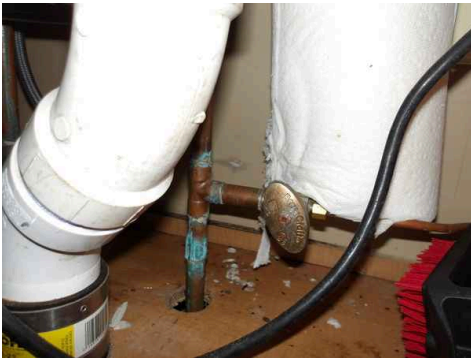
KITCHEN SINK SUPPLY VALVE: CORRODED

I observed corrosion at the kitchen sink supply valve. This condition can lead to restricted operation or potential leakage over time. I recommend having a qualified plumbing contractor replace the valve to ensure reliable performance.

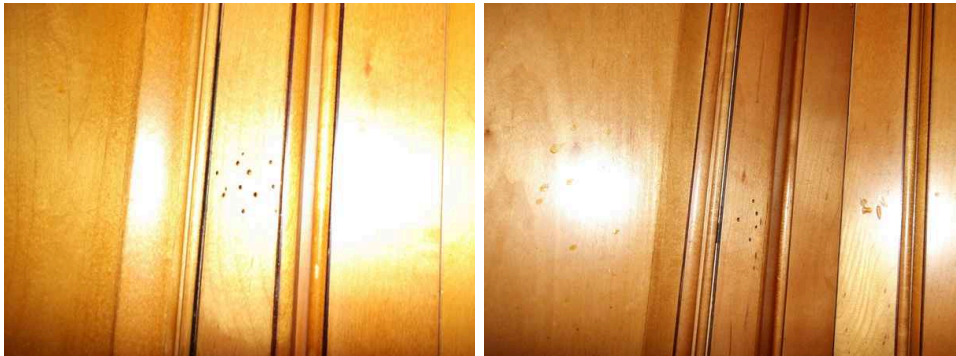
I observed multiple pinholes at cabinet surfaces, with the cause not determined at the time of inspection. This condition appears cosmetic but may indicate wear, material defects, or prior repairs. I recommend monitoring the areas and consulting a qualified contractor if the condition worsens or becomes a concern.

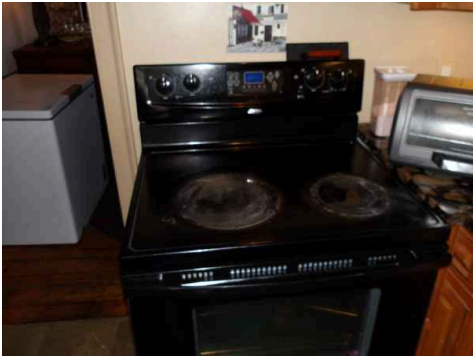
**RANGE BURNER: DIRTY**

I observed the glass burner on the range requires cleaning. This condition can affect burner performance and heat distribution during use. I recommend cleaning the burner surface to maintain proper operation and appearance.

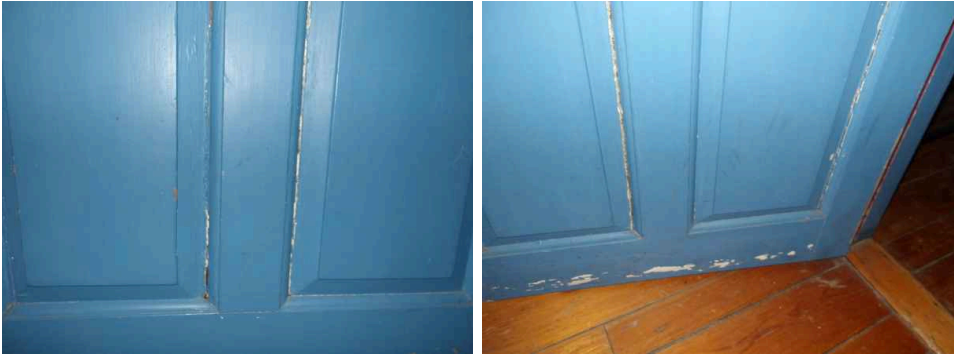
CRACKED/SPLIT DOOR

I observed a crack or split in one of the doors, which may impact its appearance and could worsen over time with regular use. Left unattended, the damage may affect the door's functionality or stability. I recommend consulting a carpenter or door specialist to evaluate repair or replacement options.

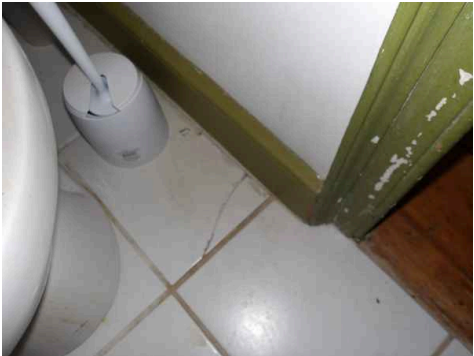
1st Floor Bathroom

**CRACKED TILE**

Cracked tiles were noted in one or more locations. I recommend consulting a tile contractor to repair or replace.

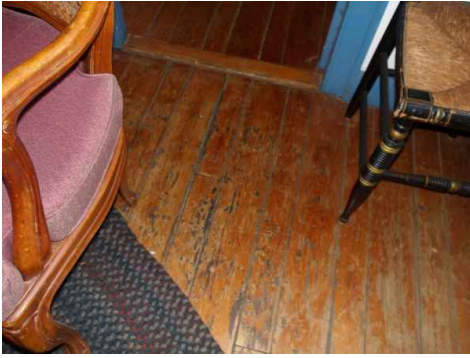
**WOOD FLOORING: AGED AND WORN CONDITION**

The historic wood floors show signs of age-related wear, including surface irregularities and finish deterioration. While still functional, the condition suggests deferred maintenance and may affect appearance or durability over time. I recommend having a qualified flooring contractor assess the floors and perform any needed restoration or refinishing.

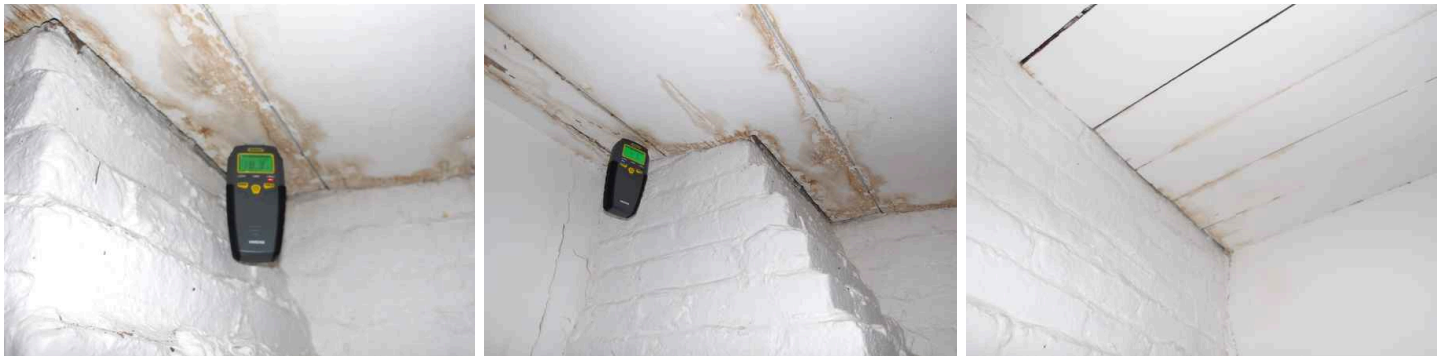
**CEILING: ACTIVE LEAK**

I observed active water leakage at the ceiling. This condition can lead to ongoing damage to finishes and structural components if not addressed promptly. I recommend having a qualified contractor identify and repair the source of the leak and restore the affected areas.

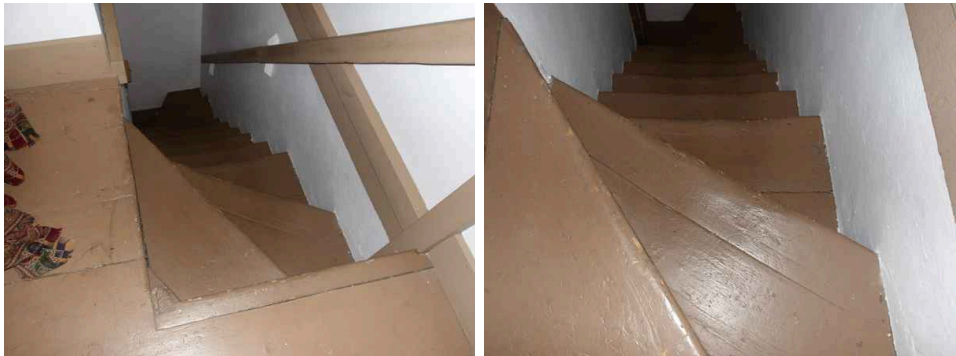
**STAIR TREADS: WORN AND DISHED**

I observed the historic wood stair treads are dished from prolonged foot traffic. This condition can affect footing stability and may increase the risk of slips or trips over time. I recommend having a qualified contractor evaluate and repair or refinish the treads to improve safety and durability.

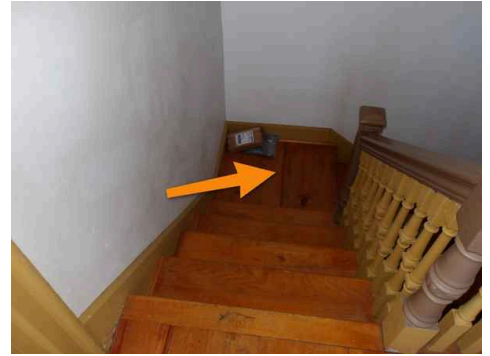
Unit 59 South

**LANDING: GAPS IN PLANKS**

I observed gaps between the wood planks at the landing surface. I recommend having a qualified contractor evaluate and secure or replace the affected boards to improve stability and durability.
