## HISTORIC HOME INSPECTIONS REPORT

1234 Main Street  
Newport, RI 02840

08/18/2026 9:00AM

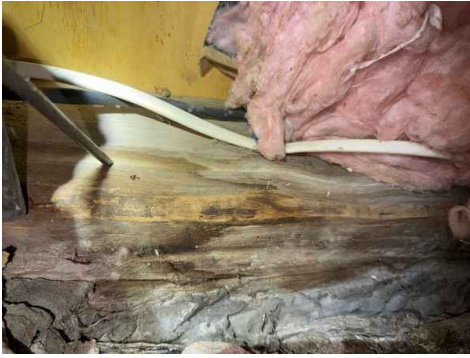
6.2.3 Floor Structure

I observed powder post beetle damage and exit holes at structural members within the floor system. This condition may reduce the strength of affected wood components and could indicate past or current wood-destroying insect activity. I recommend further evaluation and preventative treatment by a qualified pest control professional, and evaluation of affected structural members not already addressed by a qualified structural contractor out of an abundance of caution, with corrective measures completed as needed.

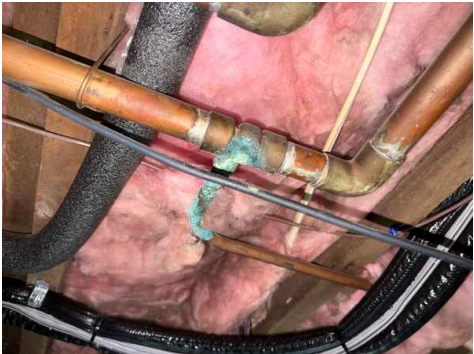
8.5.1 Hot Water Storage Tank

MISSING TPR DISCHARGE PIPE

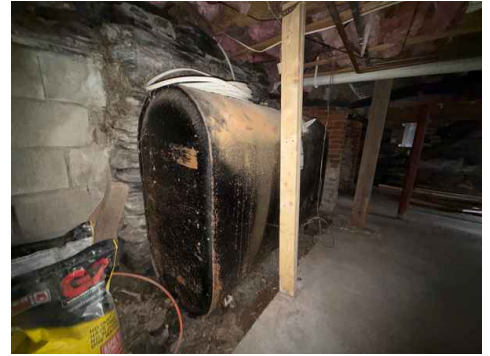
## 8.6.2 Fuel Storage Systems

**OIL TANK BEYOND LIFE EXPECTANCY**

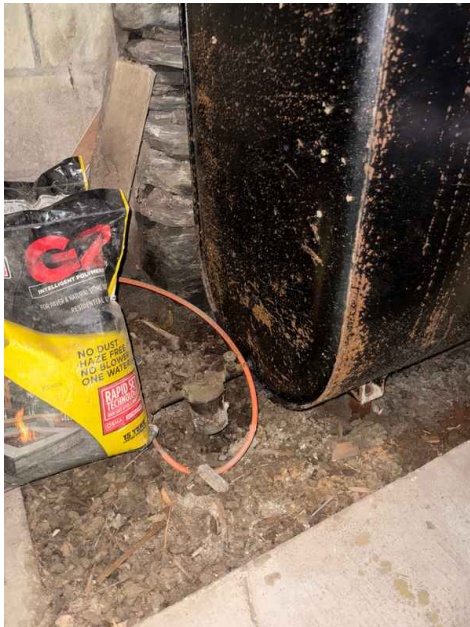
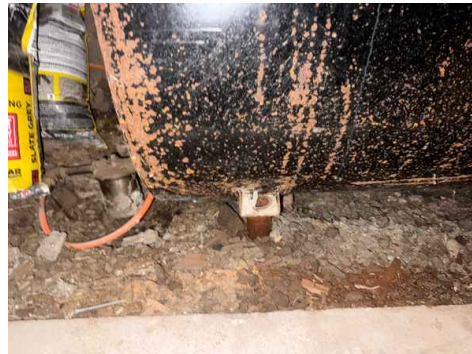
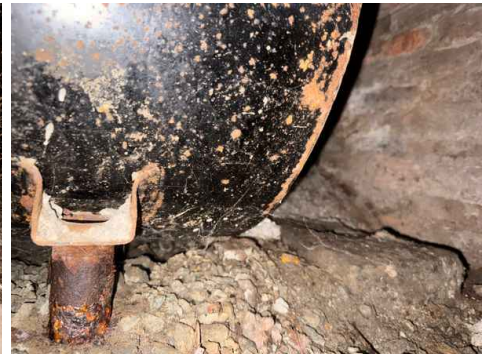
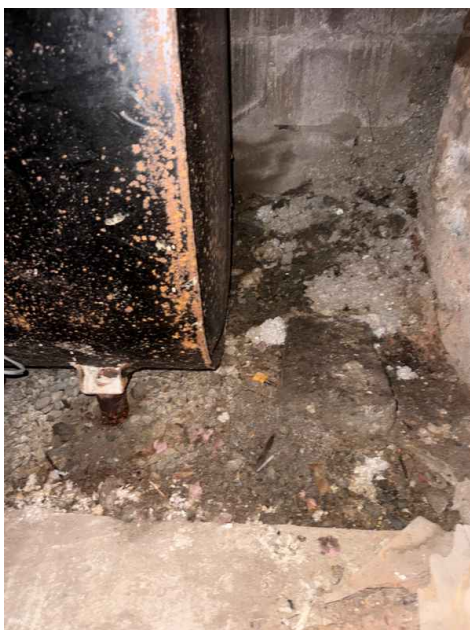
8.6.3 Fuel Storage Systems

OIL TANK: FILL AND VENT PIPES TOO SHORT

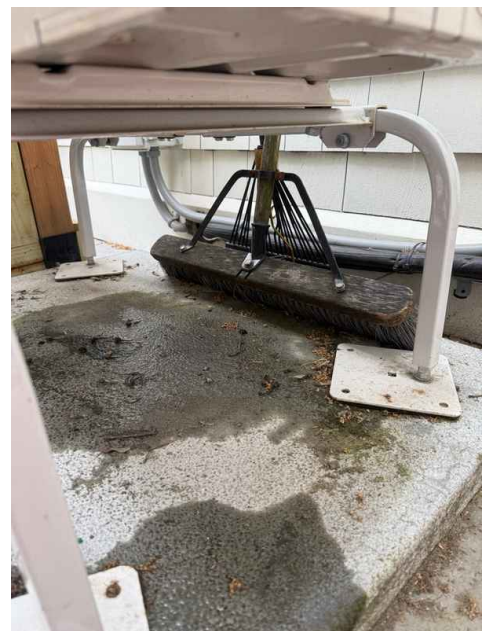
#### 9.2.1 Boiler

### MULTIPLE BOILER DEFECTS
